CALIFORNIA PUBLIC UTILITIES COMMISSION
Safety and Enforcement Division
Electric Safety and Reliability Branch

Incident Investigation Report

Incident Number: E20191024-01

Regulated Entity Facilities Involved: Geysers #9 Lakeville 230 kV Line

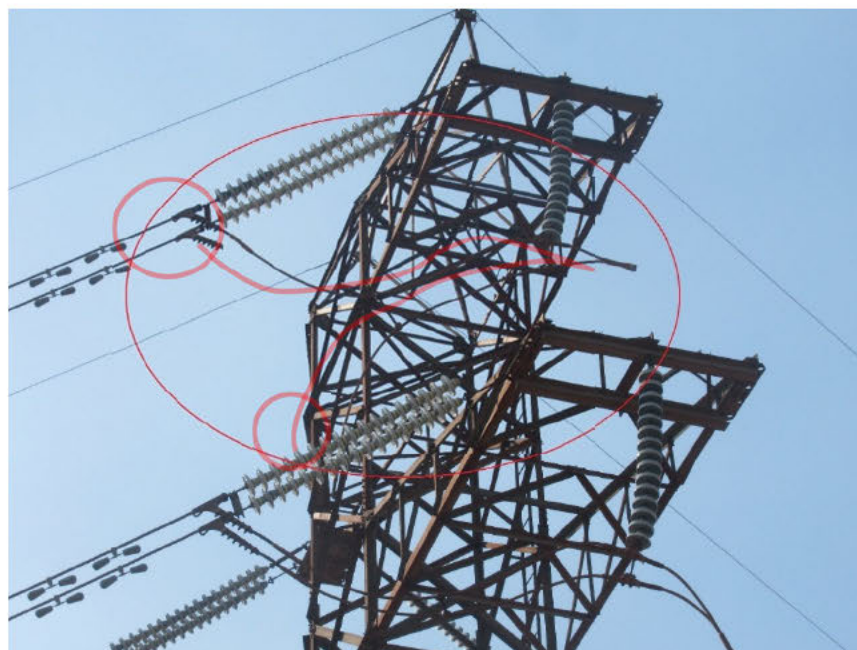
Figure 6: Broken jumper cable on Incident Tower, taken prior to evidence removal. Note that only one strand of the jumper cable’s two stands is broken. The other strand is still attached to its shoe.

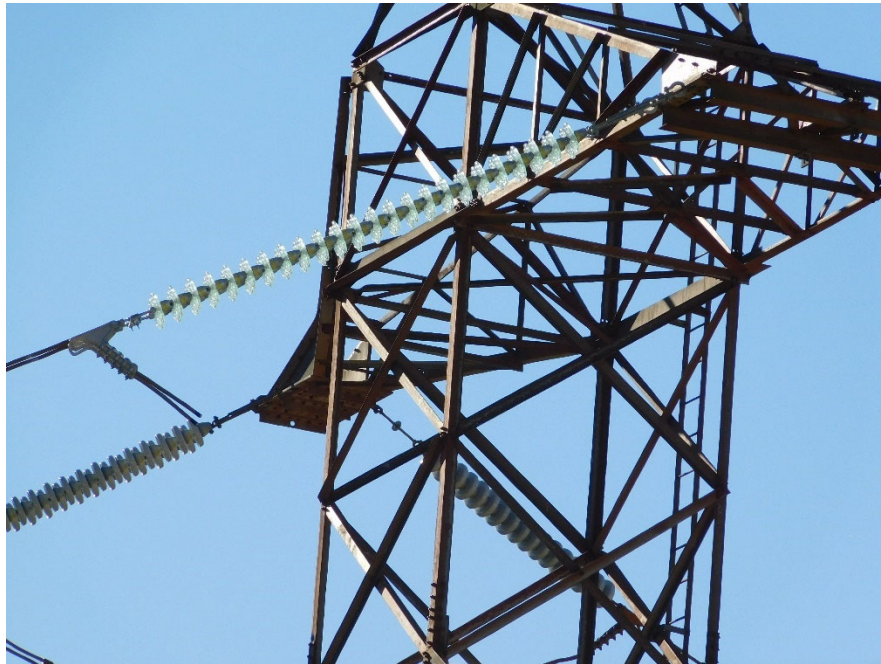
Figure 7: Installation of new insulator strings.

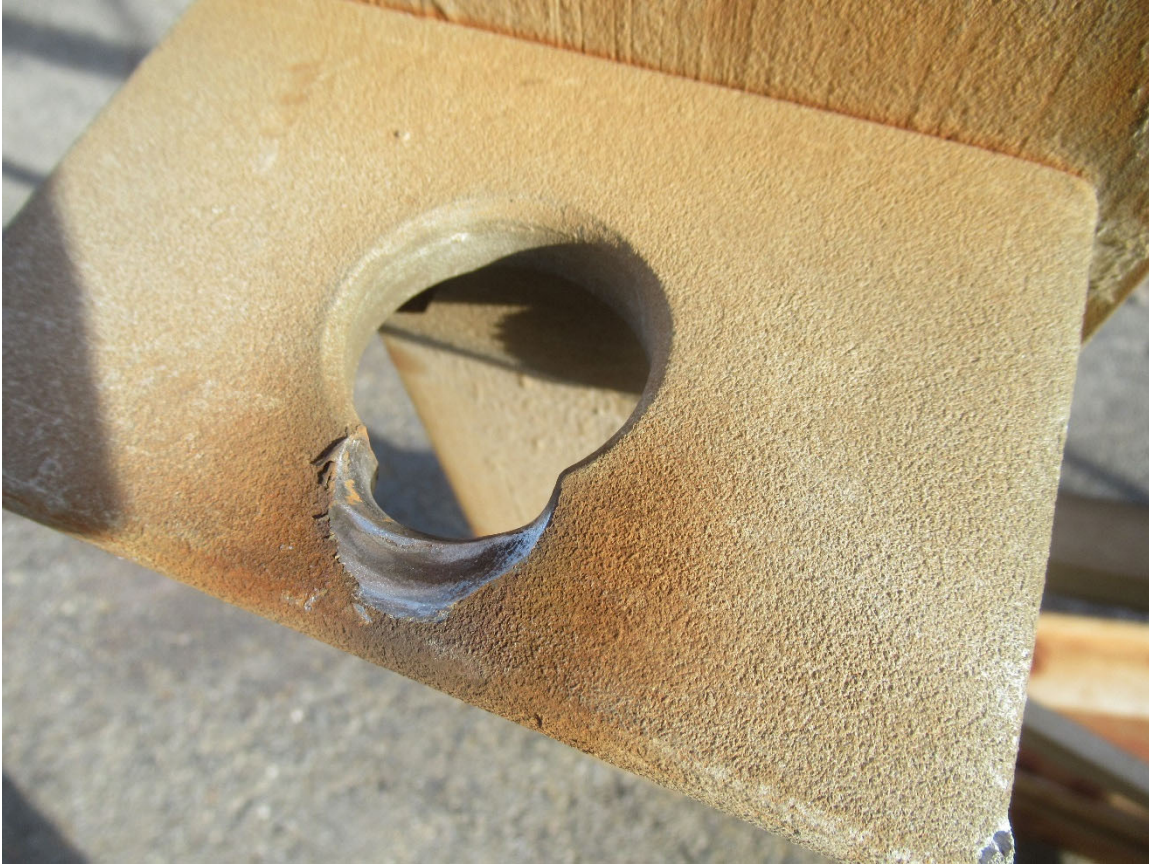
On November 13, 2019, SED accompanied PG&E as PG&E collected evidence from the Incident Site. Physical evidence was collected by a contractor retained by PG&E. PG&E collected the sections of the tower arm that CAL FIRE did not collect and had left at the Incident Site. SED noted that the bolt holes in that section of the tower arm showed signs of wear as shown in Figure 8.

Figure 8: Bolt hole on tower arm collected by PG&E on November 13, 2019.

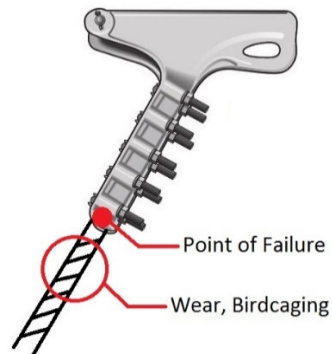
The failure point of the jumper cable was in the exit portion of the shoe shown in Figures 10 and 11. The two ends of the jumper cable on each side of the failure point showed different types of damage. The end of the broken jumper cable that is not in the shoe shows signs of arcing damage and appears to be melted and smoothed over as shown in Figure 12. On the other hand, the ends of the aluminum strands inside the shoe were jagged, with no signs of melting as shown in Figure 11. The lack of apparent melting implies that the portion of the jumper cable inside the shoe did not suffer arcing damage. CAL FIRE also found an additional wire failure inside the jumper cable splice. The wire failure in the splice showed signs of fatigue fracture and arc damage.²³

Figure 10: Depiction of the failure point of the incident jumper cable. Device that the cable is attached to is a strain clamp or “shoe”.

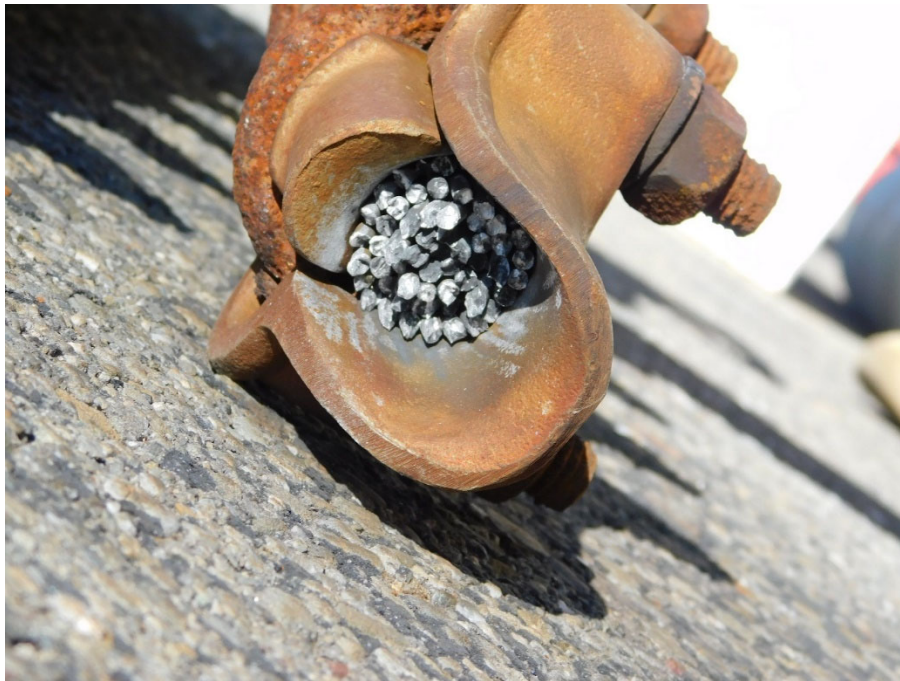
Figure 11: View of the failure point. This segment is still inside the shoe.

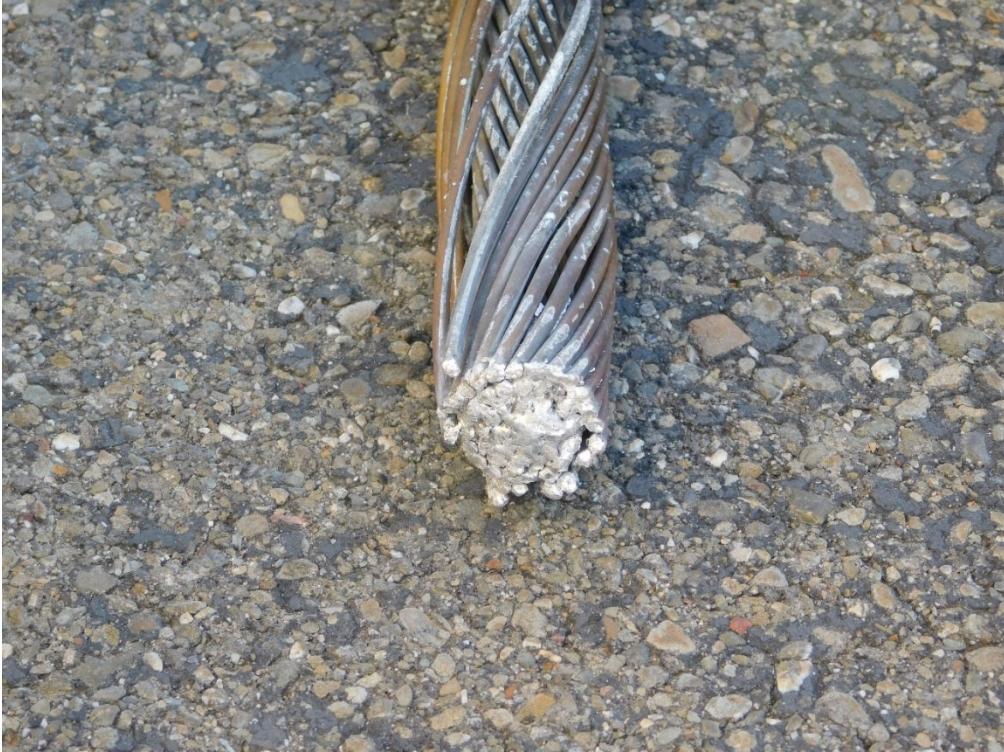
Figure 12: View of the failure point. This is the side of the failure point that was hanging in the air prior to evidence removal.

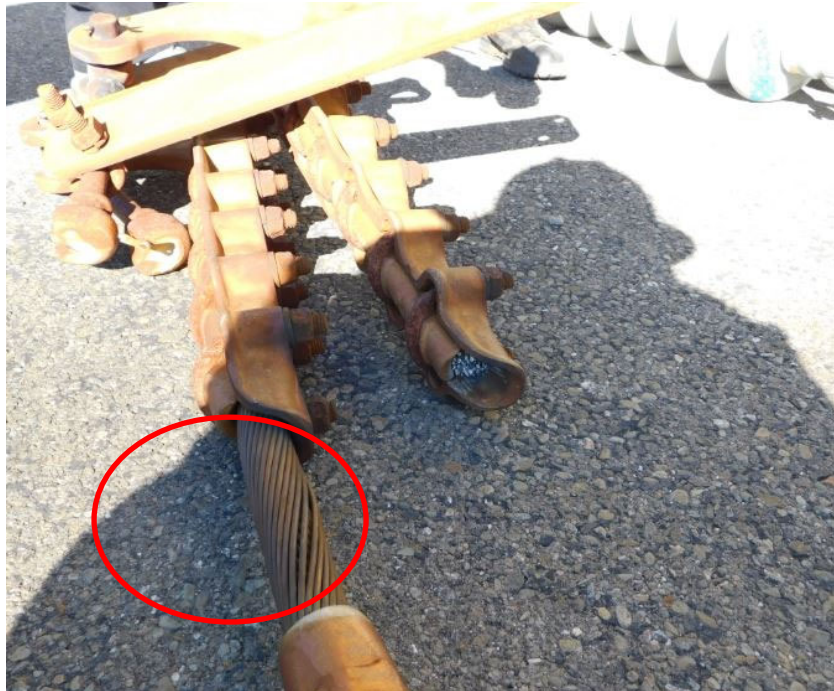
Additionally, the incident jumper cable showed slight signs of bowing or bird-caging at the points near the exit of the shoe. This was noticed not just on the incident jumper cables but also on the other phases' jumper cables for the Incident Line. It is possible that this bird-caging is indicative of fatigue stress on the jumper cables and may have weakened the structural integrity of the jumper cables.

Figure 13: Shoes of the failed jumper cable. Note slight caging on cable that has not failed.

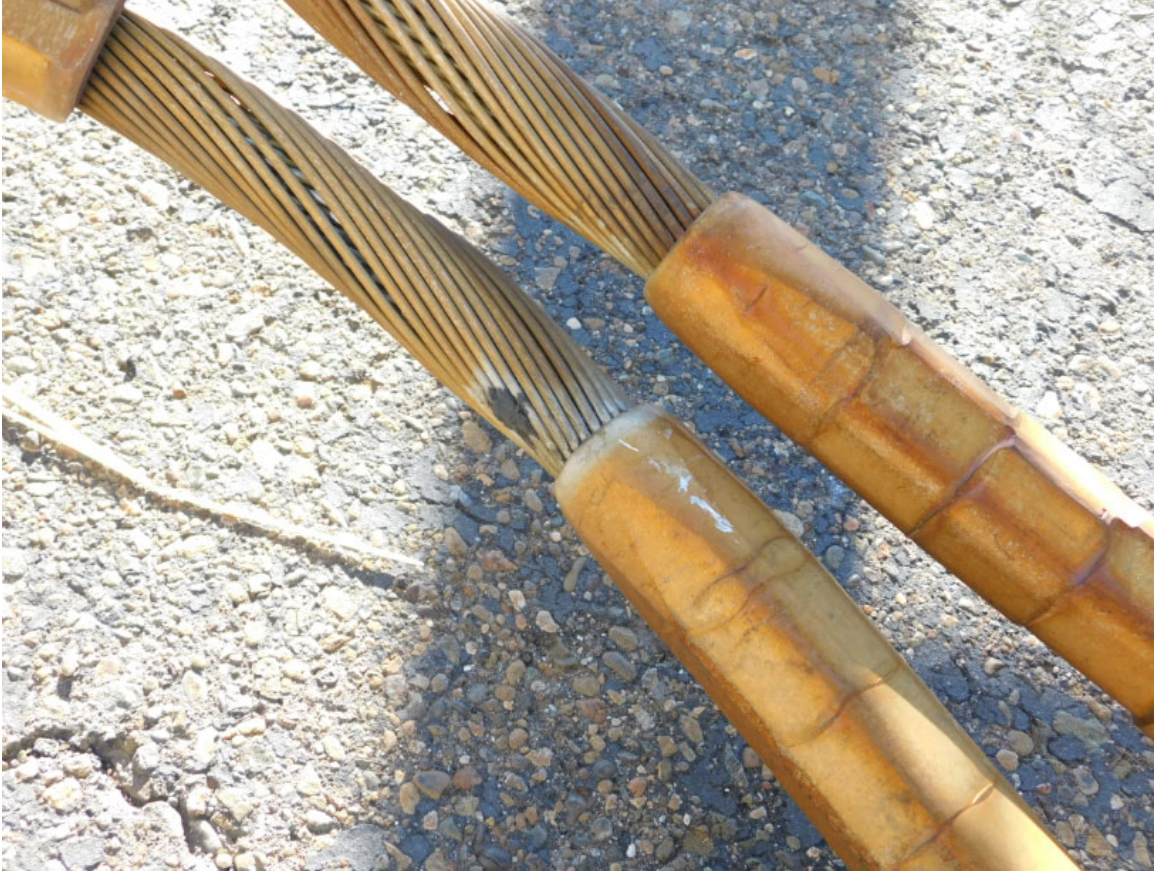
Figure 14: Signs of caging on intact jumper cables removed from the Incident Tower.

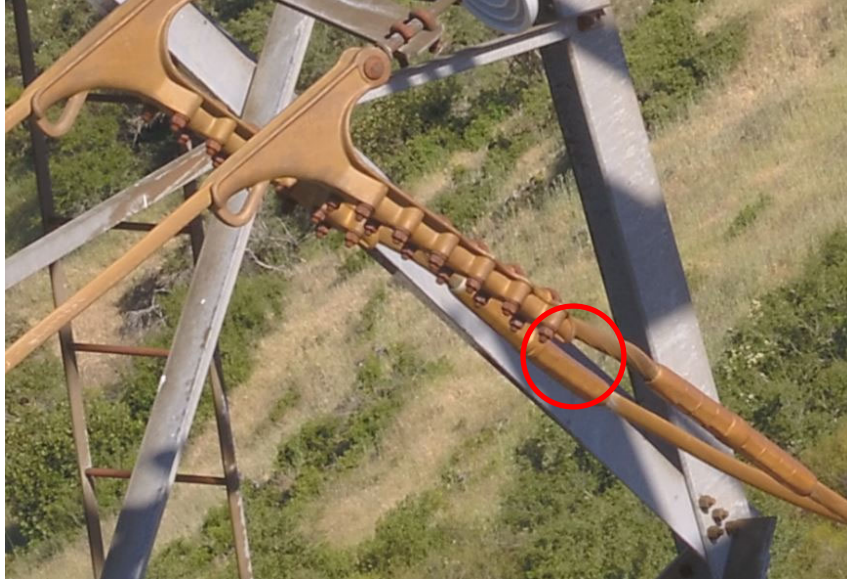
A climbing inspection occurred on February 6, 2019 of the Incident Tower.⁵⁴ The February 6th inspection form indicates that the inspector found issues with the prevalence of rust on the tower itself.⁵⁵ The inspector also noted a small crack in one of the concrete stubs of the Incident Tower.⁵⁶ However, the inspector found no issue with the jumper cables or insulators on the Incident Tower.⁵⁷ Under the field “Jumper in poor condition” the inspector’s input was “no.”⁵⁸ In reviewing photographs taken from the May 11, 2019 inspection of the Incident Tower, SED noted that the bowing present in the jumper cables on the Incident Line-side of the tower during the Incident Site visit was also present during the May 11, 2019 inspection as shown in Figure 17.

Figure 17: Jumper cable and shoe from May 11, 2019 drone inspection. Note signs of caging/bowing near shoe closer to the camera.⁵⁹

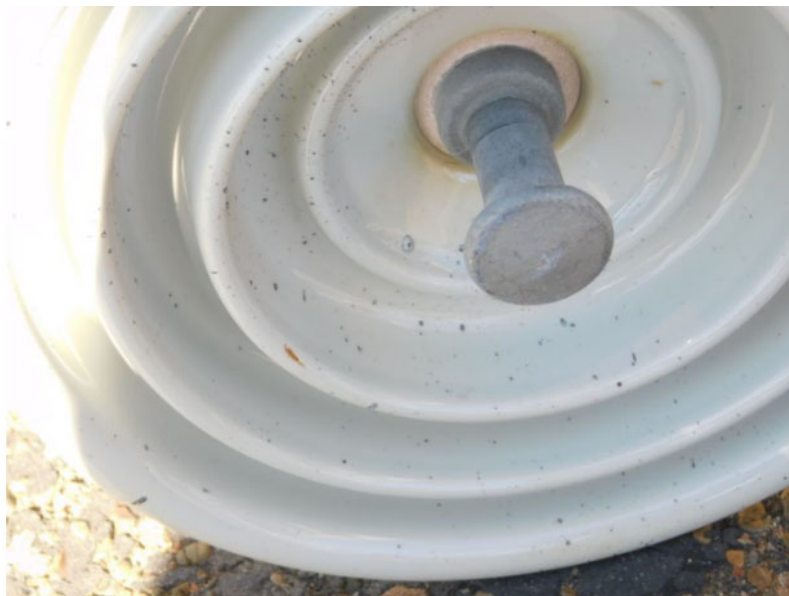
When PG&E removed the insulators from the topmost arm of the Incident Tower on November 1, 2019, the insulators were in good condition. The insulators, which are shown in Figure 18, appeared to have arcing residue, presumably from the incident.⁶⁰

Figure 18: Insulator string that was attached to incident Jumper Cable. The grey spots on the ceramic “skirt” are the arcing residue.
