PUBLIC UTILITIES COMMISSION

SUBJECT: Communications Infrastructure Audit of Sierra Telephone Company

CPUC AUDIT FINDINGS OF SIERRA TELEPHONE COMPANY

April 12-16, 2021

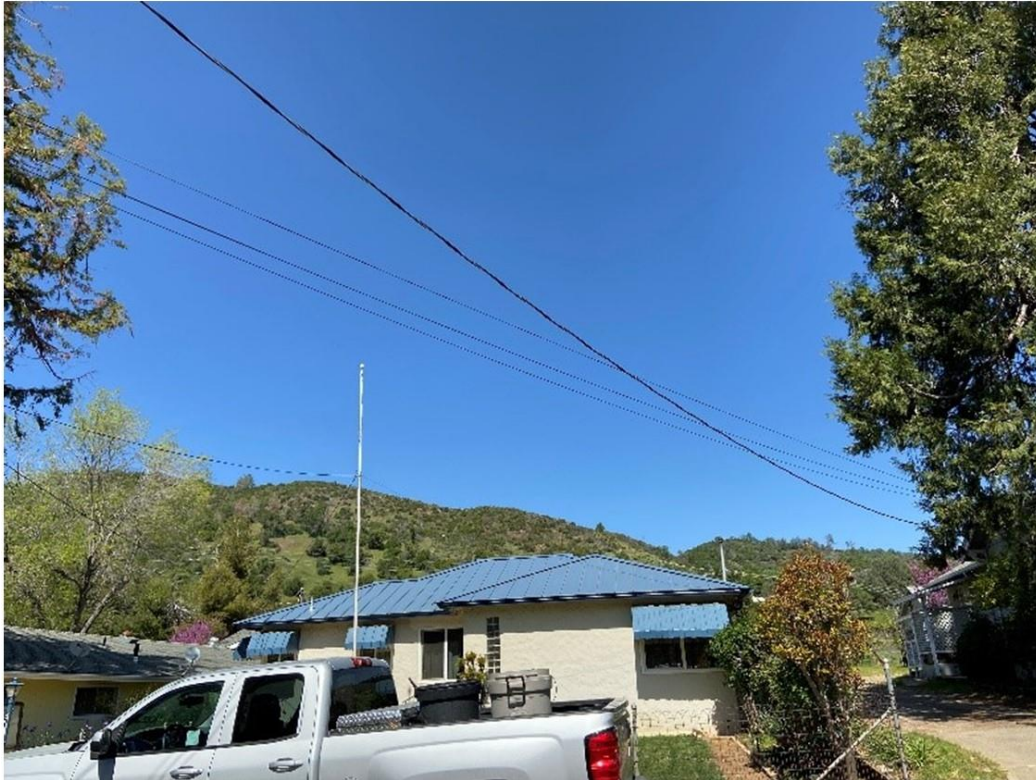
Figure 2: Clearance Issue at Location 10

GO 95, Rule 38 – Minimum Clearances of Wires from Other Wires, Table 2, Column C Case No.’s 9, 10, 11, 12, and 13 provides the minimum allowable clearances between communication conductors (including open wire, cables, and service drops) and supply conductors. The minimum clearance between communication conductors and supply conductors is 48”, with a greater minimum value with increased supply conductor’s voltage.

Communication cable located at Location 10 - 5020 Mariposa Street, Mariposa was within the minimum 48” clearance of a supply conductor. Refer to Figure 2.

Sierra is required to correct this deficiency to meet the requirement of GO 95, Rule 38, Table 2.

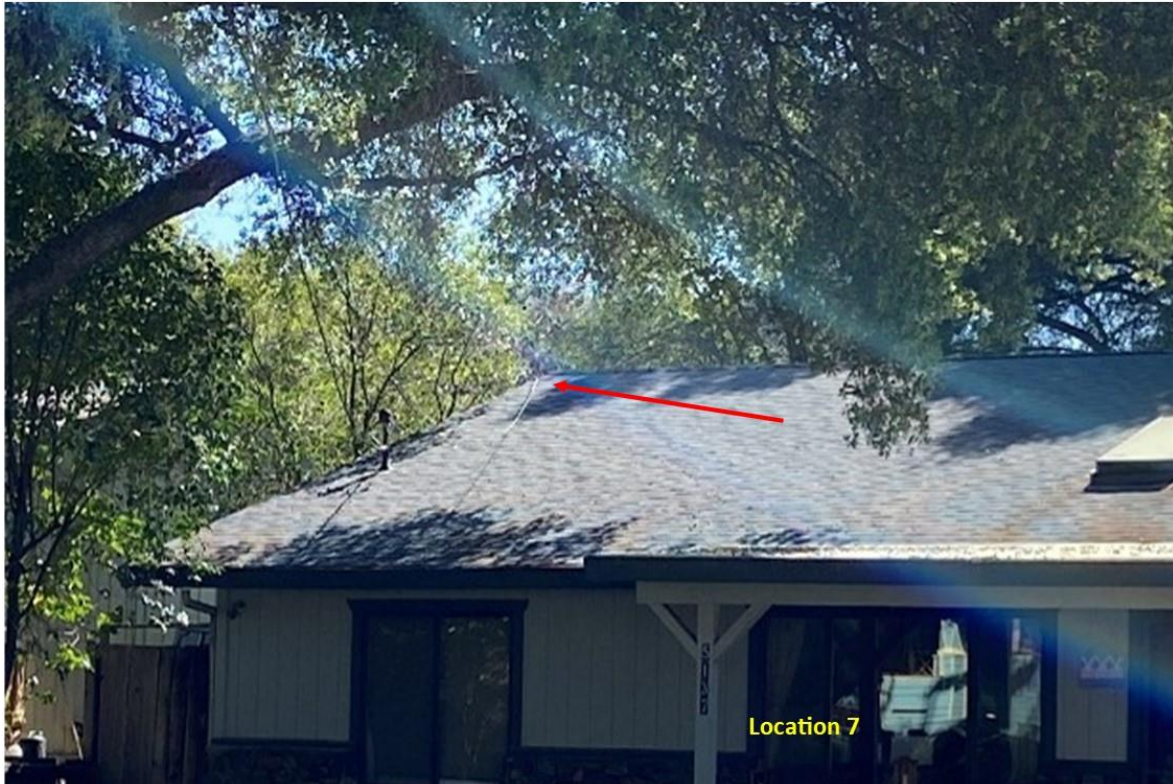
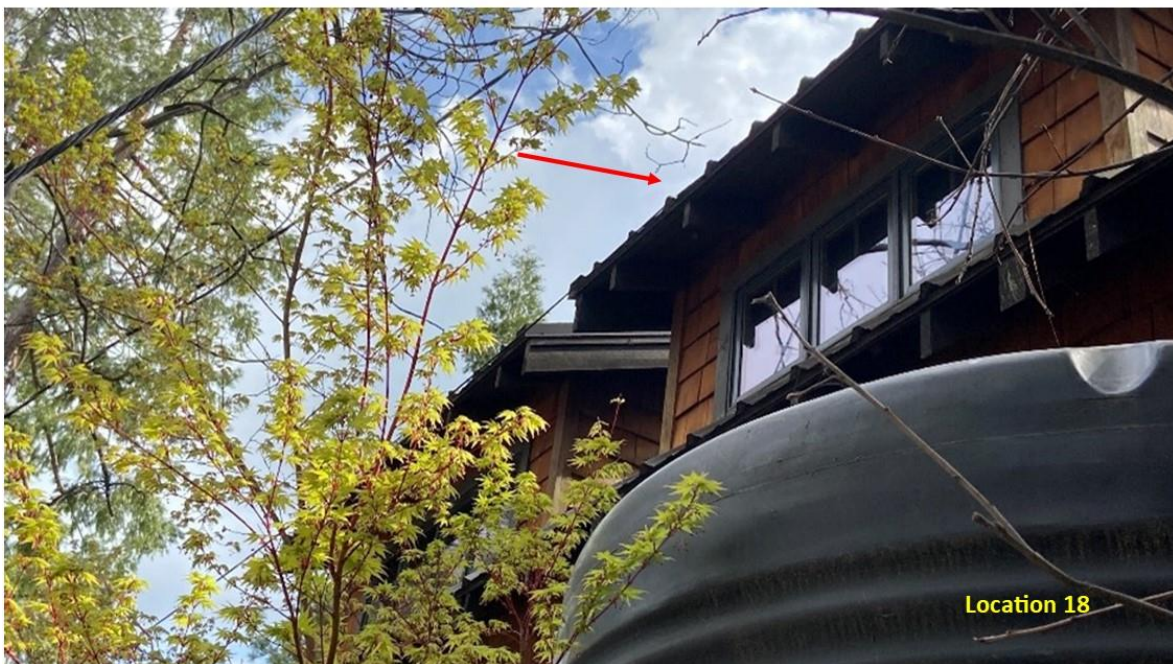
Figure 3: Clearance Issue at Location 7 and 18

Service drops are not required to clear the roofs of buildings on the premises served any specified vertical distance. The vertical clearance above buildings on premises other than the one being served shall not be less than 8 feet, except that a reduction to not less than 2 feet is permitted under either of the following conditions:

Figure 3 shows the following two locations where overhead service drops contacted the roof of buildings that are not the ones receiving the services from the service drops:

- Location 7 - 5137 Jones Street, Mariposa
- Location 18 - 39047 Island, Bass Lake

Sierra is required to correct these deficiencies to meet the requirements of GO 95, Rule 84.8.C.(4).

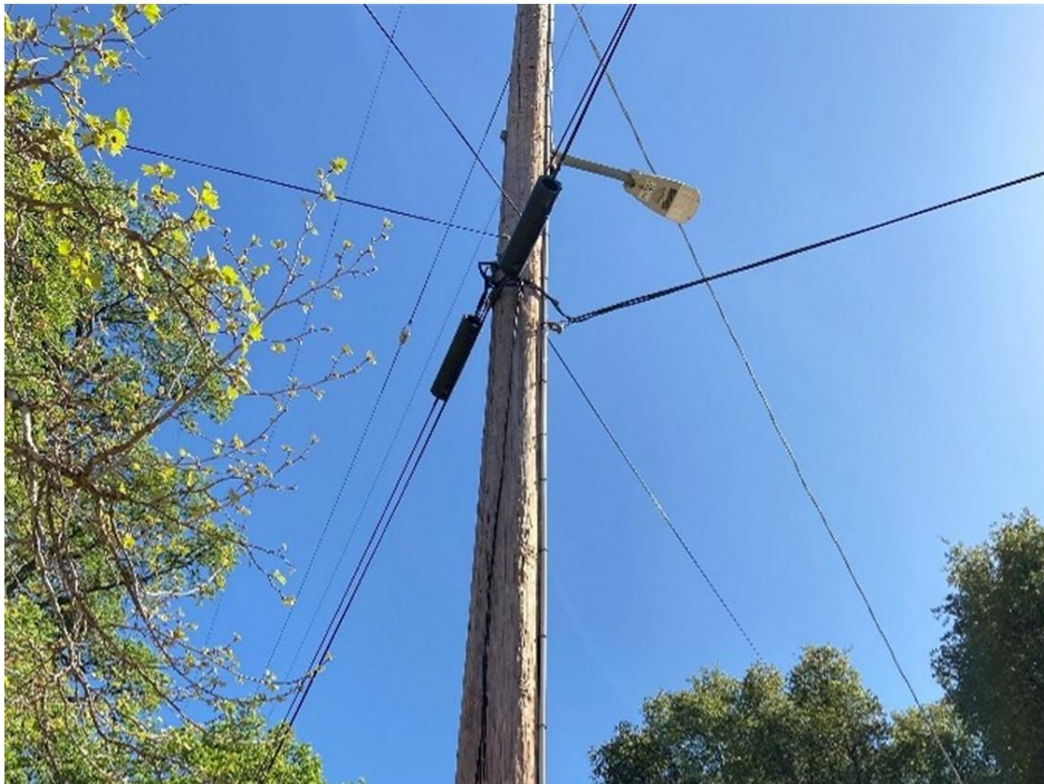
Figure 4: Ownership Marking Issue at Location 5

“Each communication cable and conductors as defined by Rules 20.4, 20.6(A), 20.9, 84.1, 87.4(C), and 89.1 that is attached to a joint-use pole shall be marked as to ownership. The marker shall (1) identify the owner of the cable and/or conductor; (2) provide a 24 hour contact number for emergencies or information; (3) be made of weather and corrosion resistant material; and (4) be clearly visible to workers who climb the pole or ascend by mechanical means. This marking requirement applies only to (A) new construction, (B) of facilities, and (C) existing aerial communication cables and conductors that a technician works on when the technician ascends the joint-use pole for regular maintenance.”

Sierra’s overhead lines at Location 5 do not have ownership markings. Refer to Figure 4.

Sierra is required to correct this deficiency to meet the requirement of GO 95, Rule 91.5.

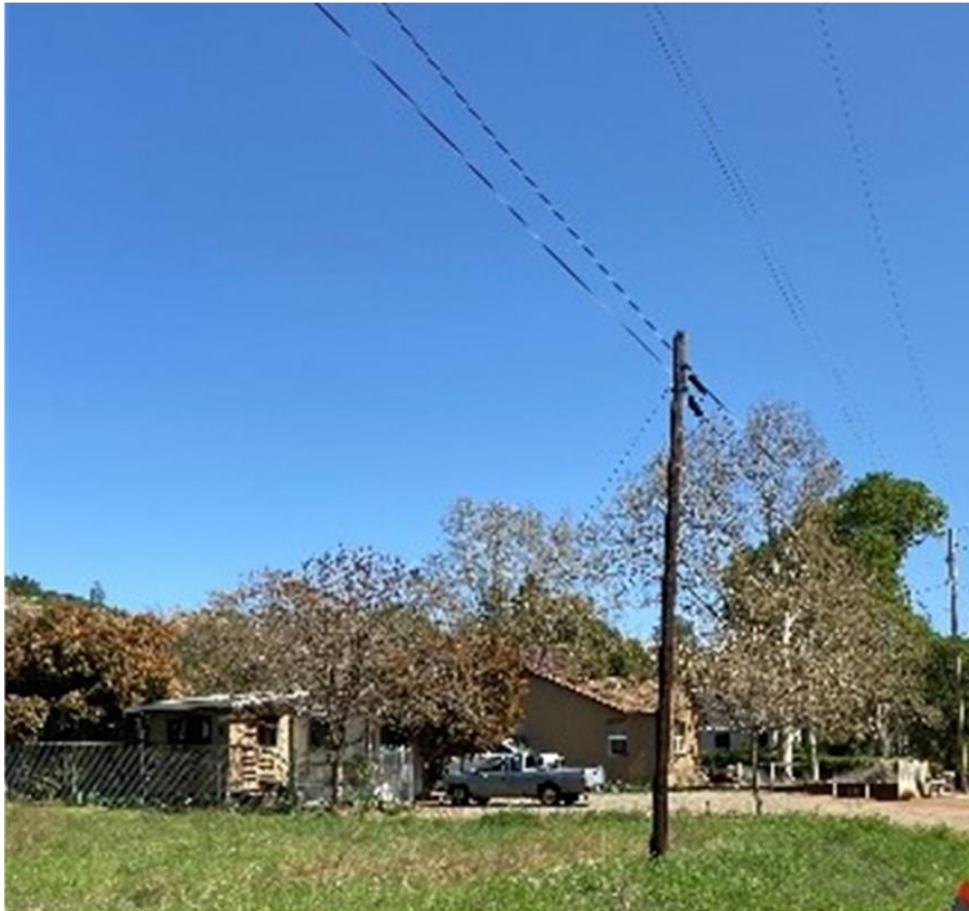
Figure 5: Lack of Intrusive Inspection at Location 5

“Wood poles in Tier 3 of the High Fire-Threat District that support only Communication Lines or equipment shall be intrusively inspected in accordance with the schedule established in General Order 165 if they are:

Sierra did not provide intrusive inspection records for the pole that is owned by Sierra at Location 6 near 5140A Jones Street, Mariposa supports only communication lines within one span of a joint-use pole (Location 5 - Pole #933) supporting supply lines. Refer to Figure 5.

Sierra needs to conduct the required intrusive inspections.

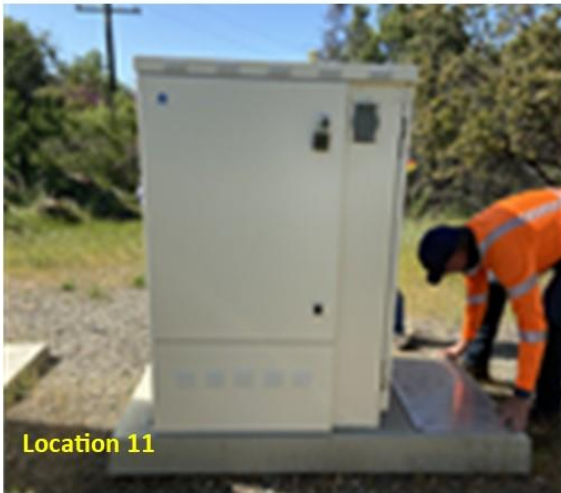
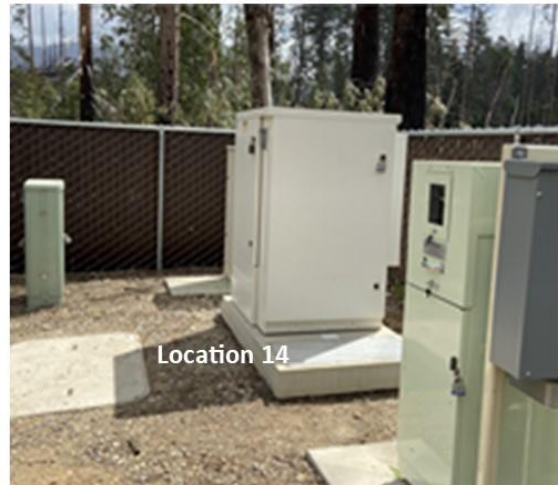
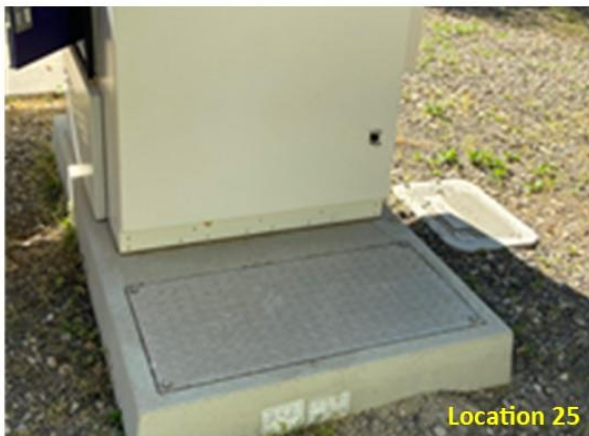
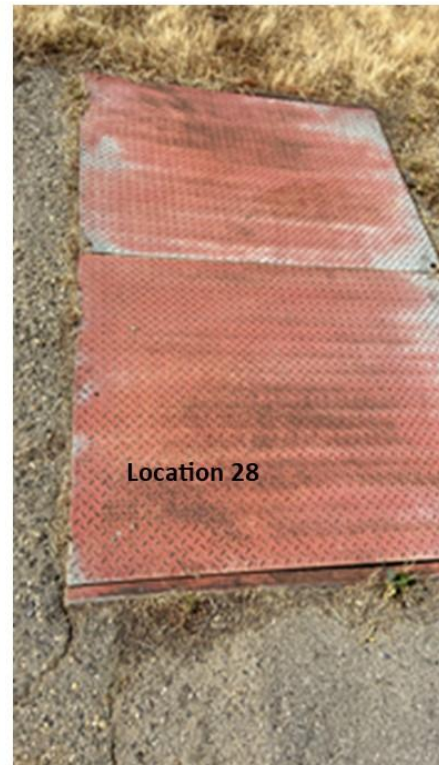
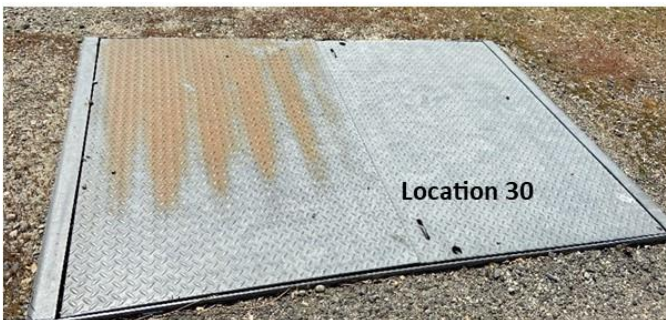
Figure 6: Ownership Marking Issue at Locations 11, 14, 25, 28, and 30

“Manholes, handholes, subsurface and self-contained surface-mounted equipment enclosures shall be marked as to ownership to facilitate identification by persons authorized to work therein and by other persons performing work in their vicinity.”

During the field audit, ESRB noted several locations where Sierra owned manholes, handholes, subsurface and self-contained surface-mounted equipment enclosures were not marked with ownership. Figure 6 shows five locations at which Sierra did not label the ownership of its facilities:

- Location 11 - MEN 11 – Heavy duty vault in equipment pad.
- Location 14 - OHA1 – Heavy duty vault in equipment pad.
- Location 25 - OKT1 – Heavy duty vault in equipment pad.
- Location 28 - OKA1 – Heavy duty vault.
- Location 30 - Raymond CO – Heavy duty vault.

Sierra needs to mark its underground facilities.

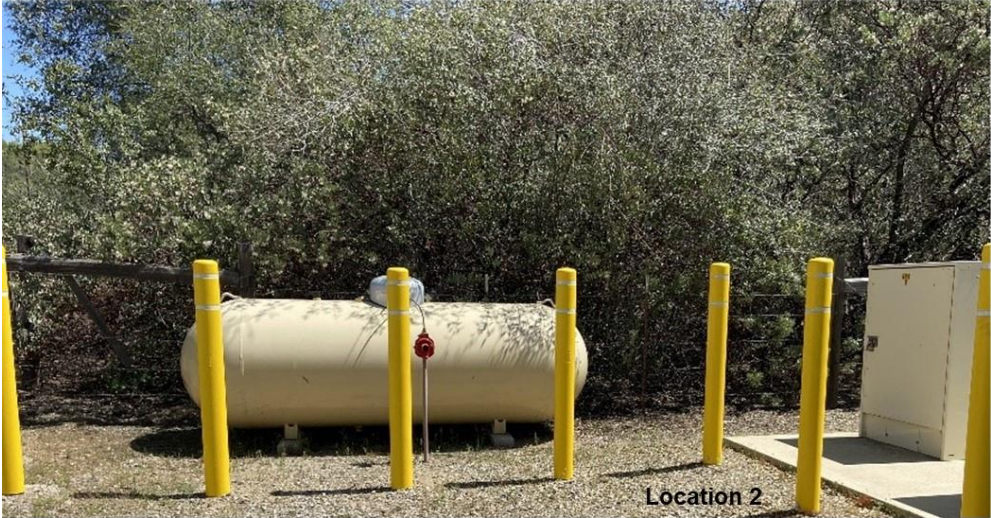
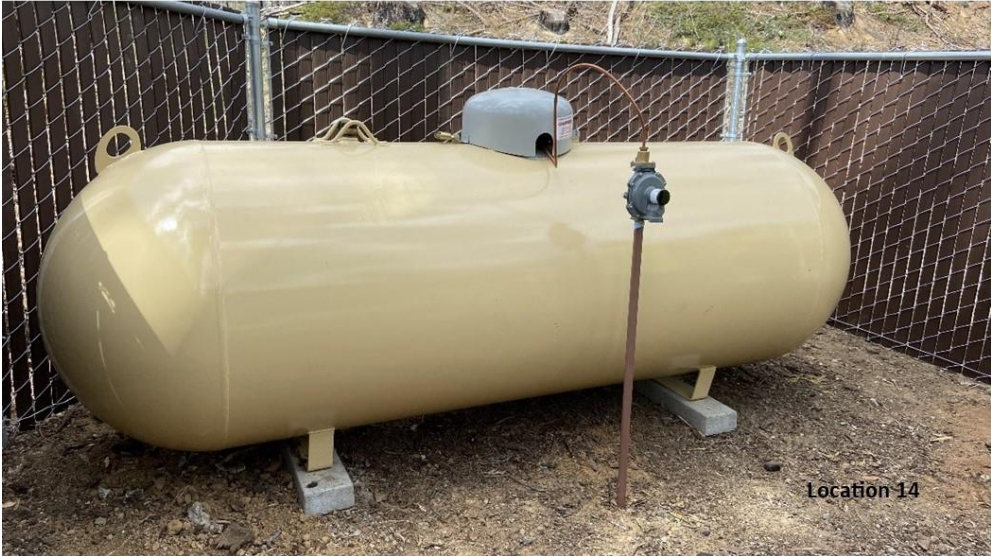
Figure 7: Inadequate labeling at Location 2 and 14

“Cabinets shall be labeled in conspicuous lettering, “Flammable – Keep Fire Away””

Figure 7 shows two locations where Sierra did not have adequate labeling for the propane tanks:

- Location 2 - MAC1
- Location 14 - OHA1

ESRB recommends Sierra correct these deficiencies.
