MERCED IRRIGATION DISTRICT

Subject: Electric Audit of Merced Irrigation District

**MERCED IRRIGATION DISTRICT
ELECTRIC AUDIT FINDINGS
October 9 – October 12, 2023**

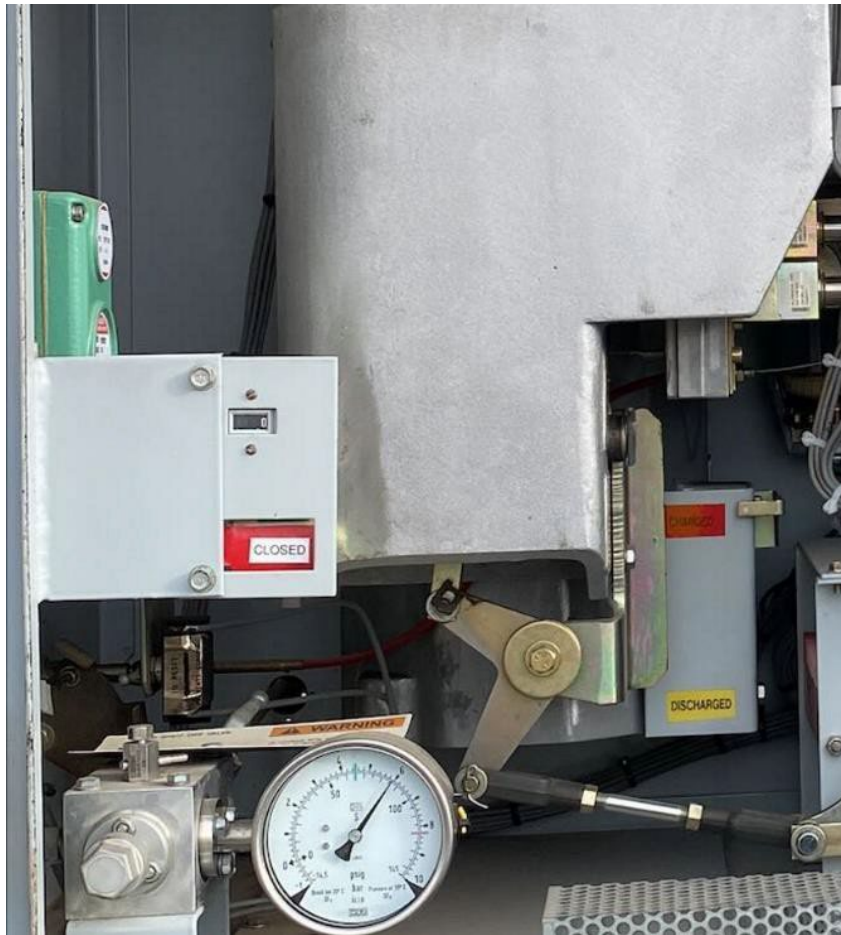
Cooper Substation

1. Circuit Breaker 700 had a faded counter.

Without admitting that MID violated GO 178, Rules 12, MID responds as follows. The above conditions have been recorded in MID's Work Management System, and it will be addressed in accordance with MEID's substation maintenance program. MID will remove Pioneer's substation grounding wire sticking out of ground grid and will continue to monitor its circuit breaker's counters and will schedule replacement of counters when deemed necessary.

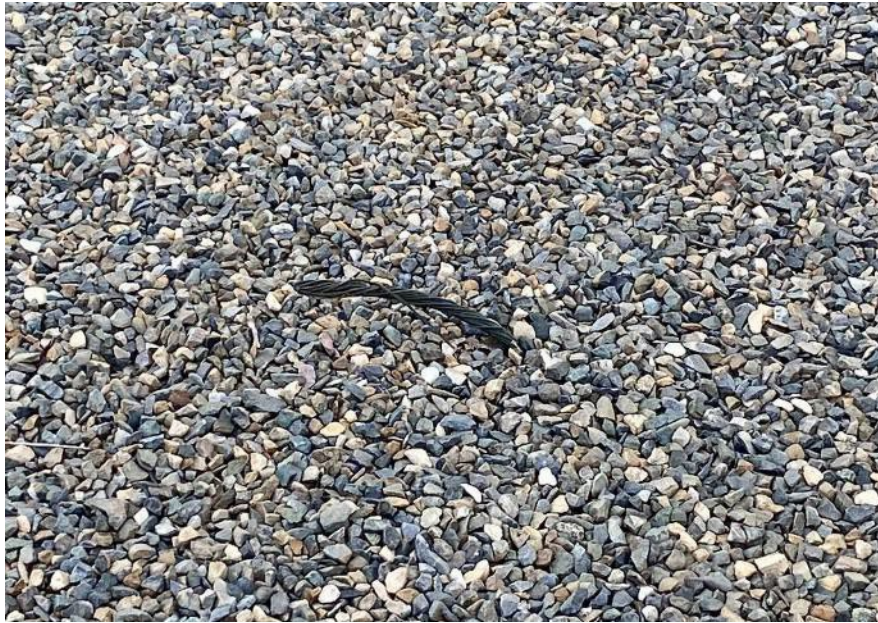
Pioneer Substation

2. Grounding wire was sticking out of ground grid.

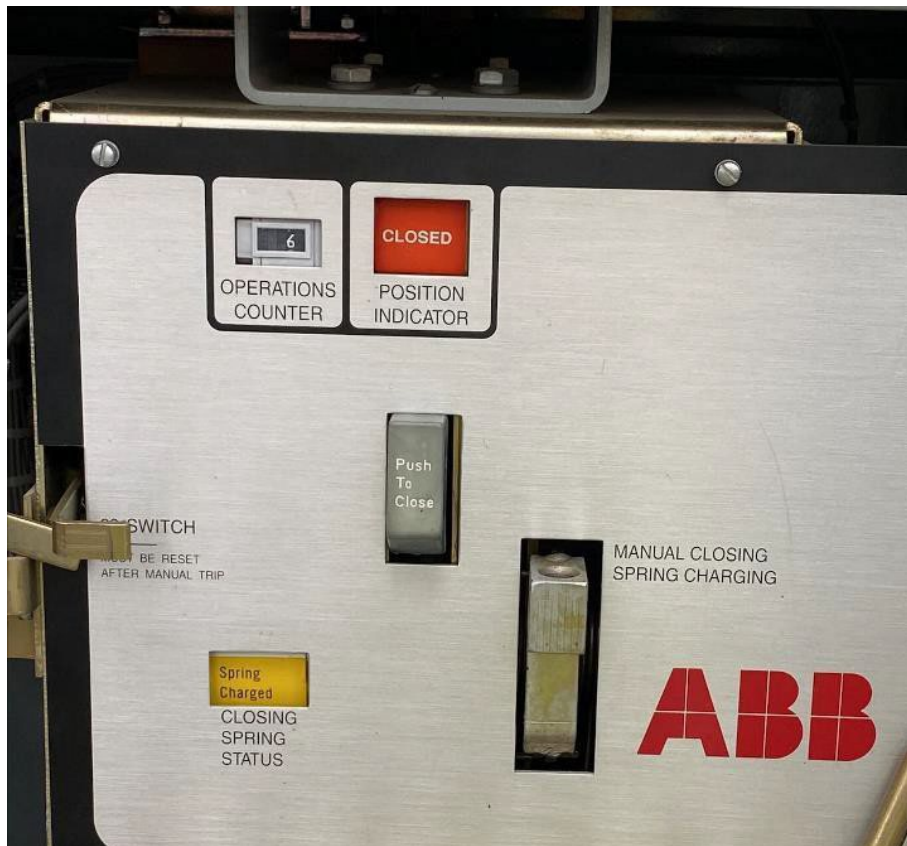
3. VCB 11 had a faded counter.

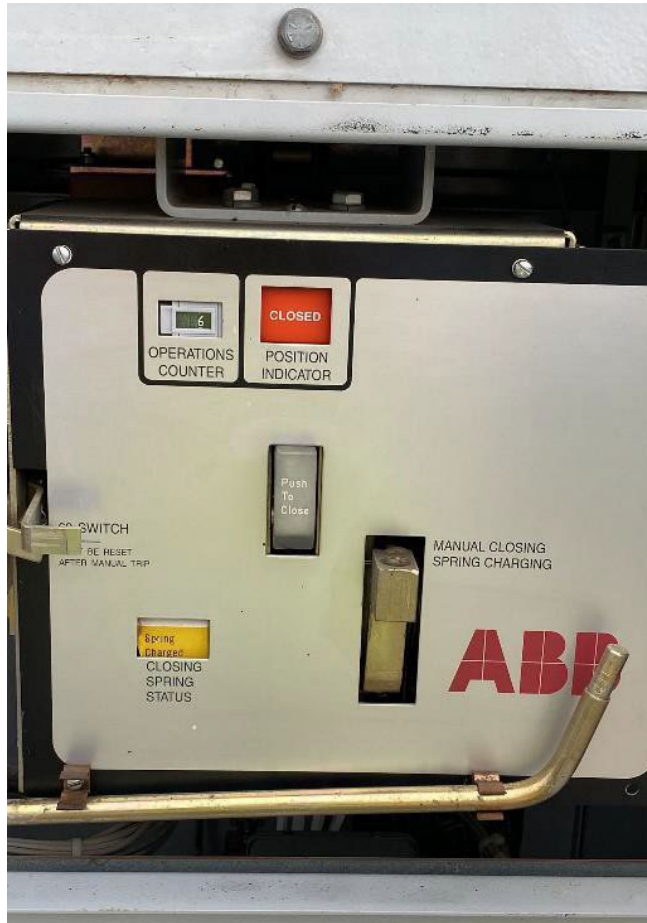
4. VCB 5 had a faded counter.

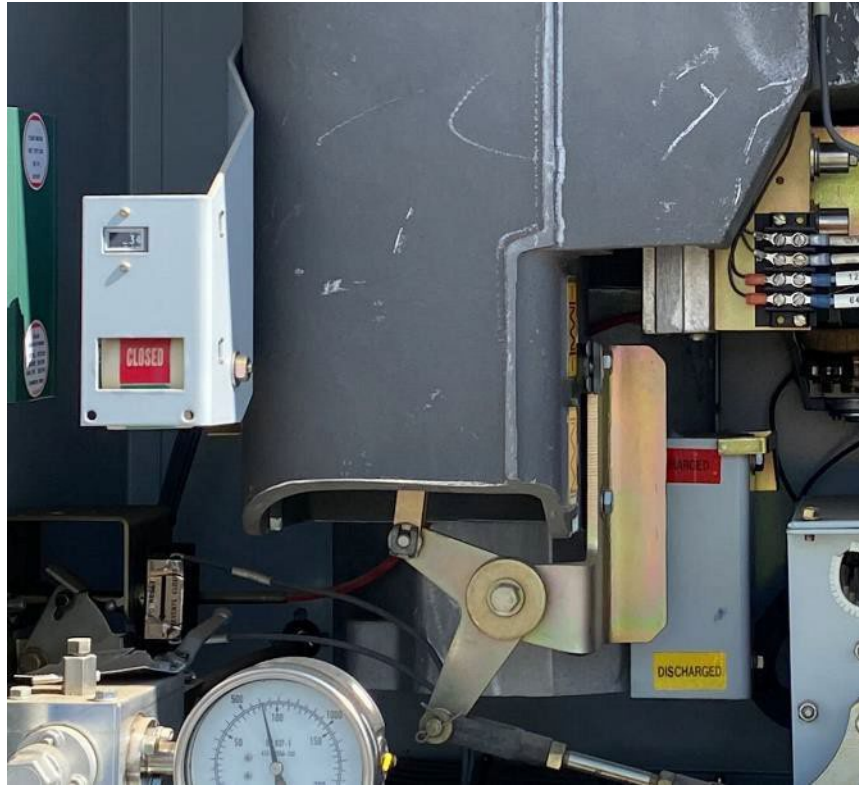
Castle Substation

5. Circuit Breaker 710 has a faded counter.

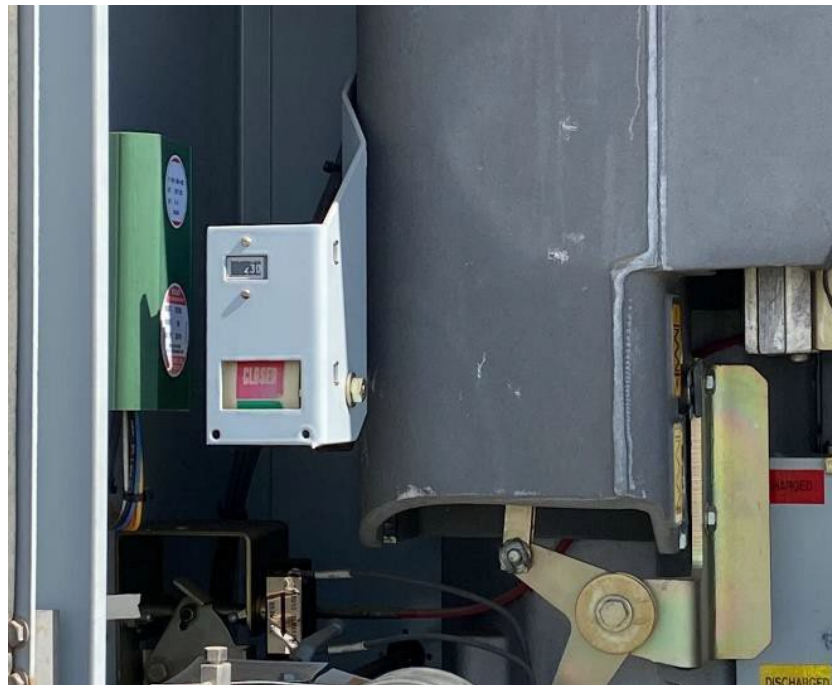
6. Circuit Breaker 700 had a faded counter.

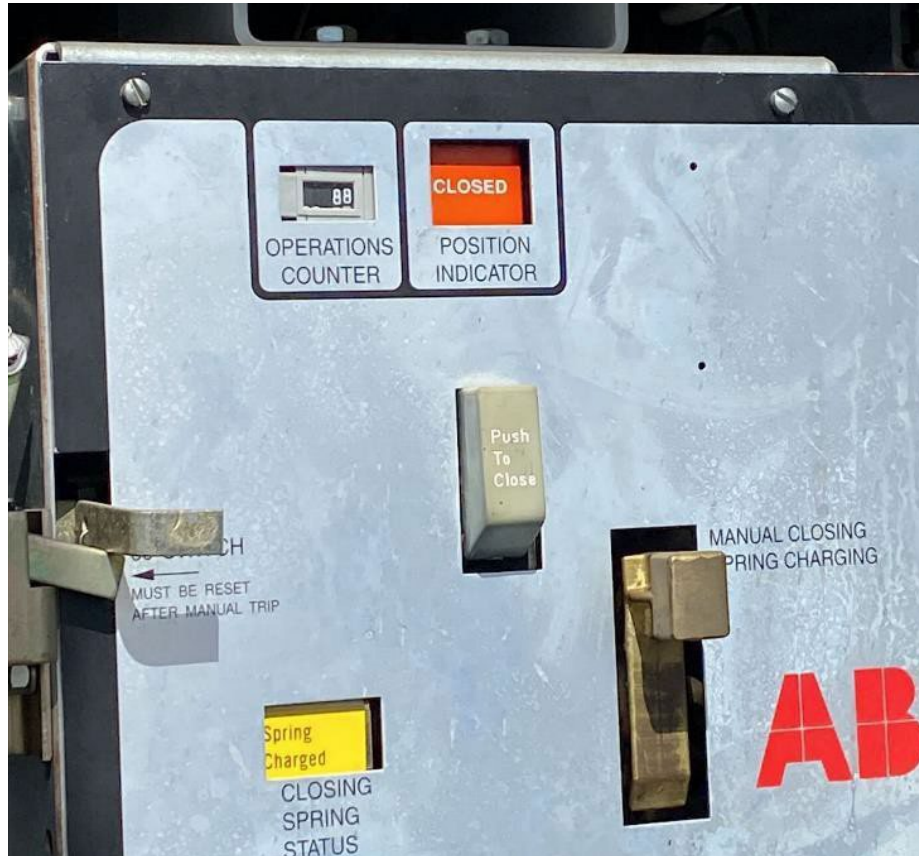
7. Circuit Breaker 4 had a faded counter.
