SA2024-1171

**SUBJECT:** Electric Substation Audit of PG&E Cottonwood Headquarters

**CPUC SUBSTATION AUDIT FINDINGS**  
**PG&E Cottonwood Headquarters**  
**May 6 – 10, 2024**

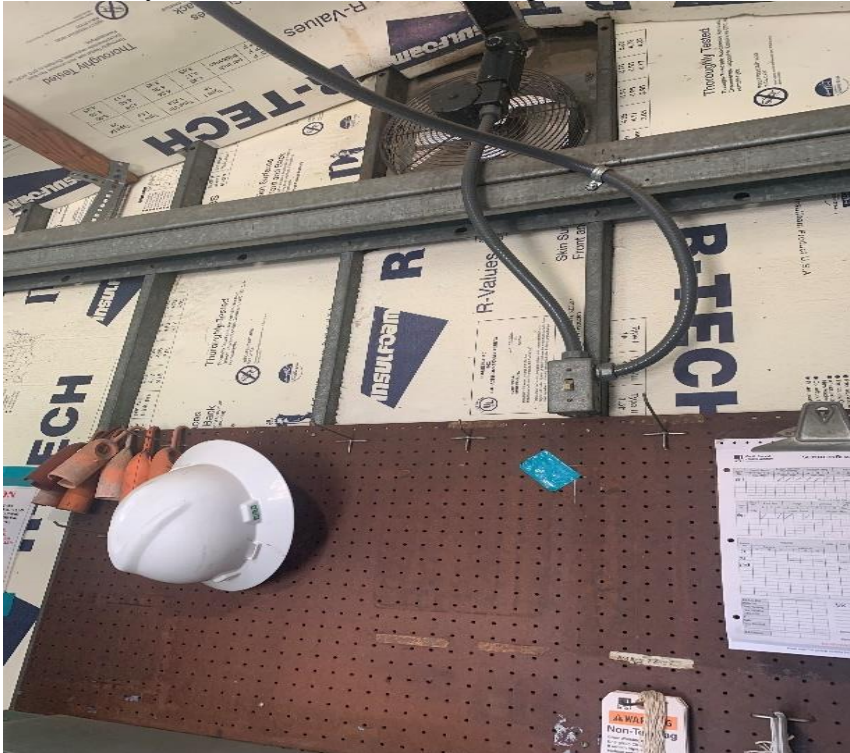
13.5 Battery Room Fan Was Not Working

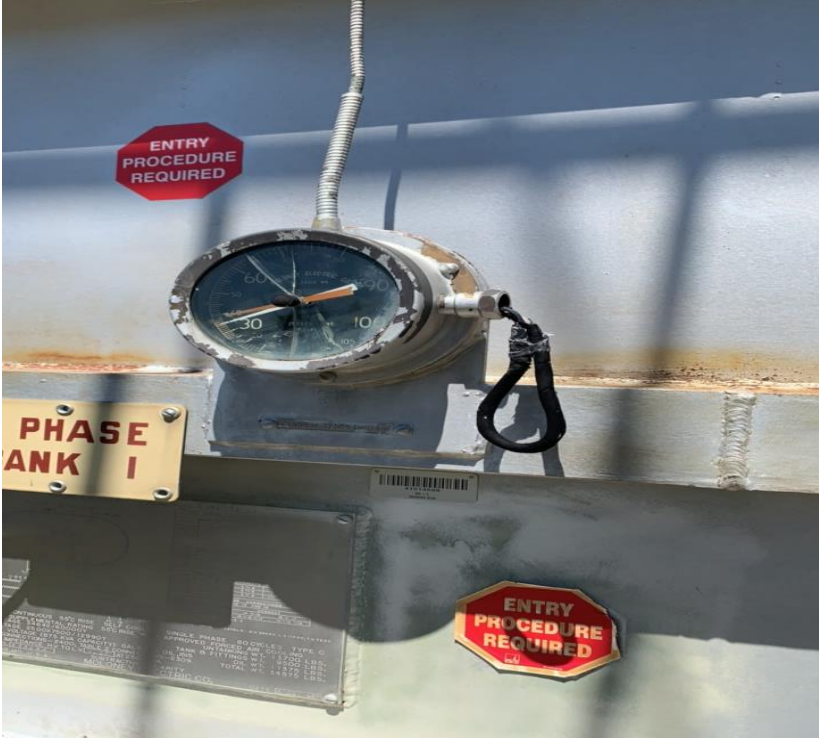
14.1 Transformer Bank 1 Phase C has Cracked Gauge Glass (Existing Tag#128545797)

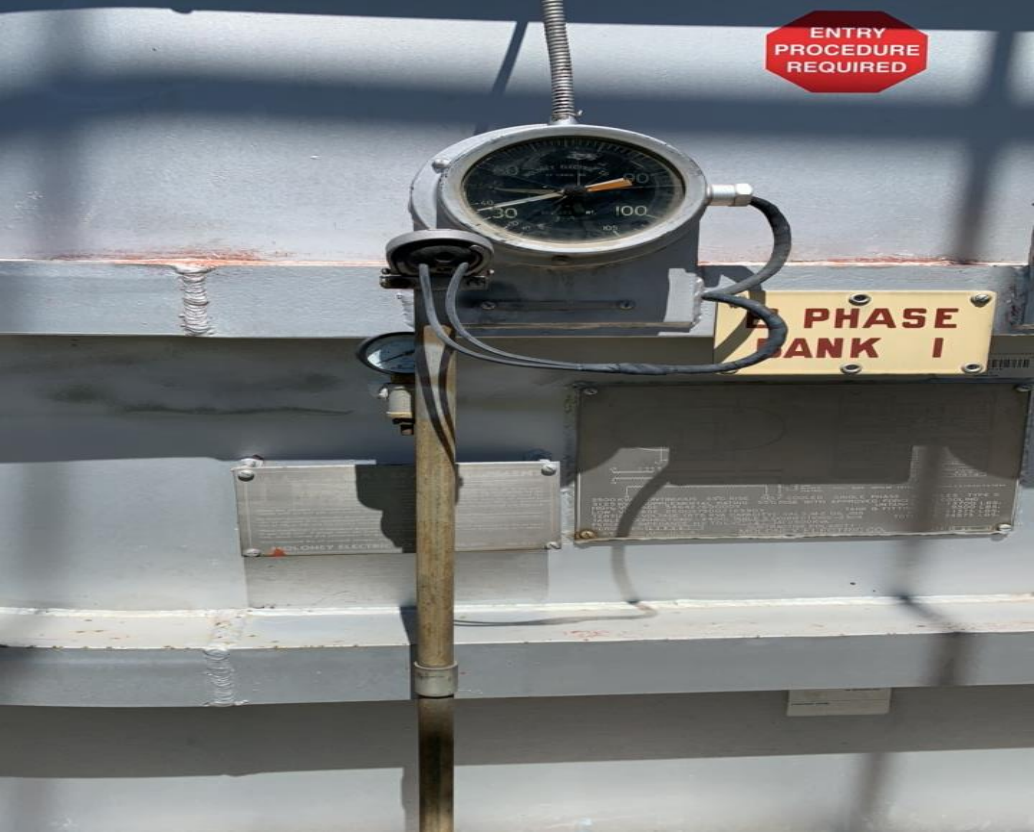
14.2 Transformer Bank 1 Phase B has Cracked Temperature Gauge (Existing Tag# 128545795)

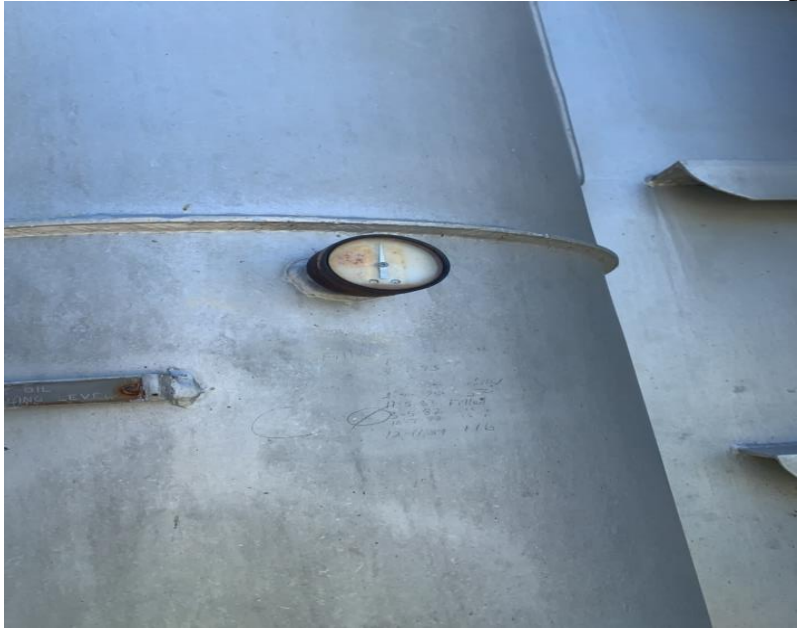
14.3 Transformer Bank 1 Phase C has a Faded Oil Level Gauge

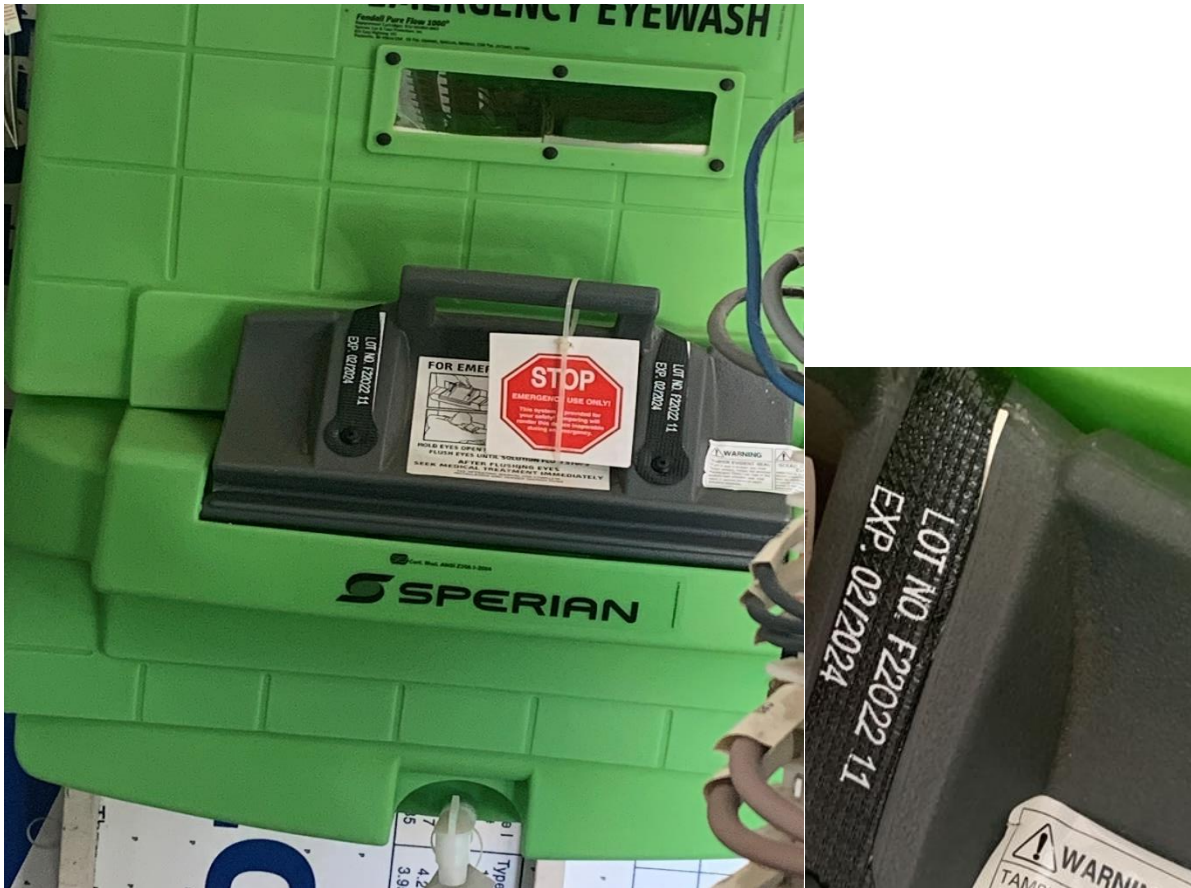
14.4 Battery Room Eye Wash Expired 2/24

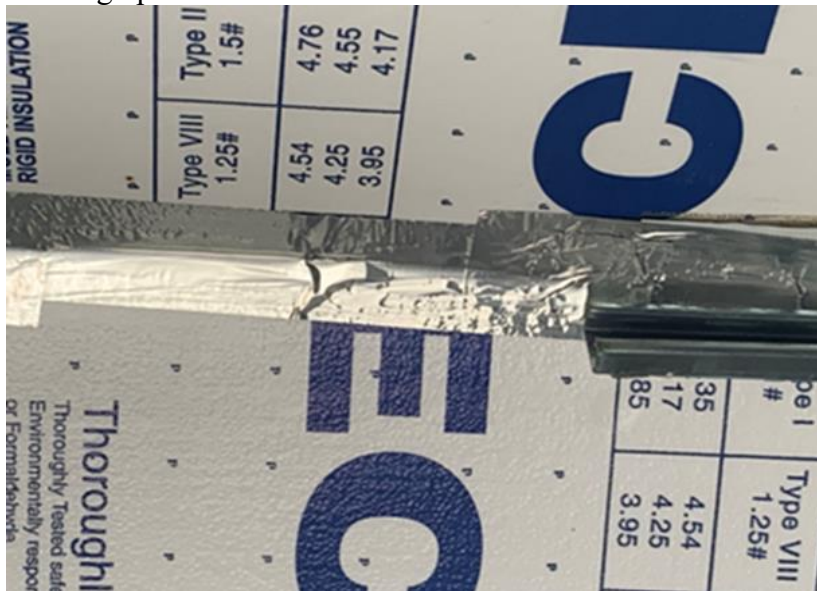
14.5 The Battery Room Fan Was Working but the interior of the Battery Room was insulated and fully sealed, thus preventing hydrogen gas from being removed through the fan exhaust. Hydrogen gas needs to be vented from the room to avoid a detonable concentration from building up.

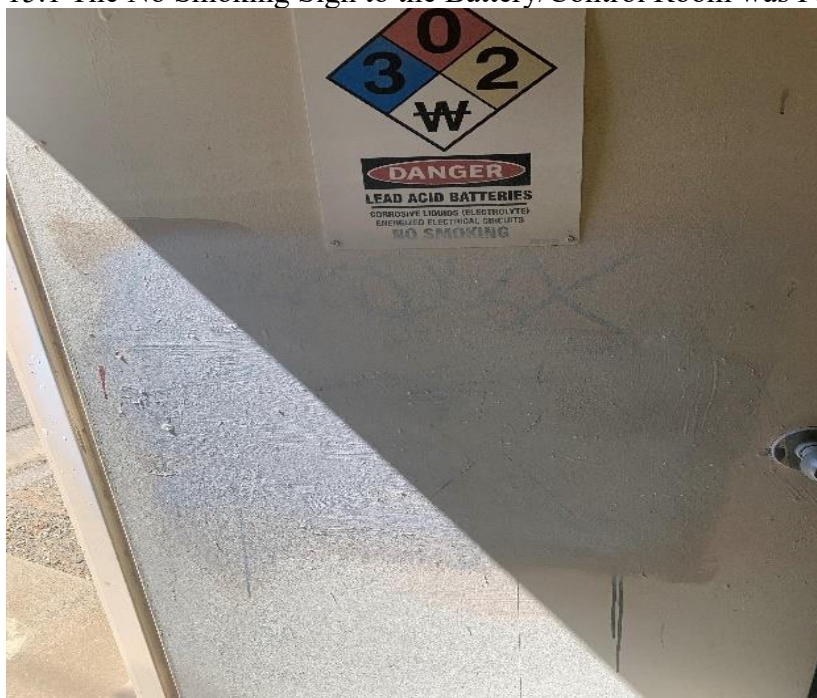
15.1 The No Smoking Sign to the Battery/Control Room was Painted Over and not readable

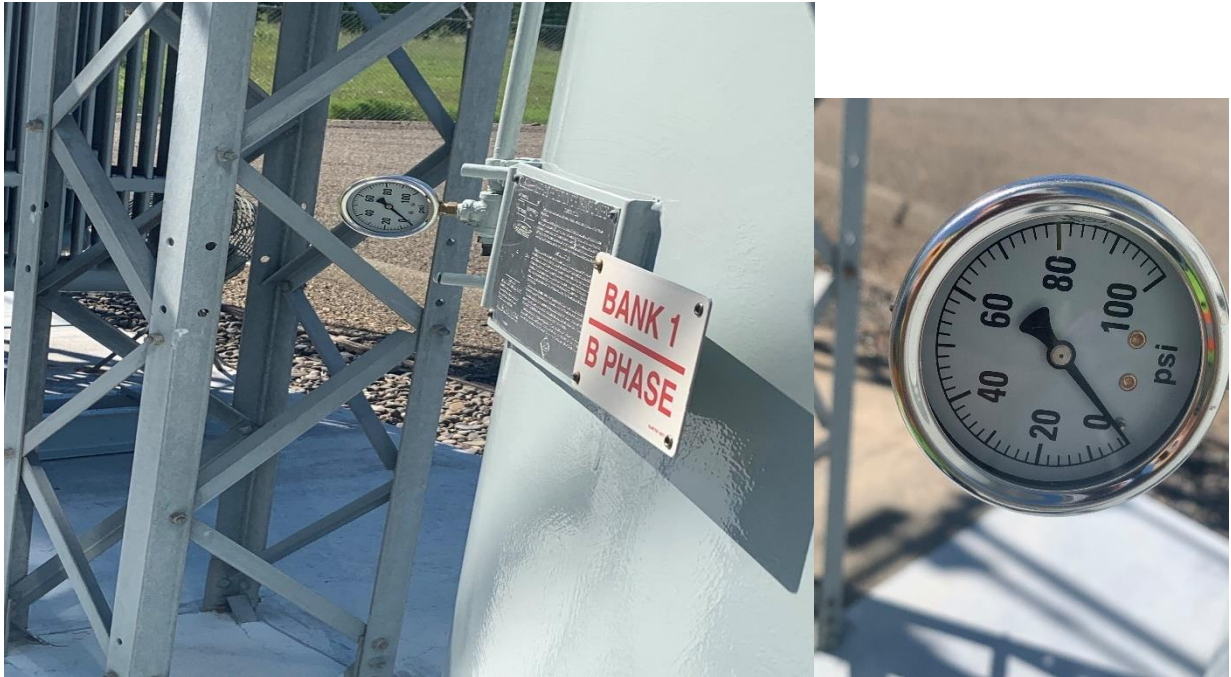
16.1 Transformer Bank 1 Phase A and Phase B had Nitrogen Pressure Readings of 0 Psig and Need Filling

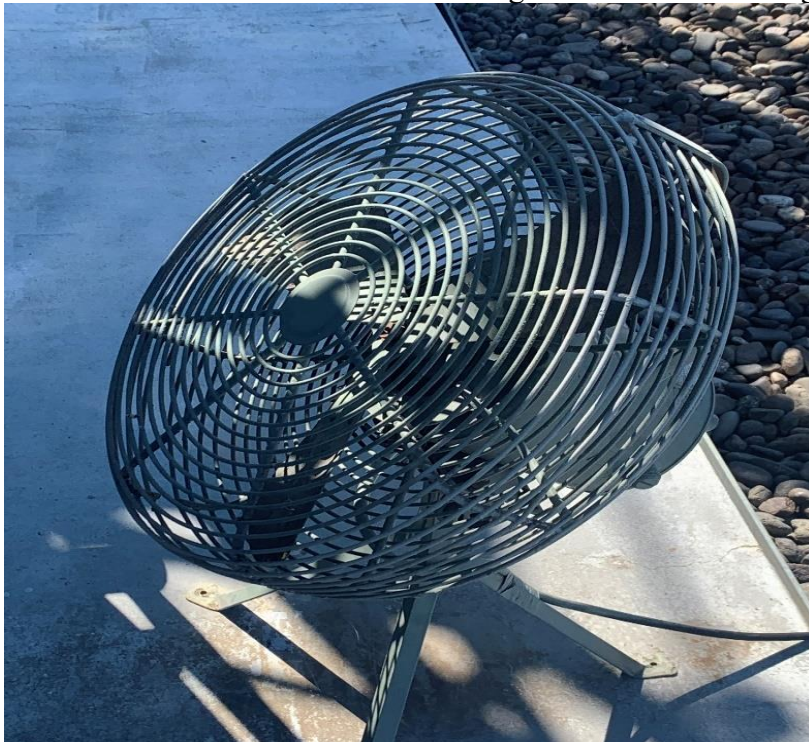
16.2 Transformer Bank Phase C Cooling Fan Was Not Working

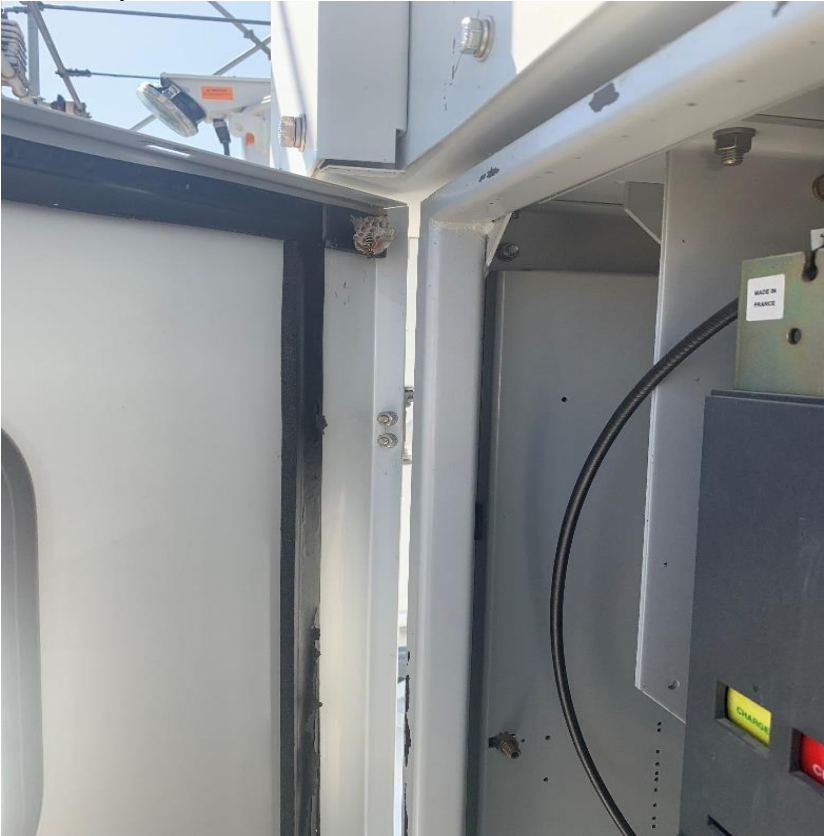
16.3 Wasp Nest Inside Circuit Breaker Cabinet

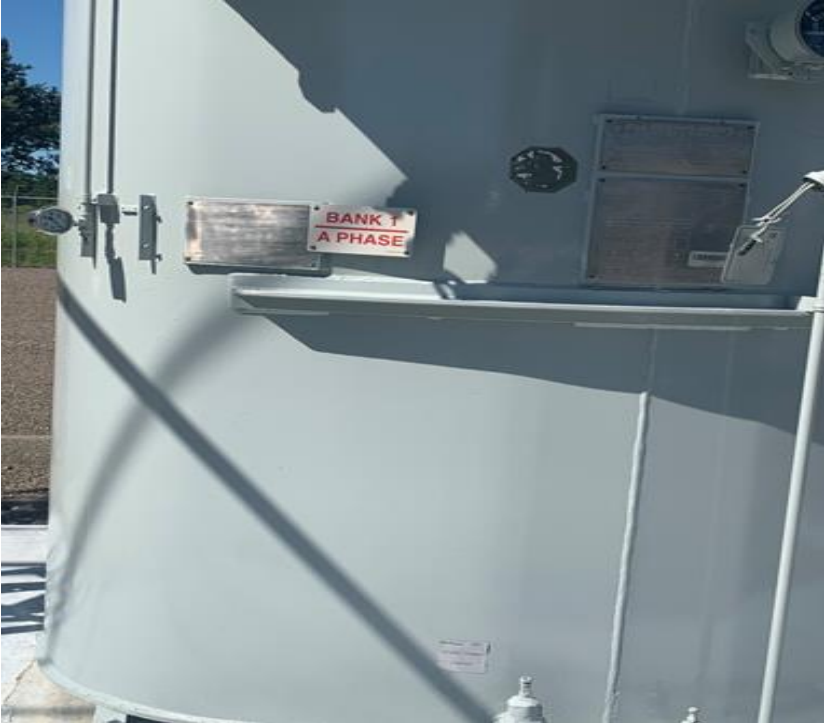
16.4 Transformer Bank Phase A Label For Tank Entry is Damaged

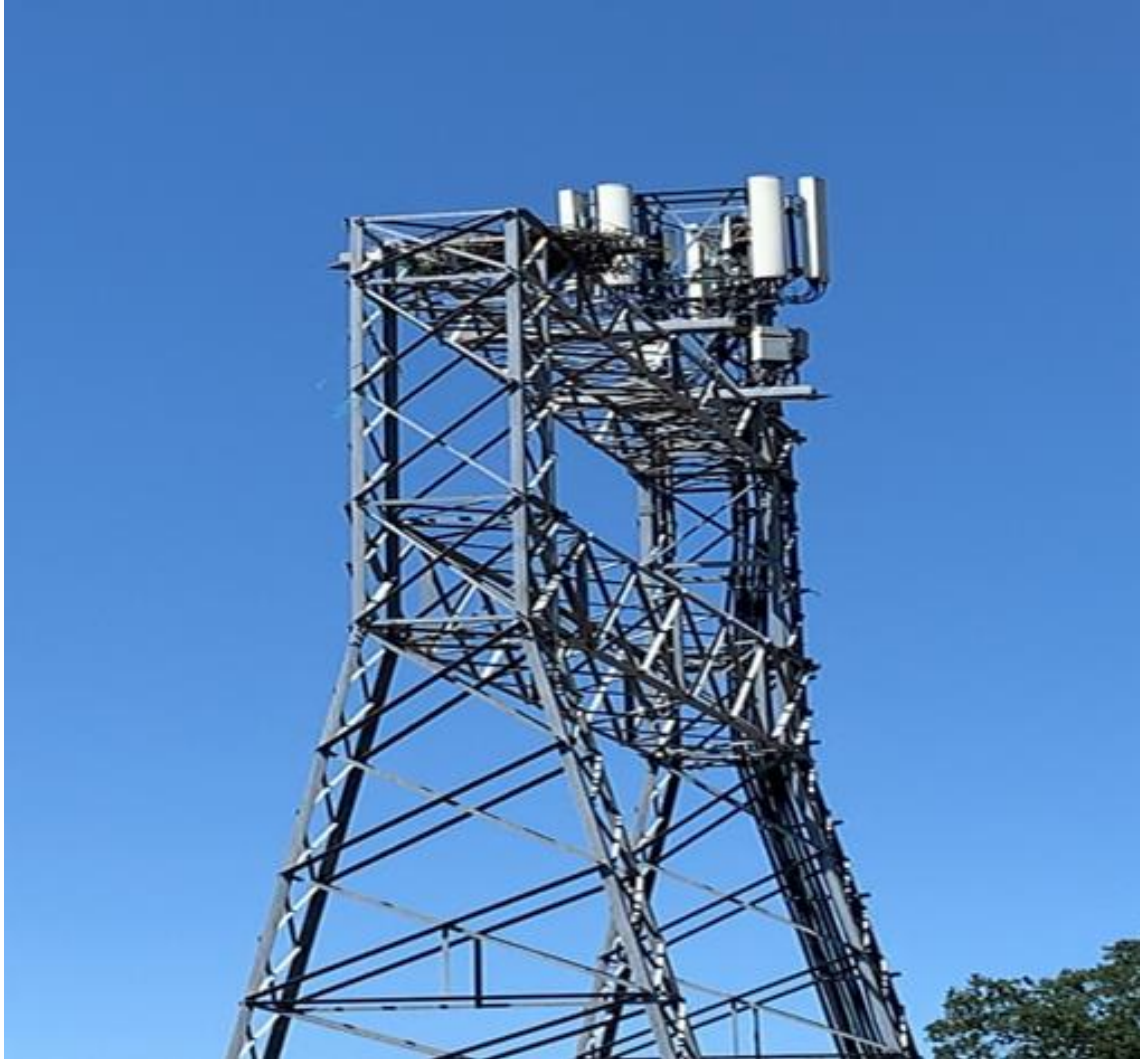
A large Osprey Nest was observed on a communication structure. The nest is active.
