**SUBJECT: General Order (GO) 167 Audit of Topaz Solar Farm
Audit Number GO167-1025**

2017 Audit of *Topaz Solar Farm*

STAFF REPORT

**PREPARED BY: ELECTRIC SAFETY AND RELIABILITY BRANCH
SAFETY AND ENFORCEMENT DIVISION**

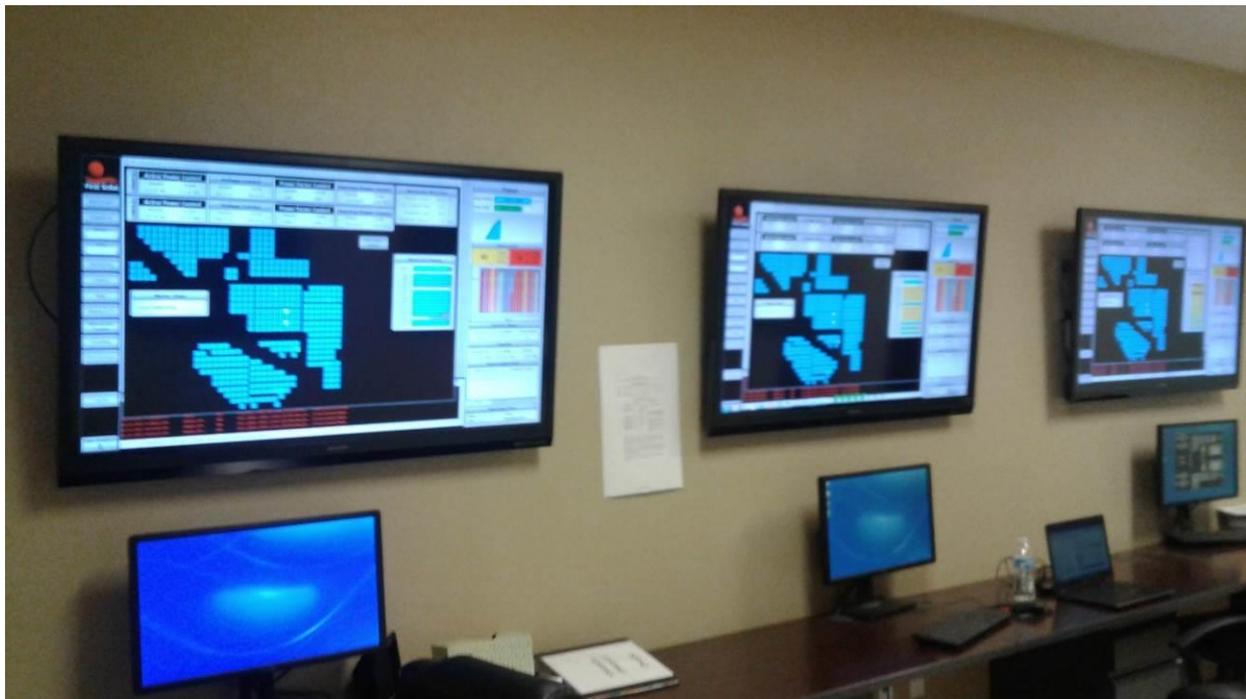
from an operator, see Figure 1. ESRB noticed several software issues in the HMI that may impact plant operations. In particular, ESRB saw the HMI showed a graphical display of an opened circuit breaker while in fact the breaker was closed at the time according to the operator. ESRB also observed an indicator on the HMI flashing on and off intermittently. The operator explained that the flashing alert indicates a loss of communication from the inverter, though it's attributed to a glitch in the software rather than an actual loss of communication. ESRB inquired about these glitches and discovered that the Plant has known, but failed to repair, at least a dozen of these so-called SCADA issues. Some of these include nuisance alarms that may be caused by improper setpoints. Though Topaz is two years into commercial operations, it has yet to resolve these issues. The issues that ESRB noticed in particular can cause an operator error and may hinder reliable operations. Topaz must evaluate and take proper corrective actions to correct these SCADA issues.

Figure 1: Topaz's SCADA operator control room.

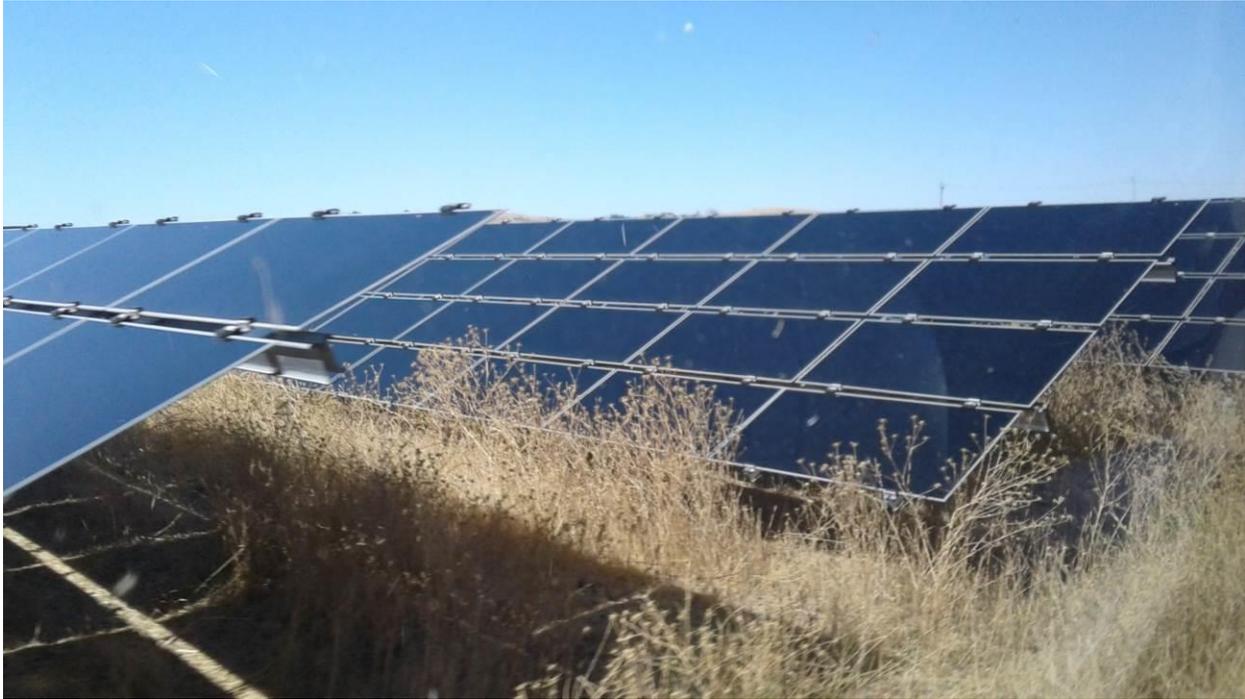
Topaz fails to manage vegetation to minimize fire risks. During the onsite visit, ESRB observed overgrown vegetation of at least several feet tall, some of which encroaches onto the solar panels, see Figure 2. This is contrary to the Plant's vegetation management goals to “*manage fuel load to minimize risk of fire*” and to “*manage vegetation height to maintain optimum function of solar PV arrays*”.⁹ Topaz is subject to environmental restrictions and maintains at least eight inches average height and at least 500 pounds per acre residual dry matter to promote a natural habitat for the San Joaquin Kit Fox, an endangered species.^{10, 11} Further, Topaz is restricted from using motorized trimming and/or mowing onsite to protect wildlife except along roadsides, fence lines, and other obstructed areas.¹² The Plant primarily uses sheep and cattle grazing as a mean to vegetation management. However, as evidenced by the overgrown and dry vegetation in some areas, this method proves ineffective in mitigating potential fire risks. The Plant is situated in the Carrizo Plain, an area of arid climates where low humidity and strong winds, combined with dry grass, make it highly susceptible to wildfires. Additionally, the Plant has had a history of fires in and around the solar panels. Since commercial operations in February 2015, Topaz has had 12 fires.¹³ In four occasions, an avian shorted an overhead conductor on a riser pole. The bird was electrocuted, caught fire, and fell to the ground, where it ignited dry vegetation and started a fire. In eight separate occasions, a rodent chewed on an underground cable, which shorted a circuit and caused a ground fault resulting in a fire. So fires have occurred and do occur at Topaz necessitating prudent and effective means of managing

Figure 2: ESRB observed overgrown vegetation of at least several feet tall, some of which encroaches onto the solar panels.

vegetation to reduce fire risks. Topaz must evaluate and implement effective alternatives to better manage vegetation to minimize fire risks.

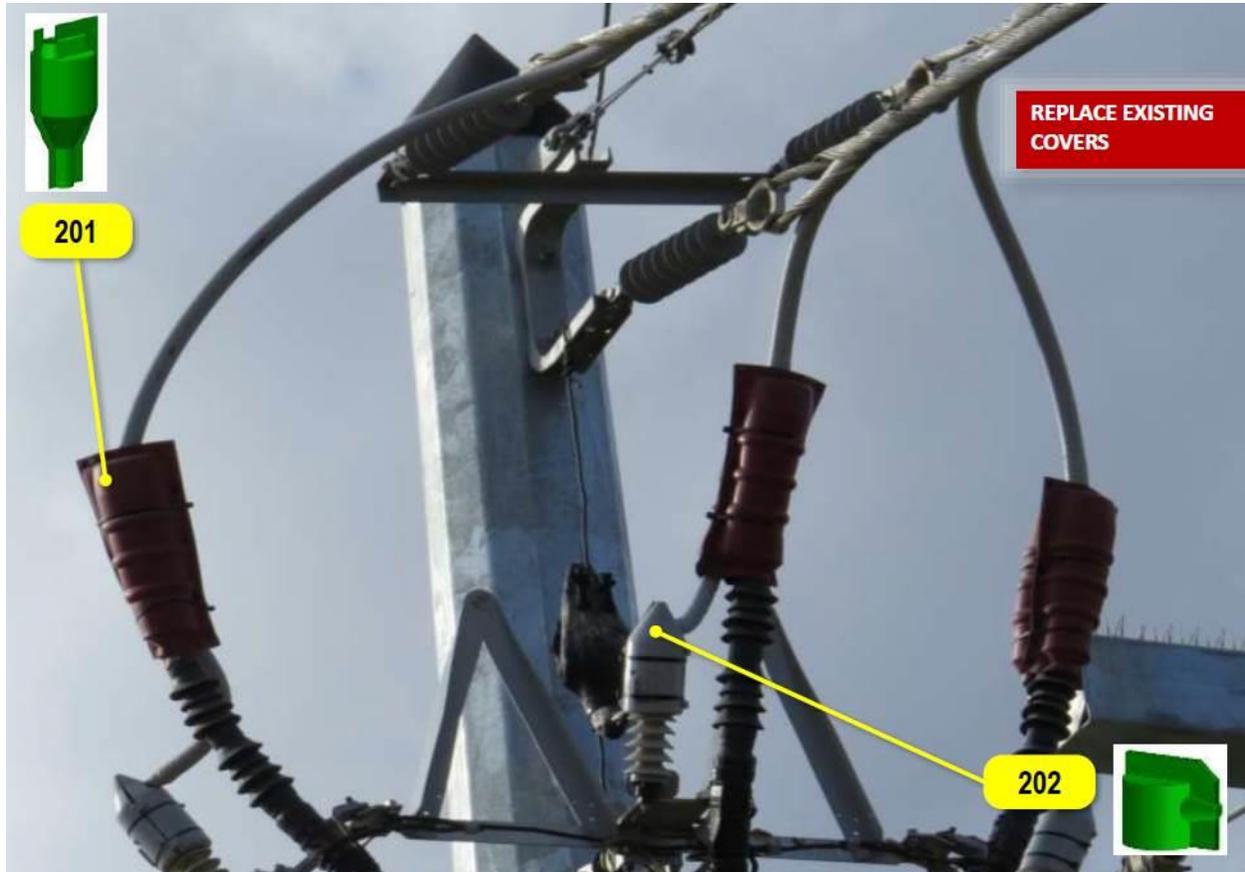
Topaz experienced 12 grass fires since July 2015: two in 2015, seven in 2016, and three in 2017. The majority were incipient fires that were contained by plant staff with fire extinguishers before CalFIRE arrived.

Topaz identified that the fires were caused by avian contact with overhead lines and ground faults resulting from rodents chewing on low voltage circuits. The Plant also identified solutions to address each of the causes. For example, the Plant installed customized “green jackets” on overhead conductors to prevent avian contact in February 2016, see Figure 3. The Plant also implemented automatic ground fault detection and isolation in one type of inverter in late 2016 (Topaz uses two types of inverters onsite). Both solutions proved effective and the number of fires was significantly reduced from 2016. And Topaz has not had any further fires from the enhanced inverters in 2017. However, Topaz has failed to implement automatic fault isolation on **all** inverters. The Plant must complete installation of this protection scheme on all inverters to reduce fire risks.

Figure 3: The Plant contracted with [Cantega Technologies](#) to install custom-designed "green jackets" shown as 201 and 202 to prevent avian contact with energized overhead conductors.

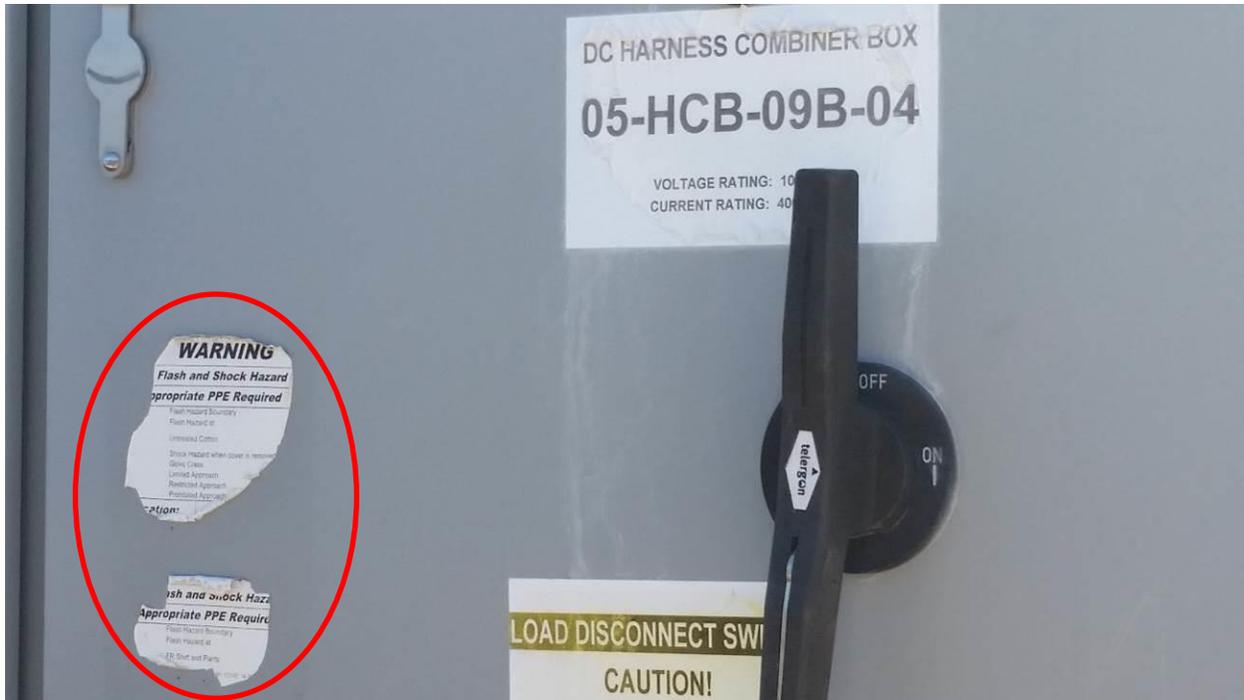
In Block 5, ESRB observed faded, partially-peeled, or otherwise illegible warning labels. For example, on some combiner boxes, the arc flash warning labels as required by National Fire Protection Agency (NFPA) 70E¹⁶ have either partially or completely peeled-off, rendering them unreadable and ineffective, see Figure 4.

Figure 4: Partially-peeled and faded arc flash warning labels on a combiner box.

Topaz must inspect warning labels on combiner boxes throughout the plant and replace them as necessary. Arc flash labels should withstand their usage environment. If necessary, the Plant should consider applying an over-laminate to protect the printed surface from exposure to sunlight and other elements.

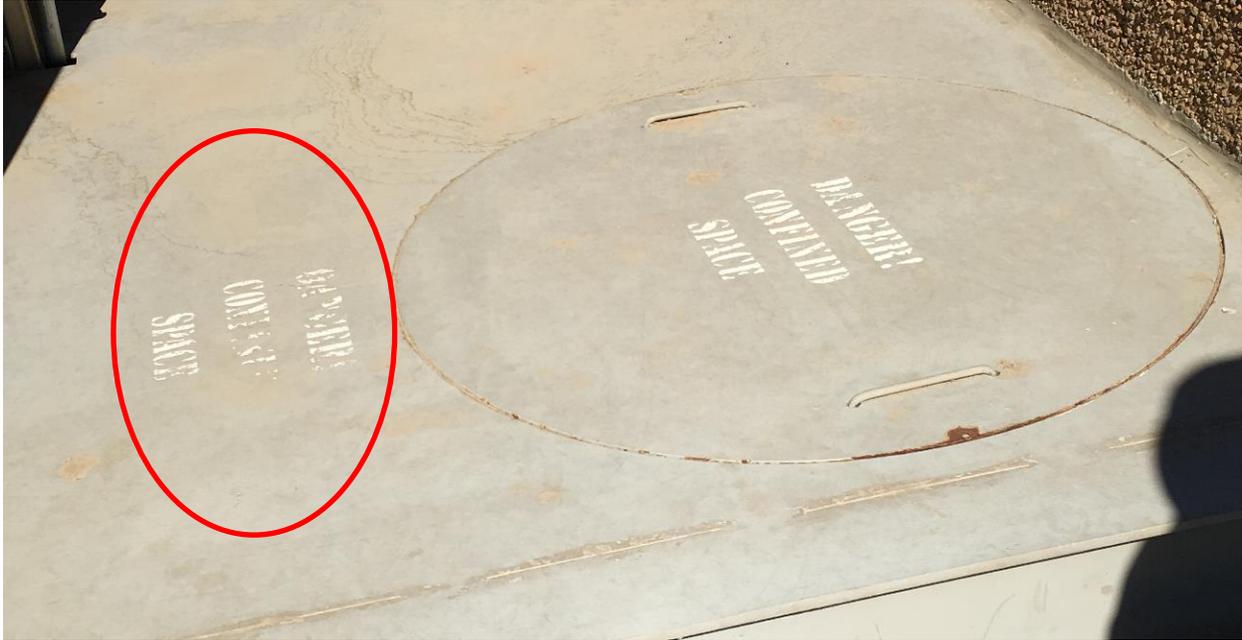
ESRB also observed faded confined space labels throughout the plant, see Figure 5. While Topaz's confined spaces are classified as "non-permit" spaces, they, nevertheless, have limited or restricted access and may otherwise present a safety hazard to workers.

Figure 5: Faded confined space label adjacent a medium voltage transformer.

Topaz must inspect warning labels on confined spaces throughout the plant and re-stencil them as necessary. The Plant should consider installing Occupational Safety and Health Administration (OSHA)-compliant signs that are more visible and resistant to wear, see Figure 6.

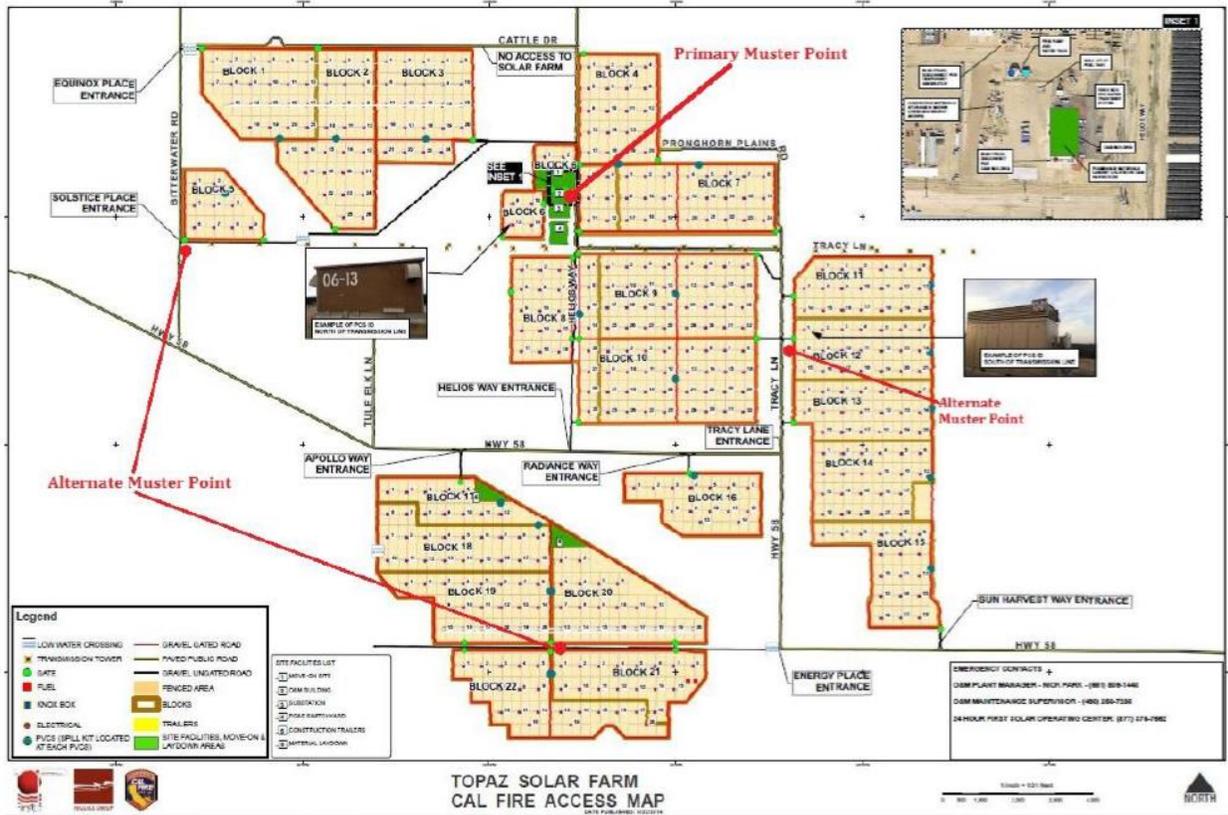
The Plant designates four muster points for workers to gather in an emergency evacuation. The main muster point is located in front of the O&M building in a gravel area east of the parking lot. Due to the size of the facility,¹⁸ the Plant also designates three other alternate muster points: one each in Blocks 5, 12, and 19/20, see Figure 7. ESRB inspected Block 5 and noted that it lacks an evacuation map. ESRB did not check Block 12 and 19/20, but those may lack evacuation maps as well.

Figure 7: Map of Topaz Solar Farm showing each of the four muster points in ‘red’ dots.

In the event of an emergency, contractors and visitors who are unfamiliar with the site may get disoriented easily. A clear and visible map that shows where you are on the map in relation to where you need to go will inform and direct workers to the proper assembly point, and may mean the difference between life and death. The lack of a map also conflicts with Topaz’s EAP, which requires staff to “*be trained in order to familiarize themselves of the locations of emergency assembly areas and the pre-determined routes in which to reach them.*”¹⁹ Topaz must affix an evacuation map on the entrance gate of each block having an alternate muster point.

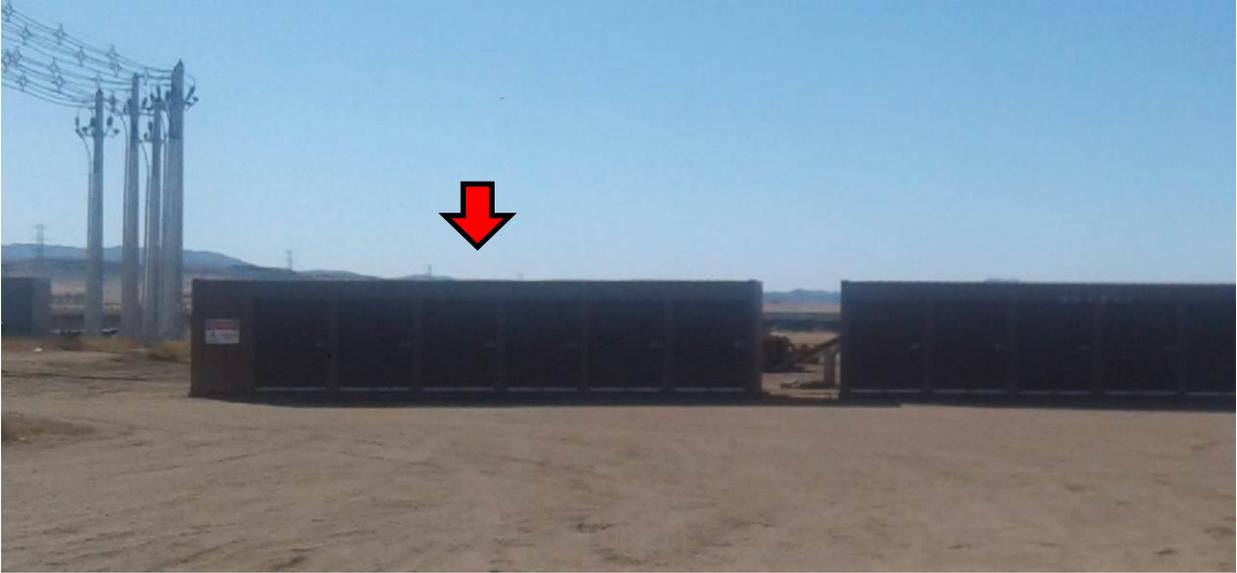
First, the Plant lacks a placard at the hazardous waste accumulation site. The Plant designates a storage shed where it stores and accumulates broken and/or defective solar panels containing the hazardous chemical *cadmium telluride*²², see Figures 8 and 9. The Safety Data Sheet (“SDS”)²³ indicates that the chemical causes harmful health effects if inhaled, swallowed, or if it contacts the eyes or skin. The Plant stores and accumulates the chemical-laden panels in the shed until they are shipped out by a hazardous waste transporter. While the shed is marked as hazardous waste storage, it lacks the proper NFPA 704²⁴ placard identifying the chemical’s hazard, see Figure 10. NFPA 704 is a widely-used standardized system for identifying materials hazards for emergency response. It provides a crucial alert to workers and first responders in an emergency situation should the material be involved in a leak, spill or fire.

Figure 8: The Plant stores and accumulates broken and/or defective solar panels that contain cadmium telluride in the pictured storage shed.

The Plant must install a hazmat placard at both locations. Not only does the placard provide a crucial alert to emergency response personnel, but it also allows the Plant to easily identify and assess its hazards when it plans for an emergency response.

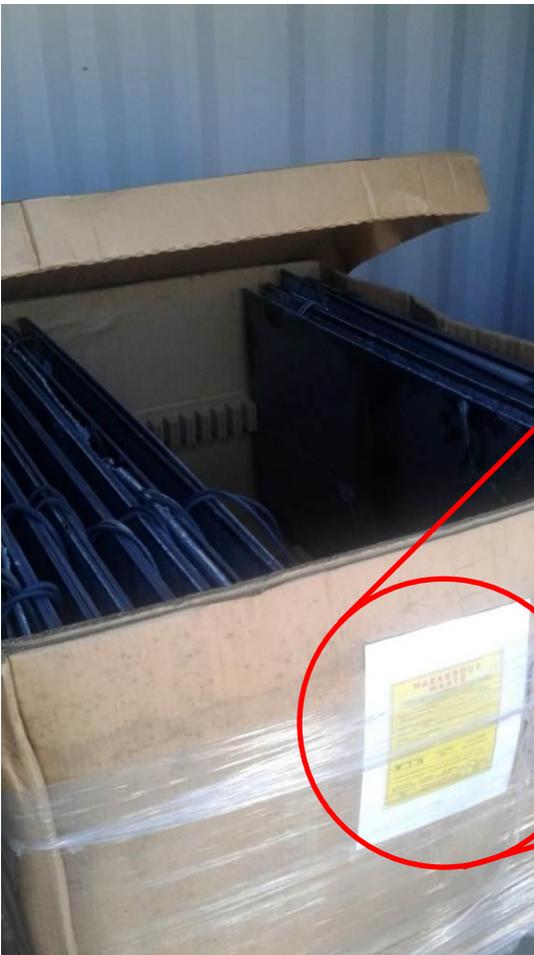
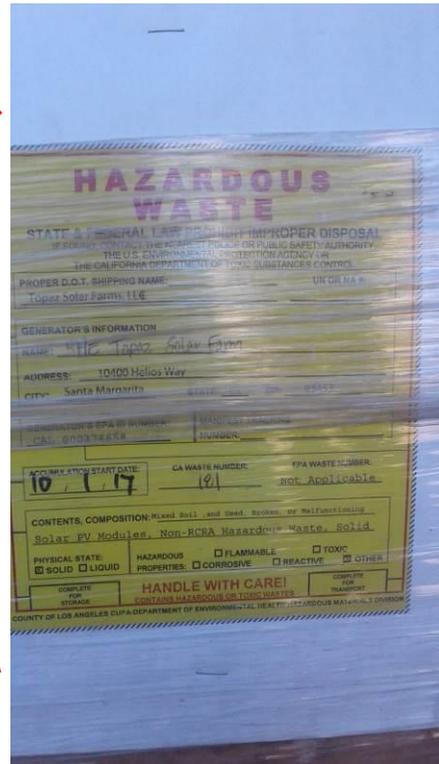
Figure 9: Inside the storage shed, defective panels are stored in boxes.

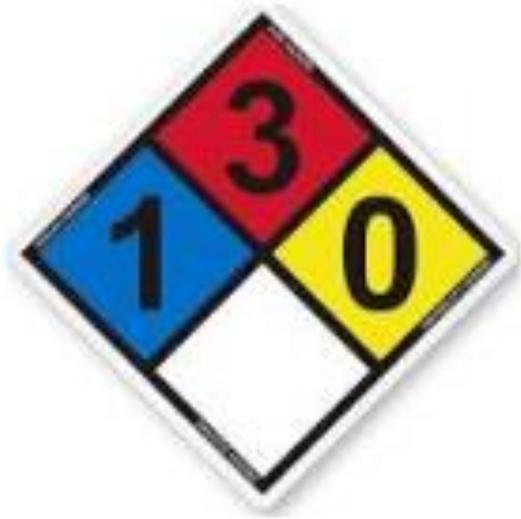
Figure 10: A typical NFPA 704 hazmat placard.

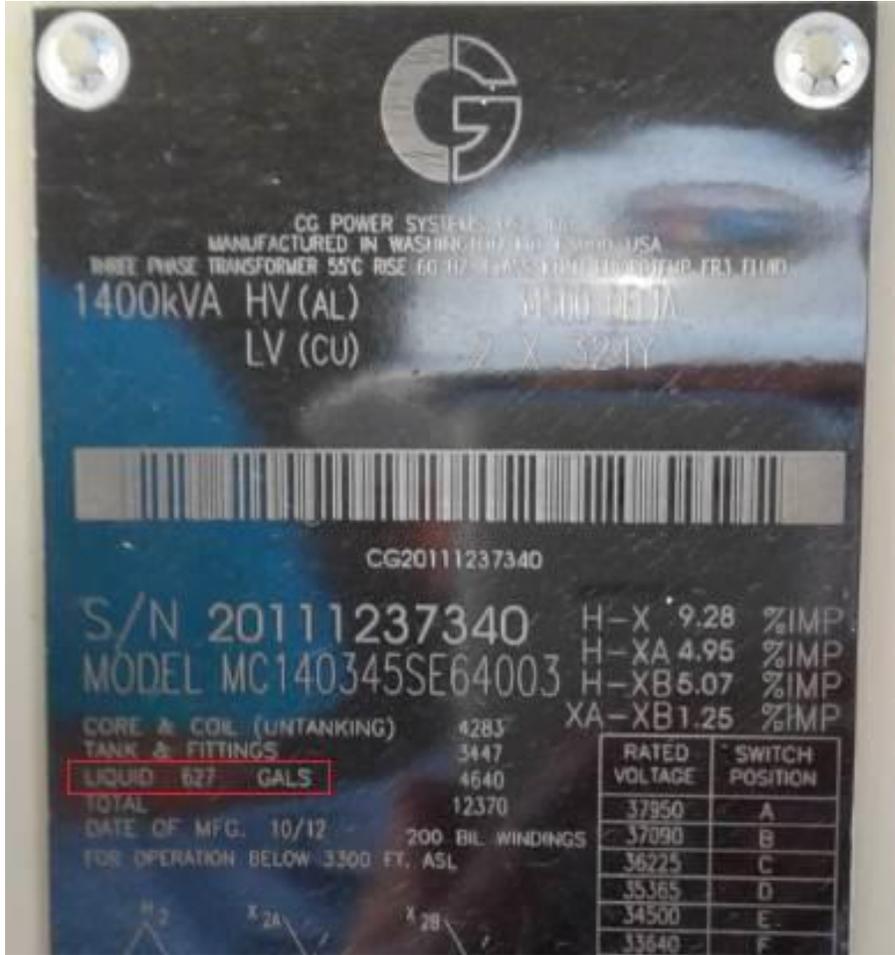
Second, the medium voltage transformer uses a vegetable oil derivative, FR-3³⁵, to cool and insulate its windings. Per the SDS, prolonged or repeated skin contact with the oil may cause drying, cracking, or irritation to the skin. And direct contact with the eyes may cause temporary irritation. Therefore, in addition to stocking absorbent socks in the kit, ESRB recommends that Topaz include items such as nitrile gloves and eye goggles that provide workers more protection when they perform spill cleanups.

Figure 13: The nameplate on the medium voltage transformer shows it uses 627 gallons of insulating oil.
