**SUBJECT: General Order (GO) 167 Audit of Delta Energy Center
Audit Number GO167-1026**

STAFF REPORT

Audit Report of Delta Energy Center

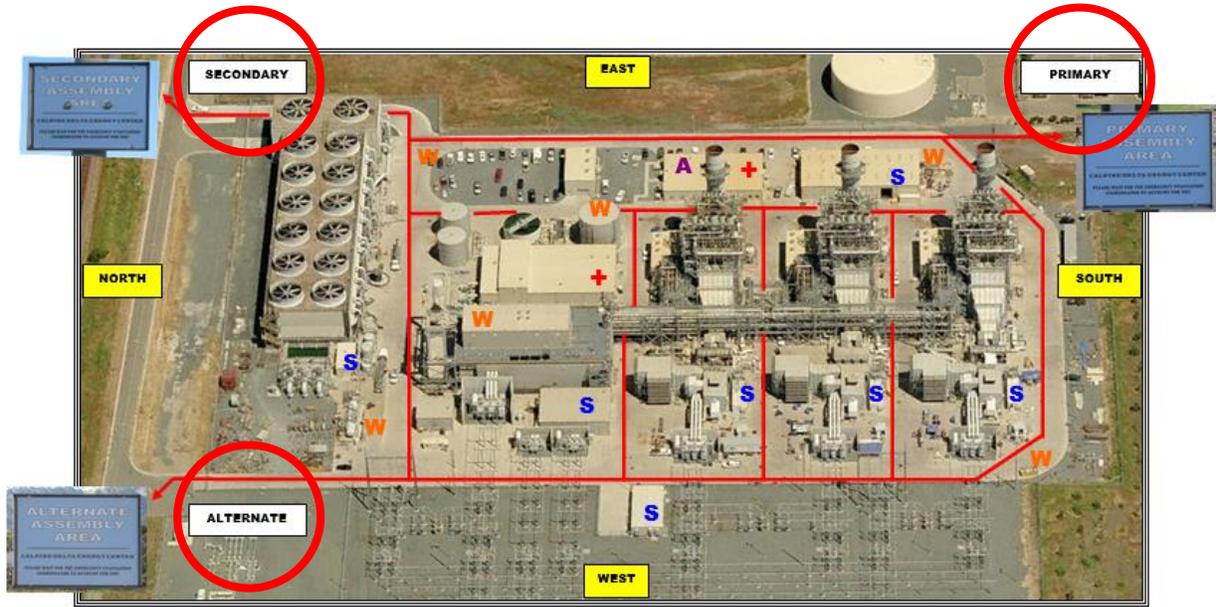
Delta designates three assembly points (primary, secondary, and tertiary or alternate) for workers to gather in the event of an emergency evacuation, see Figure 1. However, the safety video makes no mention of the *alternate* assembly point nor its whereabouts. In the event of an emergency, contractor and visitor who are unfamiliar with the site may get disoriented easily. Orienting contractor and visitor correctly is crucial prior to starting work and setting foot onsite, and may mean the difference between life and death. Delta must update its safety video to include the location of its alternate muster point.

Figure 1: Delta Energy Center's Evacuation Map.

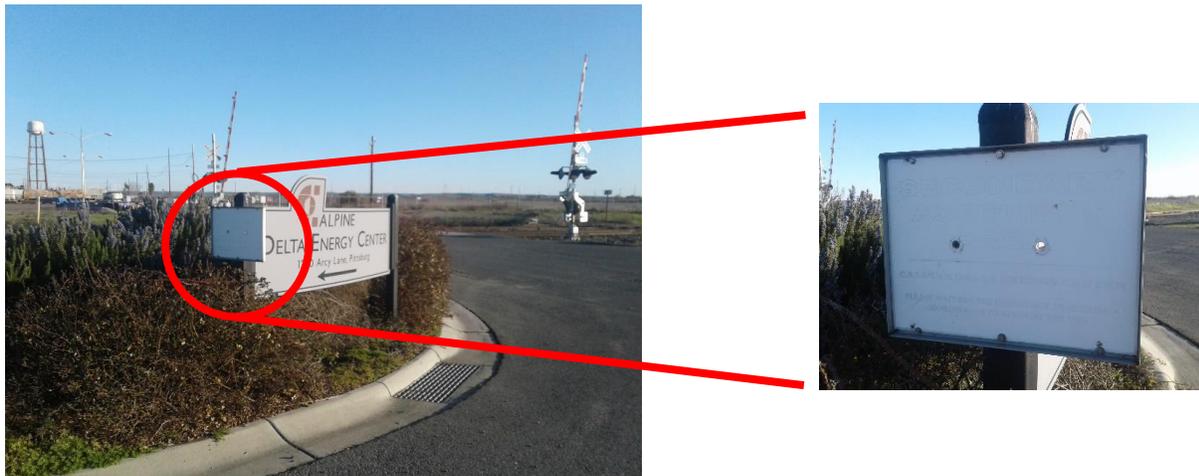
Delta fails to mark and identify both its secondary and tertiary assembly points. At the secondary muster point, the original sign has faded and is no longer readable, see Figure 2.

Figure 2: Faded sign at the secondary muster point on Arcy Lane.

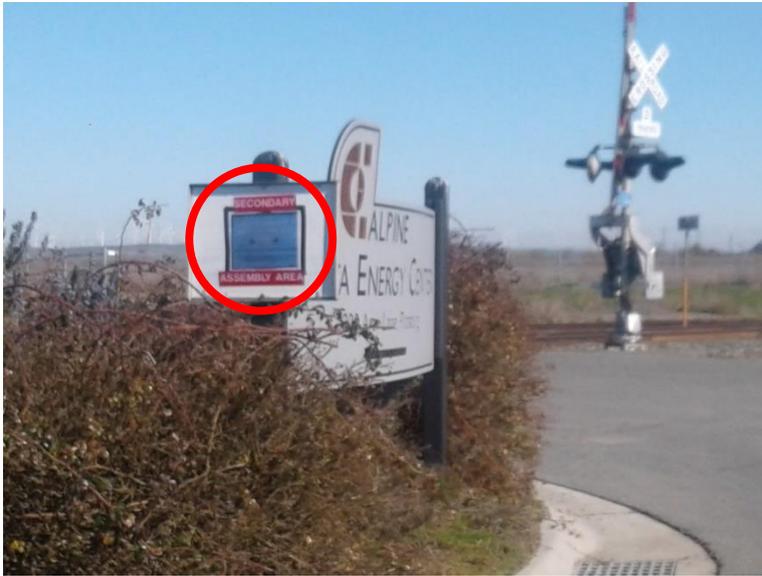
Figure 3: Temporary label at the secondary assembly point on Arcy Lane.

In response, Delta has temporarily labeled the secondary assembly point while it awaits for a permanent sign which is in-ordered, see Figure 3. Delta has provided ESRB with a copy of the Purchase Order for the new sign. Delta must clearly identify both the secondary and the tertiary assembly points with permanent signs. Further, ESRB recommends Delta to erect a directional sign in front of the main entrance gate to direct workers to the secondary assembly point, which is further down the road on Arcy Lane. Without a directional sign, it may be ambiguous where workers should gather as the actual assembly point is at least 300 feet away from the main entrance.

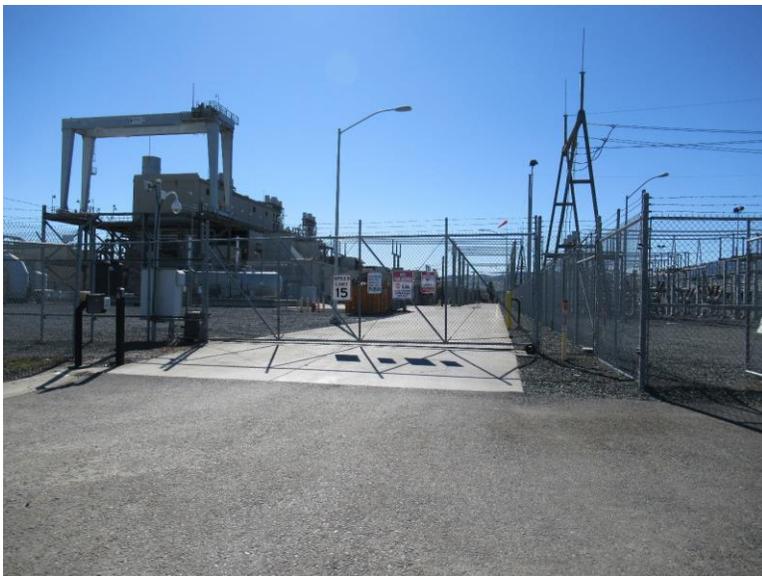
At the tertiary muster point, Delta fails to erect a sign at all, see Figure 4.

Figure 4: Missing sign at the tertiary or alternate assembly area.

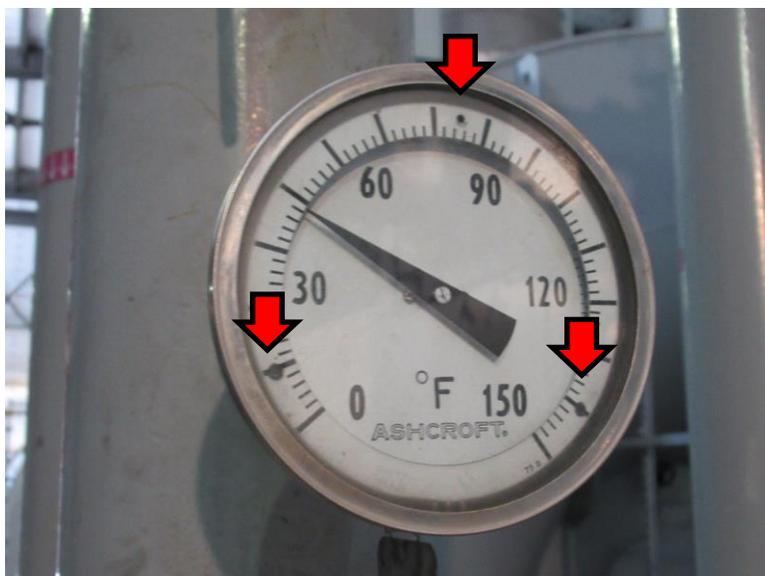
First, ESRB observed a faulty temperature gauge² on a cooling water discharge line, see Figure 5.

Figure 5: Faulty temperature gauge on a cooling water discharge line.

As shown in Figure 5, the marking plate has detached and is no longer secured to the gauge. Due to equipment vibration, ESRB observed the plate free-spinning inside the gauge. Therefore, the gauge does not provide an accurate reading to operators. Monitoring cooling water temperature is crucial to ensure the generator is adequately cooled and to prevent the generator coils from overheating. In response, Delta generated a Work Order (WO) to replace the defective gauge. Delta must complete the WO in a timely-manner to prevent operational errors.

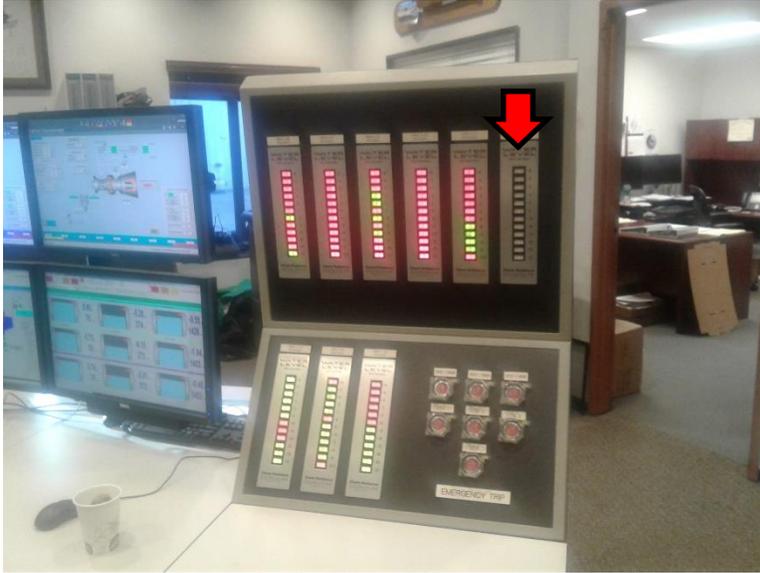
Second, ESRB observed defective Eye-Hye® drum level gauges in the Control Room, see Figure 6. These gauges provide water level readings in the HRSG drums that are crucial for normal operation. Per ASME Code Section 1 (Part PG-60.1.1), “Boilers having a maximum allowable working pressure exceeding 400 psi shall have *two* gage glasses.” While the plant’s Digital Control System (DCS) also provides drum level readings on computer displays and digital gauges, both of these readings come from the same feed, see Figure 7. Per the Code, two independent and discrete systems (that continuously measure, transmit, and display water level) must be provided. Therefore, Delta must repair the Eye-Hye® gauges to comply with this ASME requirement.

Figure 6: Defective Eye-Hye® drum level gauges in the Control Room.

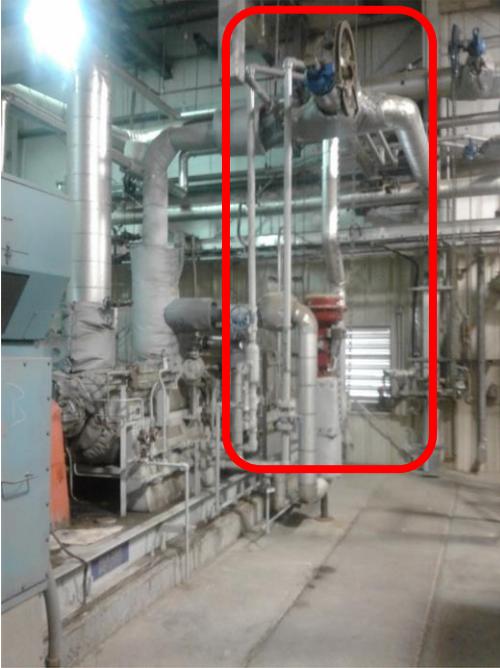
Third, ESRB observed a metal chain dangling from an overhead valve that was obstructing the walk path, see Figure 8. This is a defect and a safety hazard warranting corrective action as operators can accidentally get caught in the chain and inadvertently hurt themselves or operate the valve. In response, Delta repositioned and secured the chain away from the path, see Figure 9. Delta must inspect Unit 2's and 3's BFPs and do the same to mitigate this hazard.

Figure 8: Dangling chain obstructs walk path at Unit 1's BFP.

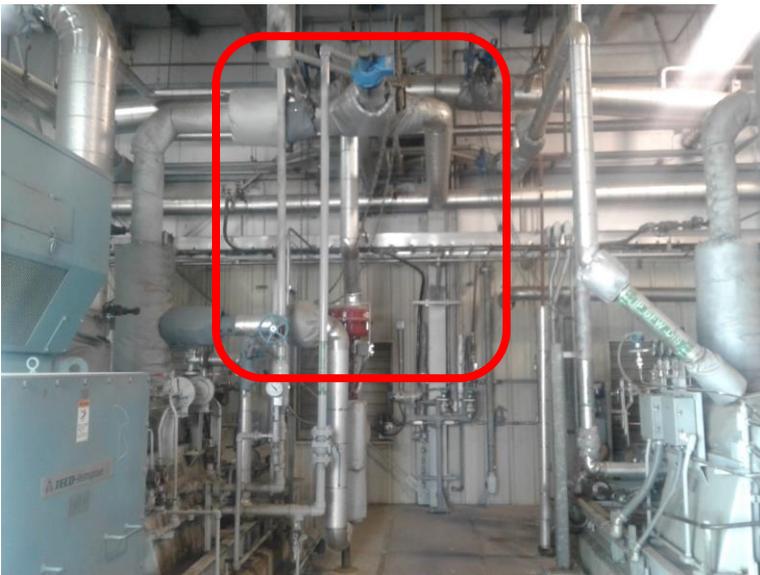
Figure 9: Delta repositioned and secured the chain away from walk path.

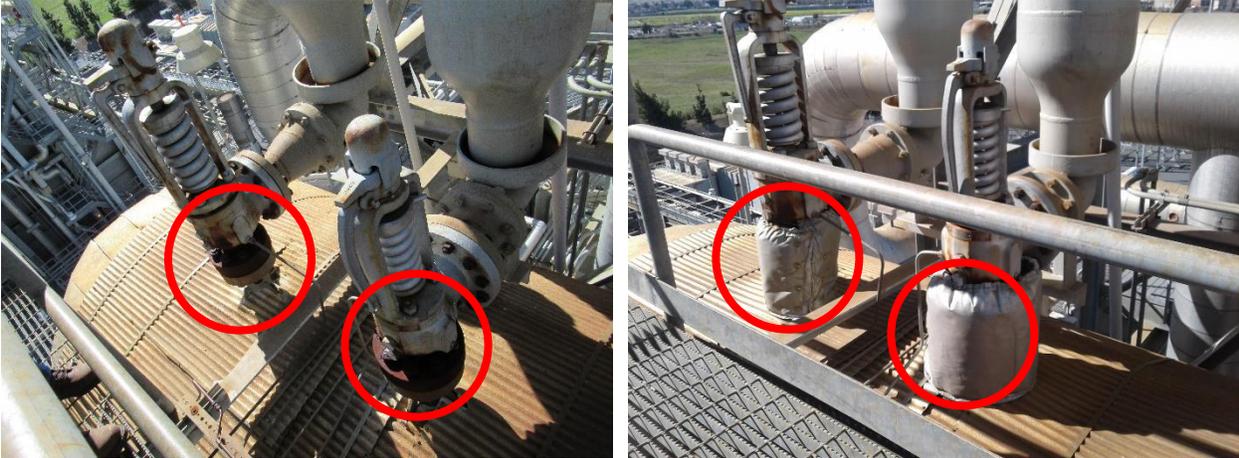
Forth, ESRB observed fallen insulation blankets on two pressure relief valves. These insulation blankets, in addition to preventing burn risk hazards, are used to minimize heat loss and enhance

Figure 10: Fallen insulation blankets on two HP steam drum pressure relief valves.

thermal efficiency. In response, Delta re-installed the insulation blankets, see Figure 10. Further, ESRB observed the valve tag for 'TB2A' was detached from the valve. Valve tags help operator and maintenance personnel identify the valve and provide crucial data such as the valve's pressure setpoint. In response, Delta rehung the tags, see Figure 11; therefore, the Plant does not need to take any further corrective action.

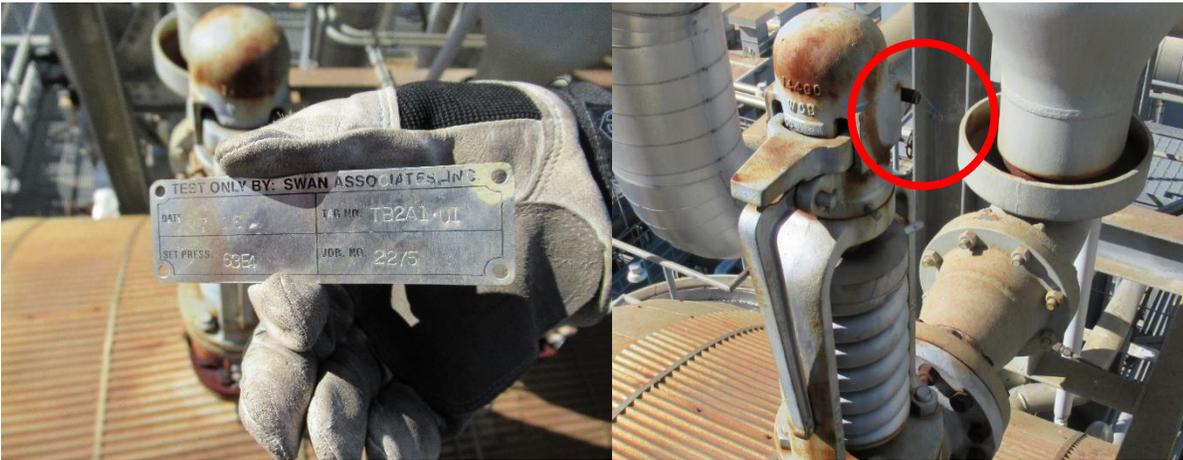
Figure 11: Valve tag detached from PRV TB2A.

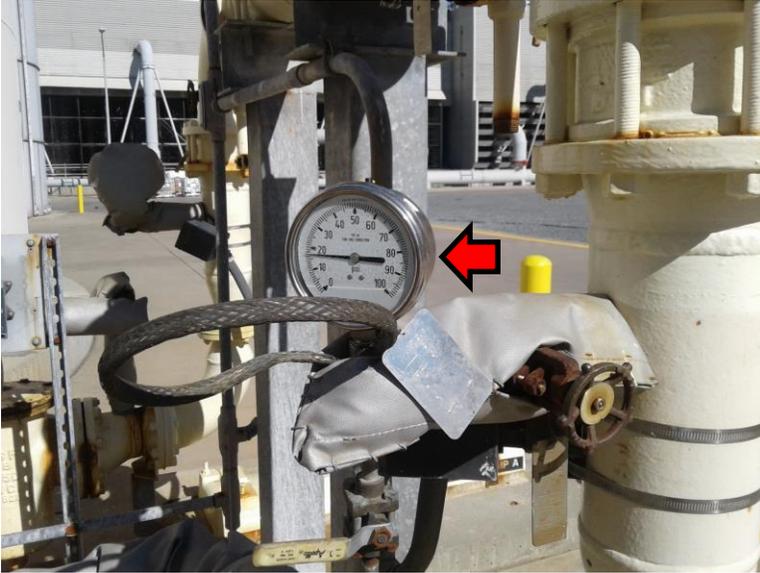
Fifth, ESRB observed depleted liquid-filled gauges at the raw water booster pumps, see Figure 12. Liquid gauges are typically filled with glycerin to help dampen vibration and prolong the gauge's life. In response, Delta refilled the gauges with liquid glycerin; therefore, the Plant does not need to take further corrective action.

Figure 12: Depleted liquid-filled gauge at the raw water booster pumps.

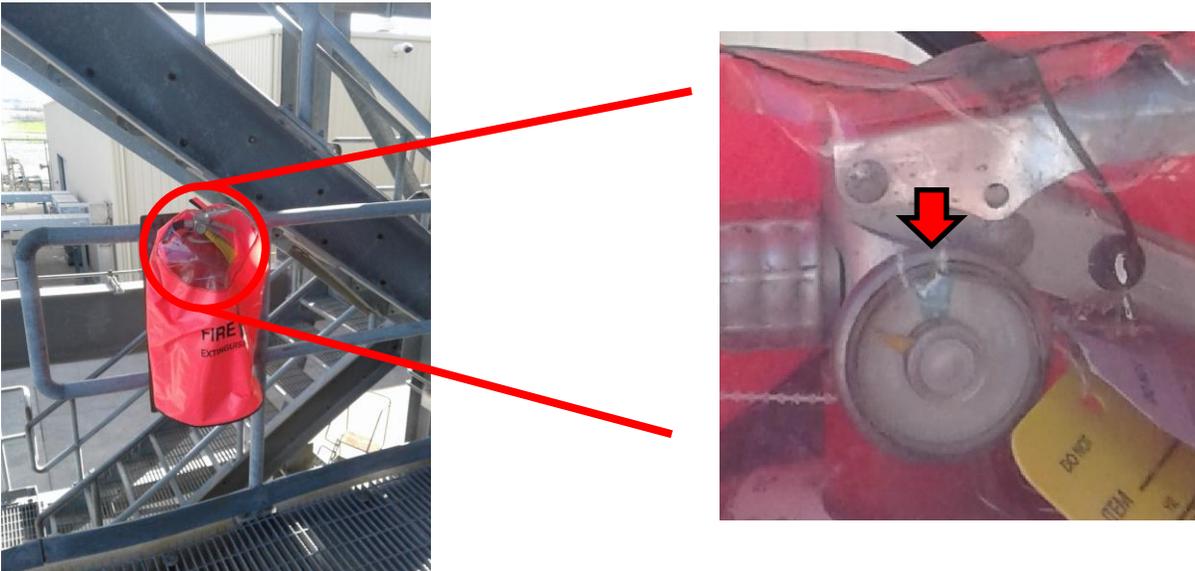
Sixth, ESRB observed a defective fire extinguisher next to a stairway on the steam turbine deck. Although the extinguisher was last inspected in January 2018, it was not properly charged, see Figure 13.

Figure 13: Defective fire extinguisher on the steam turbine deck.

Fire extinguishers are an effective mean to fight incipient fires and must be regularly inspected to ensure they're working properly. In response, Delta replaced the extinguisher with one that was fully-charged; therefore, the Plant does not need to take any further corrective action.

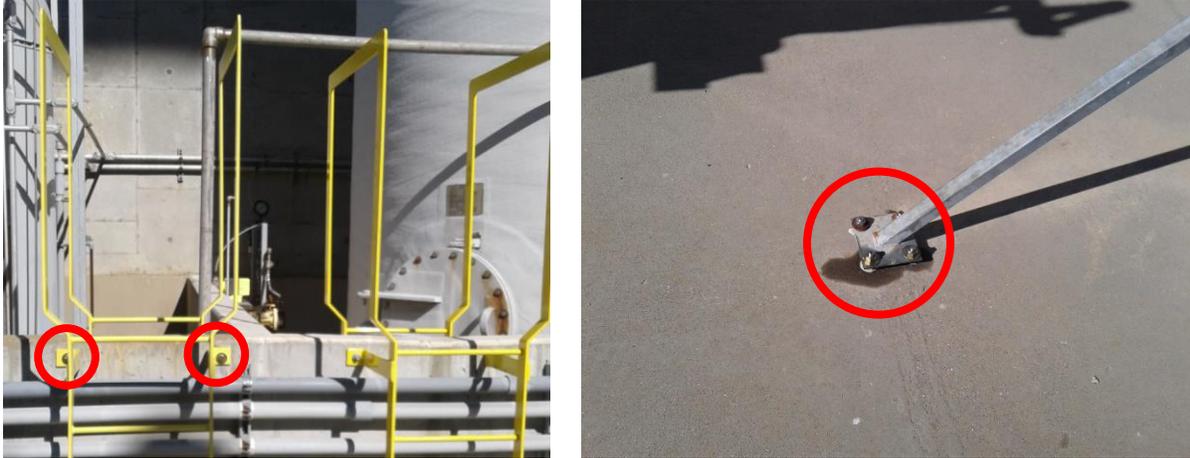
Seventh, ESRB observed missing anchor bolts at two locations, see Figure 14. ESRB observed missing bolts at a climb ladder on the containment wall by the cooling tower and missing bolts at a brace support. In response, Delta re-installed the anchor bolts; therefore, the Plant does not need to take further corrective action.

Figure 14: Delta re-installed missing anchor bolts at two locations.

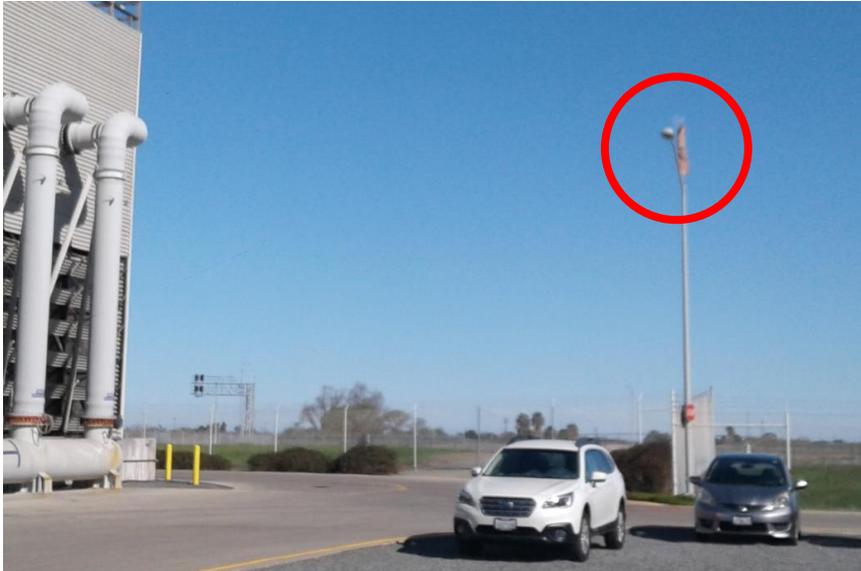
And finally, ESRB observed a torn wind sock by the main entrance, see Figure 15. In response, Delta replaced the torn sock with a new one, see Figure 16; therefore, the Plant does not need to take further corrective action.

Figure 15: Torn wind sock by the main entrance.

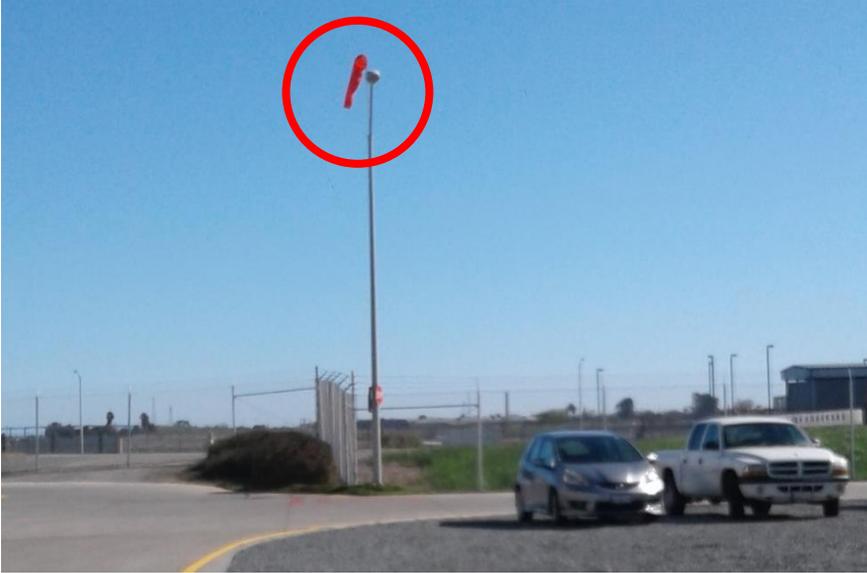
Figure 16: Delta replaced torn wind sock with a new one.

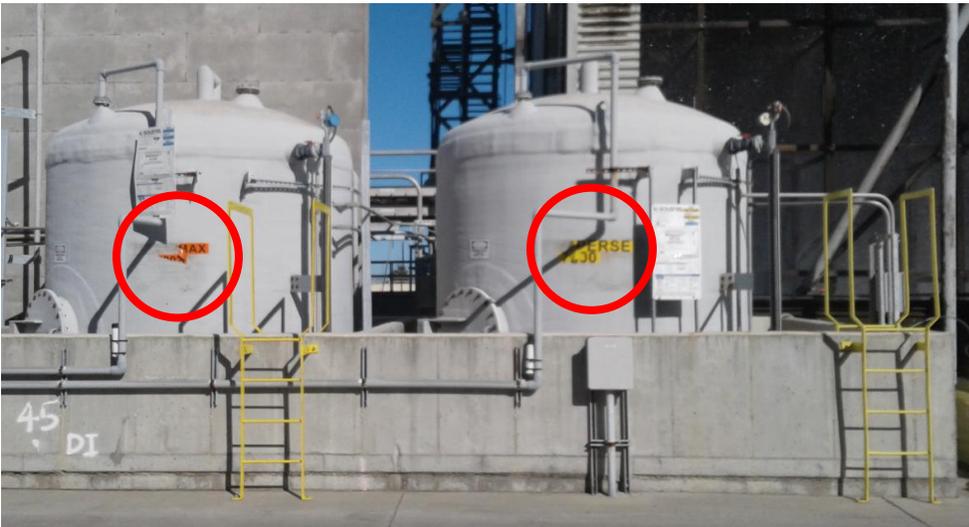
Delta fails to maintain proper signage and labeling to ensure they're secured, legible, and provide adequate notification as intended. ESRB observed faded, partially-peeled, or otherwise illegible labels throughout the plant. Labels help identify equipment and chemical to prevent operational and maintenance errors. For example, ESRB observed partially-peeled labels on chemical storage tanks by the cooling tower, rendering them unreadable and ineffective, see Figure 17.

Figure 17: Partially-peeled labels on two chemical storage tanks.

In regards to illegible signage and labels, Delta must conduct a plant-wide survey to identify all faded, partially-peeled, or otherwise illegible labels on critical pieces of equipment and re-stencil or relabel them as necessary to prevent operational or maintenance errors. All labeling should withstand their usage environment. If necessary, the Plant should consider applying an over-laminate to protect the printed surface from exposure to sunlight and/or other elements or consider installing Occupational Safety and Health Administration (OSHA)-compliant signs that are more visible and resistant to wear.

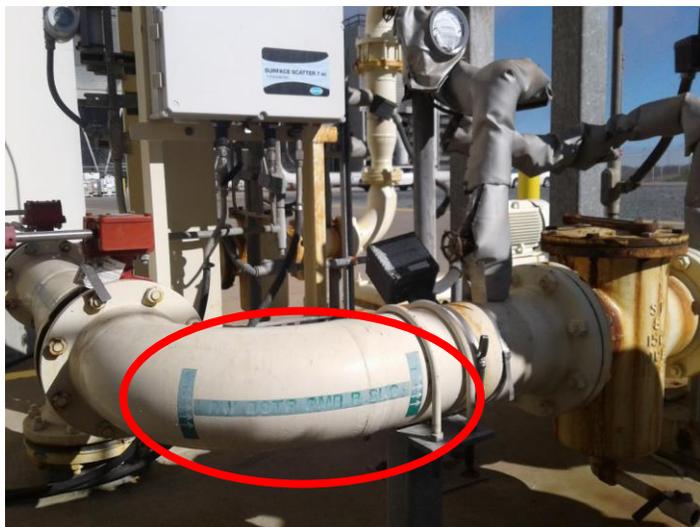
ESRB also observed faded labels on a suction pipe at the raw water booster pumps, see Figure 18. The labels were intended to provide operators important data regarding the medium and the direction of its flow.

Figure 18: Faded labels on a suction pipe at the raw water booster pumps.

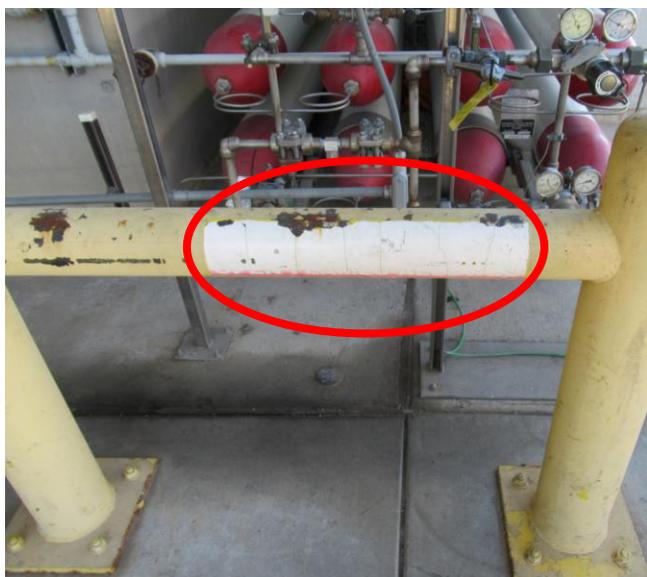
At the generator hydrogen storage area, ESRB observed a faded sign, see Figure 19. Hydrogen is highly flammable. Workers should exercise precautions in the area.

Figure 19: Faded warning sign at the generator hydrogen storage.

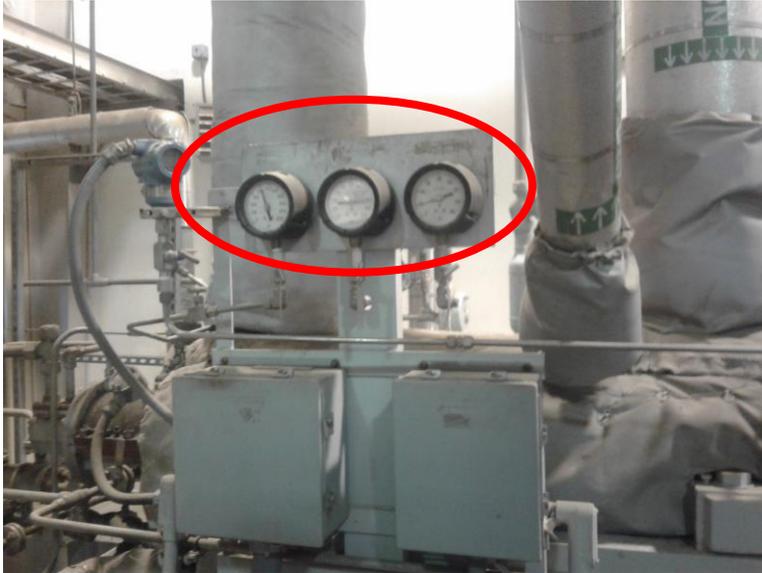
At Unit 1's Boiler Feed Pump (BFP), ESRB observed unlabeled pressure gauges, see Figure 20. These gauges provide the pump's suction and discharge pressure readings that are crucial for normal operation. While these gauges are also equipped with digital transducers that provide the same readings to the plant's DCS, outside operators often look at these gauges to reconcile and

Figure 20: Unlabeled pressure gauges at Unit 1's BFP.

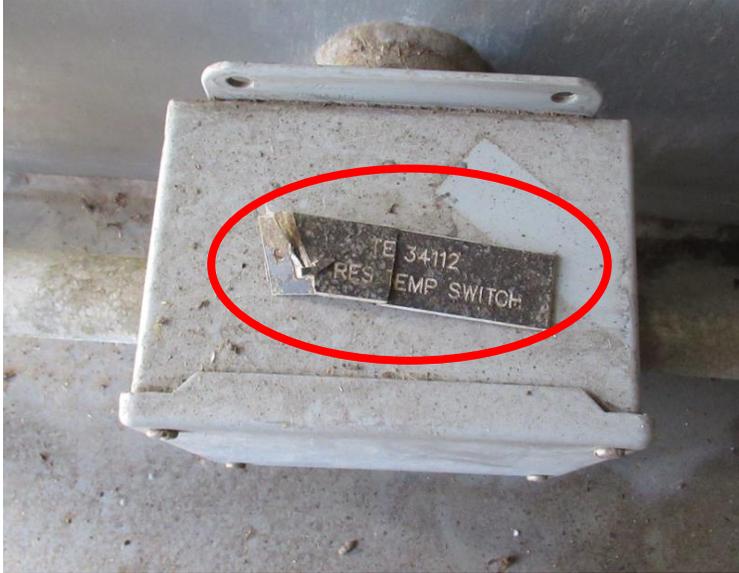
At Unit 3's gas turbine mechanical package, ESRB observed a fallen and broken switch label, see Figure 22.

Figure 22: Fallen and broken switch label at Unit 3's turbine package.

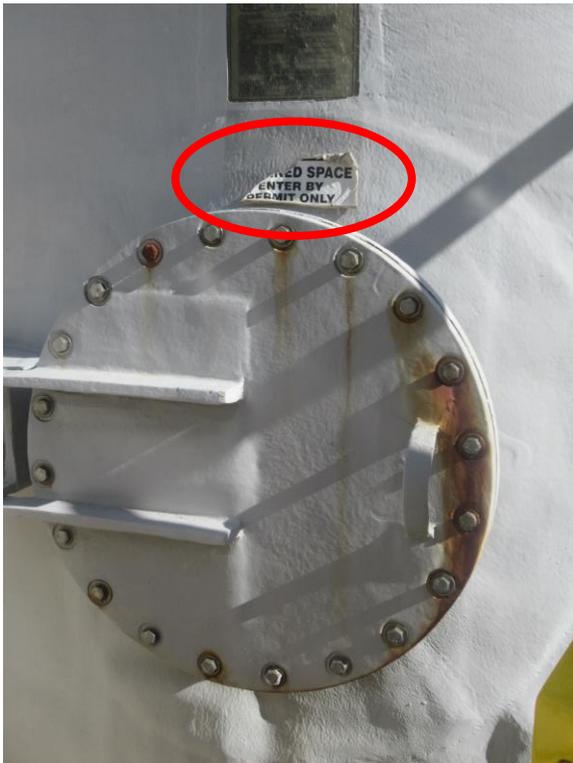
Throughout the plant, ESRB observed tattered and faded confined space warning signs, see Figures 23 and 24. Confined space warning signs notify workers of potential hazards and inform workers to obtain proper permit prior to entry.

Figure 23: Tattered confined space warning sign at the Sodium Hypochlorite tank.

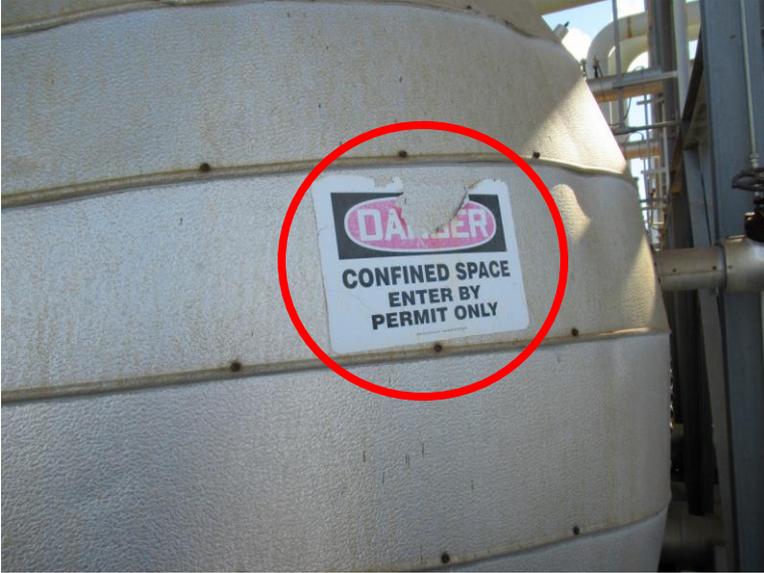
Figure 24: Tattered and faded confined space warning sign at Unit 1's high pressure steam drum.

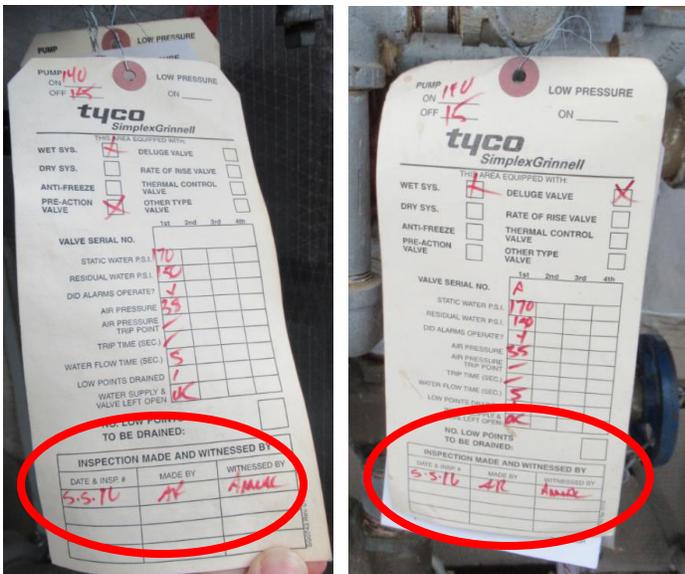
The Plant uses tags to record inspection dates for its STG (Steam Turbine Generator) fire system. ESRB inspected control valves inside a fire system cabinet and found most inspection tags out-of-date, see Figures 25 and 26. For example, the STG fire system cabinet had inspection tags dating back to May 5, 2016. Delta explained that it regularly inspects its fire protection system, but its contractor has not kept its inspection tags up-to-date. Inspection tags provide crucial data for operator and maintenance workers at the equipment's physical location. Delta must keep its inspection tags up-to-date.

Figure 26: Outdated inspection tags inside the STG fire system cabinet.

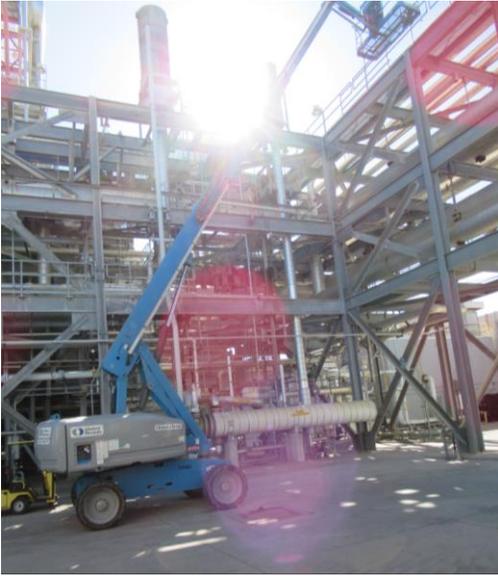
ESRB observed Delta performed a lift operation without the use of cones or barrier tapes to restrict the lift area, see Figure 27. Such a protocol is crucial in preventing worker’s injuries from falling objects. Delta must retrain its workers on its safety procedures and proper lift operations.

Figure 27: Delta performed lift operation without restricting access to the lift area.

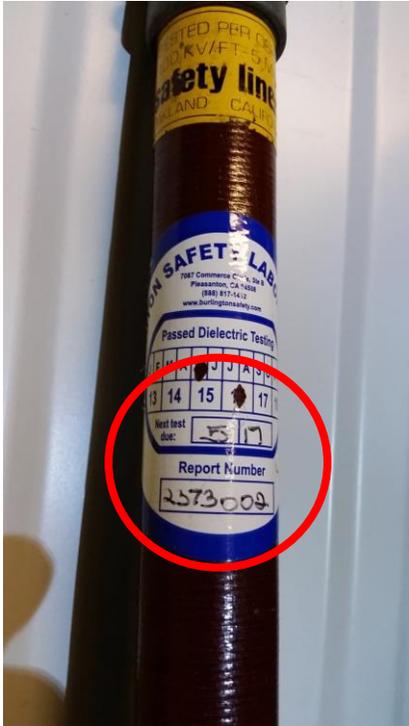
One label showed an overdue test date, see Figure 28. And another is missing the test date and report number altogether, see Figure 29. Delta explained that the overdue test date was the vendor's recommended test date. The Plant, however, tests the sticks every three years per NFPA 70E. Regardless, wrong and/or missing information on the label can confuse and mislead workers. Workers who use the sticks may not be aware of the 70E requirement and may rely strictly on the test labels. To avoid confusion, Delta must maintain test labels to ensure they are accurate.

Figure 28: Test label showing an overdue test date.

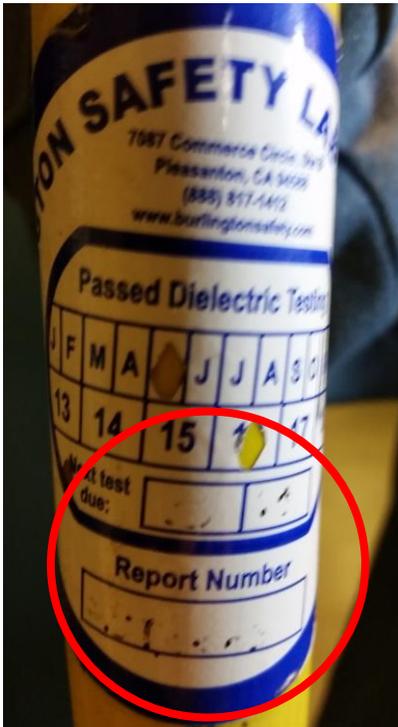
Figure 29: Test label missing test date and report number.

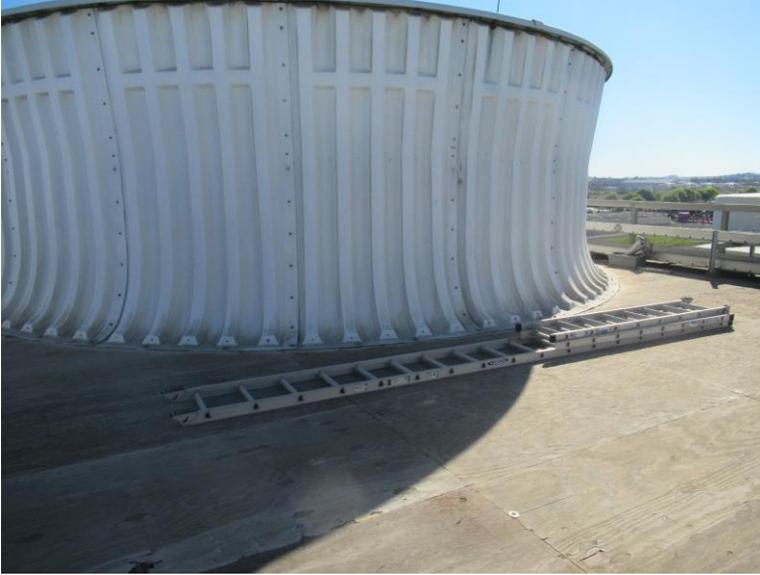
Figure 33: A ladder lying next to a cooling tower stack.

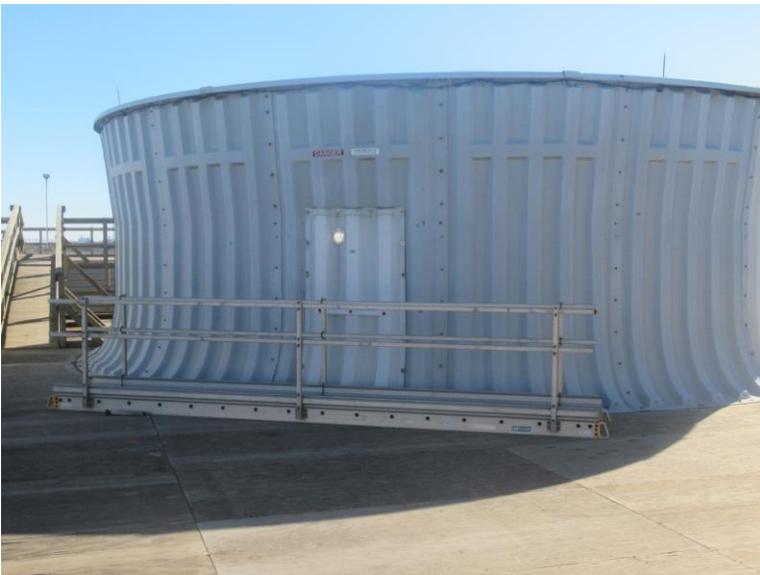
Figure 34: A portable platform obstructing a stack's entrance.

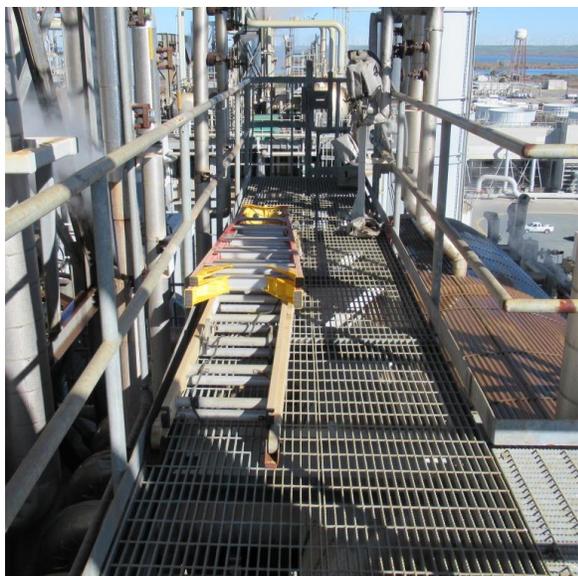
Figure 35: Ladder in the walkway near Unit 1's HP drum.

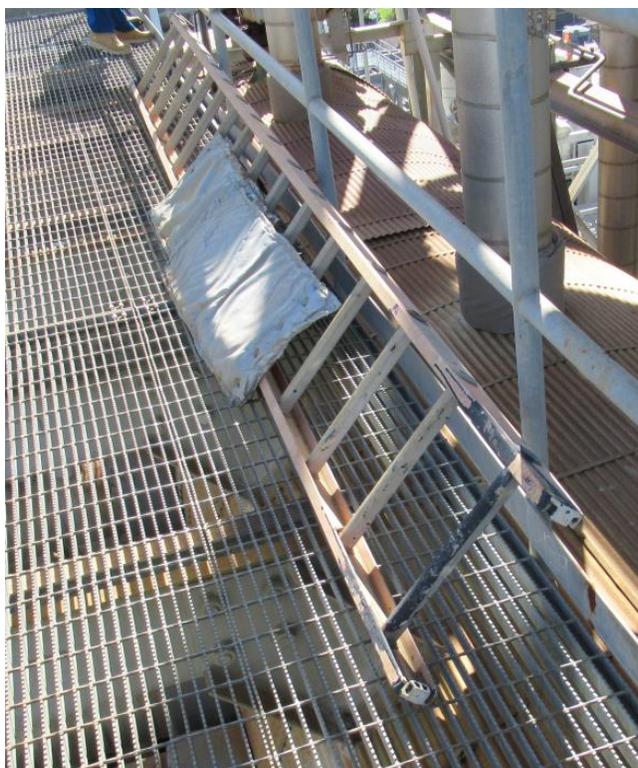
Figure 36: Ladder leaning against railing near Unit 3's HP drum.

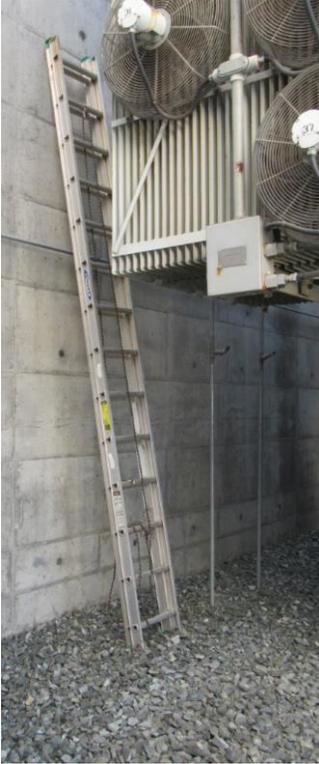
Figure 37: Ladder leaning against a wall near a transformer.

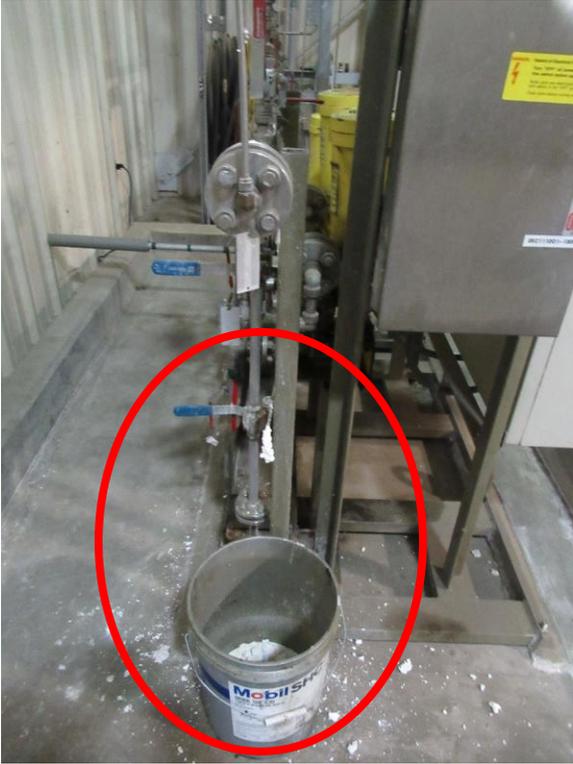
Figure 38: Delta used a bucket to collect fallen phosphate buildup at a chemical skid.

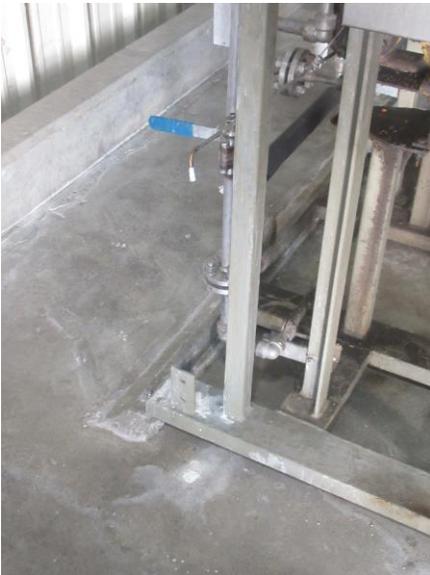
Figure 39: The Plant cleaned up the area and removed the bucket after ESRB notified the Plant.

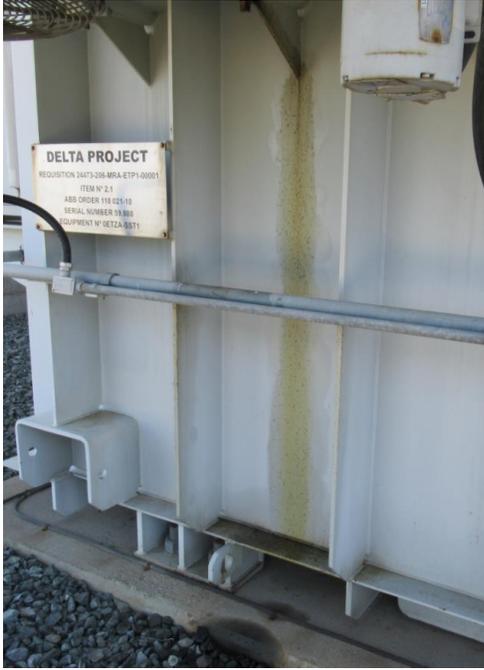
Figure 40: Oil leak at Station Service Transformer 1.

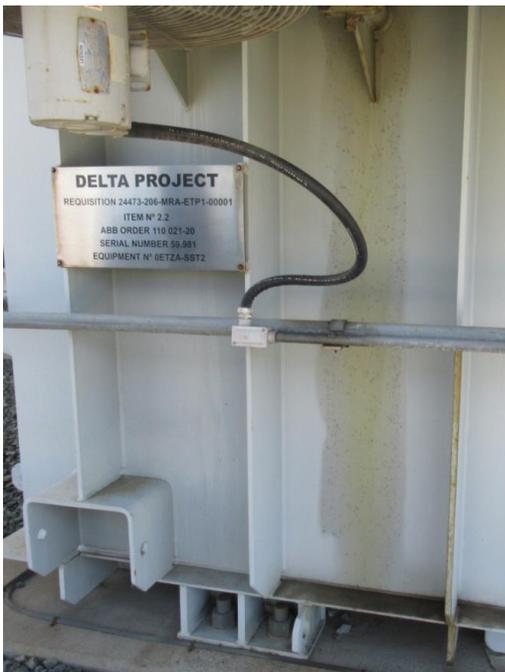
Figure 41: Oil leak at Station Service Transformer 2.

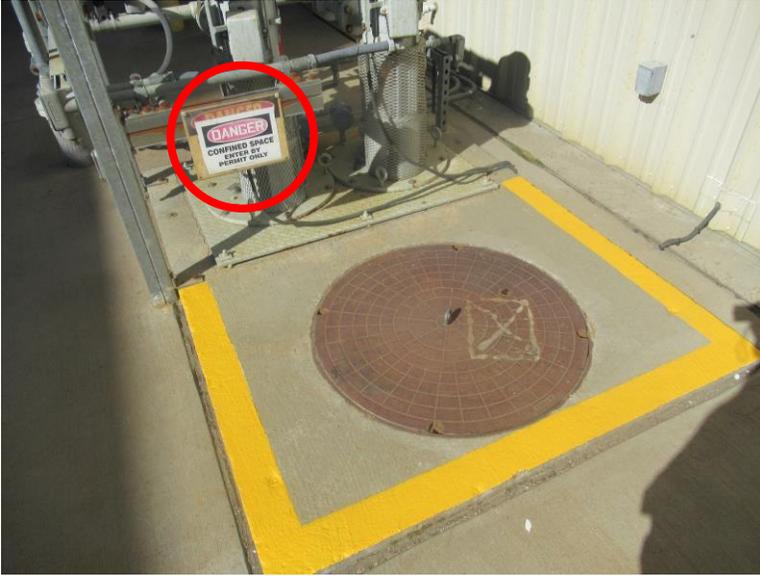
Figure 42: Delta re-secured the confined space warning sign next to the manhole.

Confined space warning signs notify workers of potential hazards and inform workers to obtain proper permit prior to entry. In response, Delta reinstalled and securely fastened the sign near the manhole, see Figure 42.

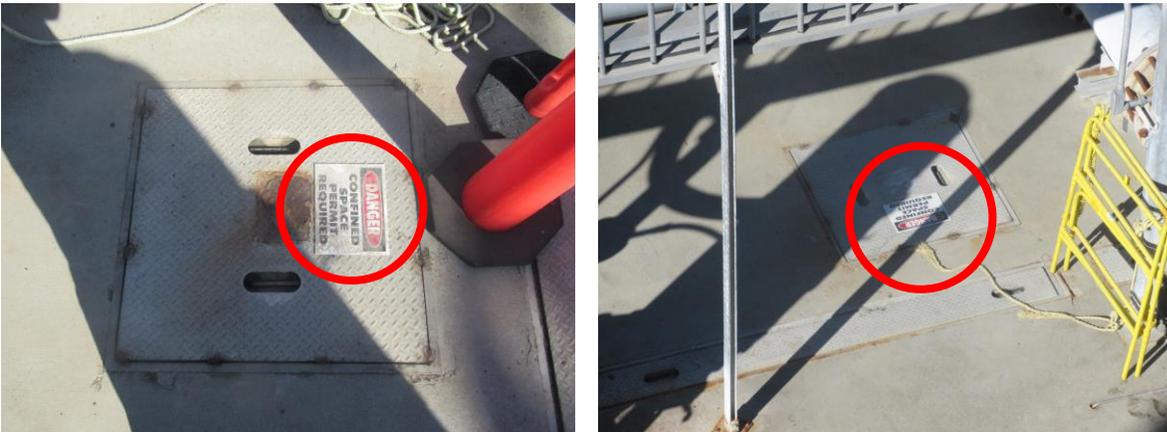
However, throughout the plant, ESRB observed many confined space signs attached on manhole covers, see Figure 43. While the signs were appropriate, ESRB recommends that Delta installs signs near the space in addition to the one on the cover. This will ensure proper identification of the space even while the cover is removed, which may obstruct the sign from proper view.

Figure 43: Confined space sign on manhole covers at the circulating water pump bay.
