**SUBJECT: General Order (GO) 167 Compliance Audit of Shiloh Wind Project  
Audit Number GA2019-02SH**

**Audit of the**  
*Avangrid Renewables LLC*  
***Shiloh Wind Project***

**Audit Number GA2019-02SH**

**STAFF REPORT**

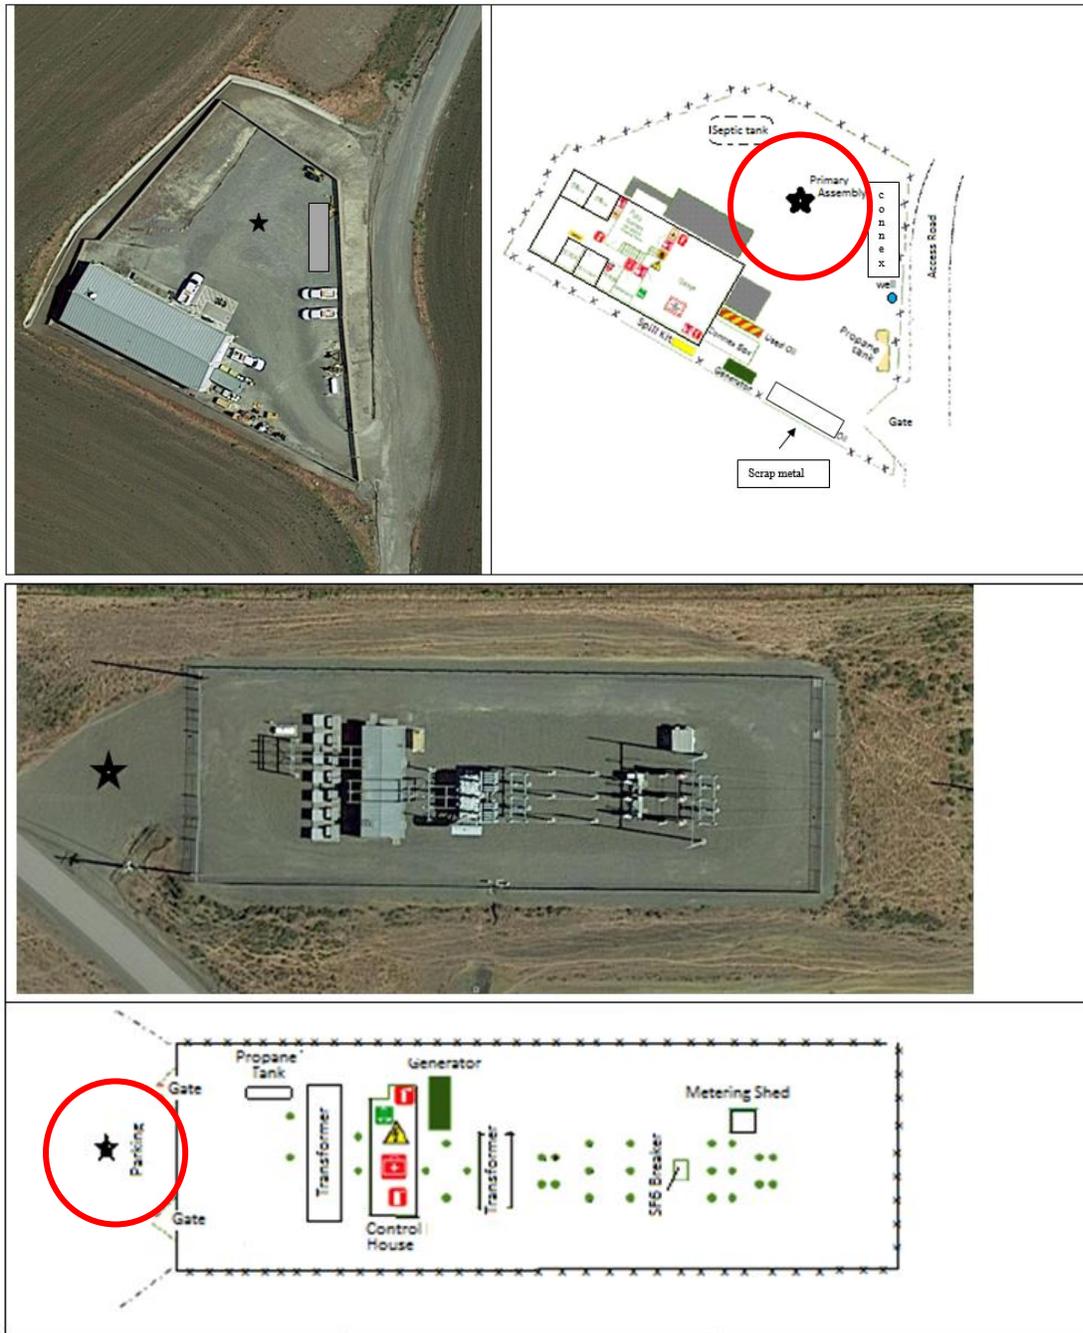
**Finding 4: Evacuation assembly areas are not marked and identified.** Shiloh designates two assembly points (primary and secondary) for workers to gather in emergency evacuations. However, ESRB observed that the primary assembly point, which is at the parking lot in front of the admin building, is not marked and identified. Shiloh must clearly identify the primary assembly point with a permanent sign.

Further, the secondary assembly point, which is offsite and located at the Birds Landing Hunting Preserve, is also not marked and identified. While ESRB understands this is a public site used for gathering, and does not expect Shiloh to erect a sign, the Plant must ensure the location is well-understood and communicated to staff. For example, the Shiloh Site Map as reported to the California Environmental Reporting System (CERS) and provided to ESRB implies that the secondary muster point is, instead, located at the substation (See Figure 1).

Figure 1: Shiloh Site Map provided to ESRB.

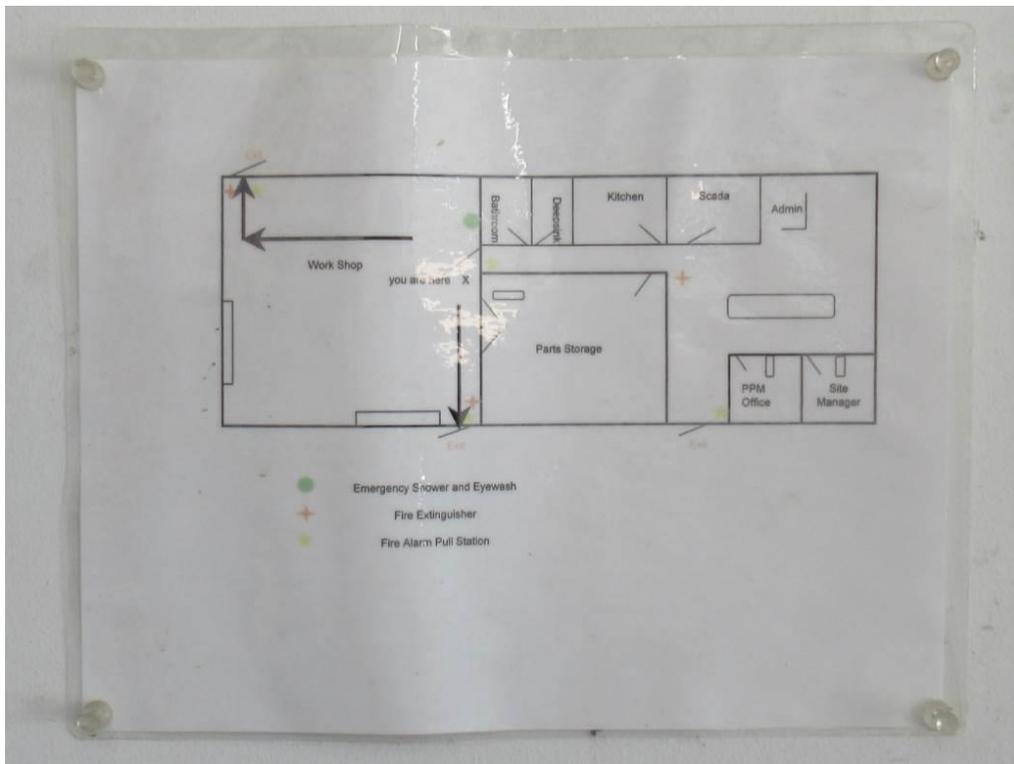
**Finding 5: Evacuation map is out-of-date.** ESRB observed an outdated evacuation map in the shop area by the shower/eyewash station. Contrary to the map as presented in the safety orientation, this map did not include the location of first aid kit and AED as well as the location of flammables and oil storage. The Plant must update this map and ensure that it uses the same map consistently throughout the site and across all plant documents.

*Figure 2: Outdated evacuation map in the shop area.*

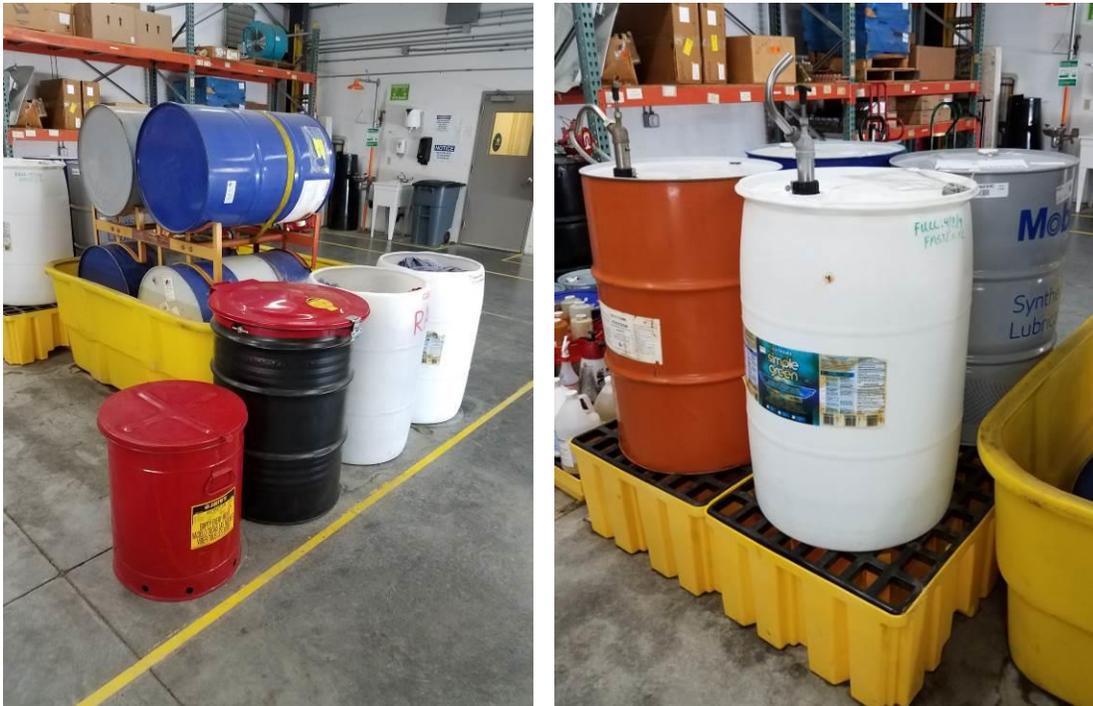
**Finding 6: Hazmat warning sign is missing.** Shiloh uses various hazardous materials as part of its normal operation, including flammable lube and hydraulic oil and environmental and

health hazardous chemicals, such as antifreeze, nitrogen, and sulfur hexafluoride. However, ESRB observed no posting of a hazmat warning sign on the roll gates of the shop where the Plant stores these materials. National Fire Protection Association (NFPA) establishes industry consensus standards for fire protection. NFPA 704 is the standard system for identifying hazards of materials for emergency response. The posting of an NFPA placard is a common industry practice to alert first responders of the risks posed by a facility’s hazardous materials. This helps emergency workers determine what safety precautions and equipment to use and how best to respond to different scenarios. The Plant must install a hazmat warning sign at the shop, where it stores the bulk of its hazardous materials.

Figure 3: Bulk storage of flammable lube and hydraulic oil in the shop.

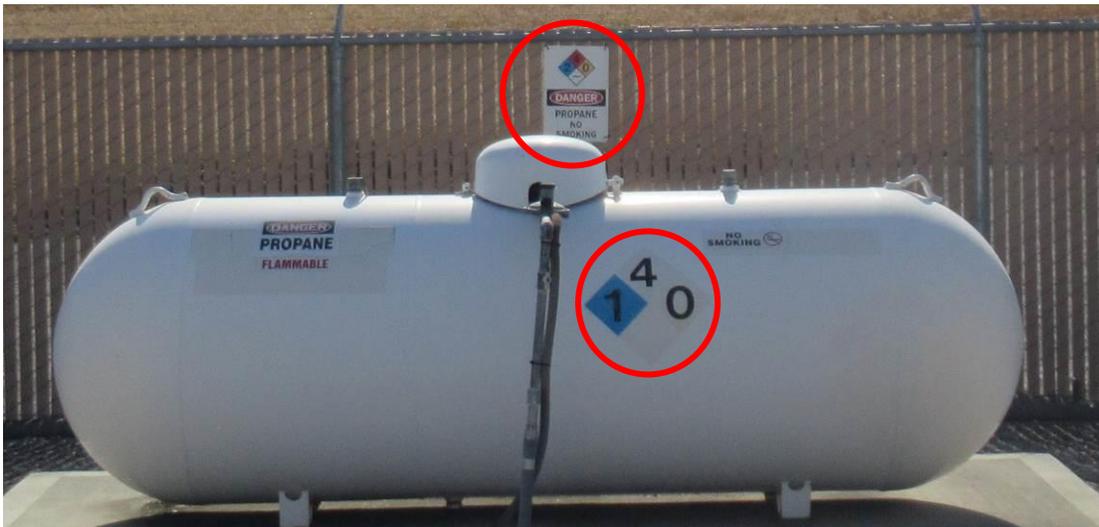
**Finding 7: Hazmat placards for the propane tanks are mismatched.** Shiloh maintains a propane tank at the admin building and the substation. While warning placards are conspicuously posted at both locations, ESRB noticed the placard on the tank conveyed a different health hazard warning than its respective placard posted on the chain link fence.

Mismatched placards or signs can confuse workers and first responders and may lead to operational errors or cause response delays. The Plant must take corrective action to reconcile and correct the mismatched signs.

*Figure 4: Mismatched placards on the propane tank at the admin building.*

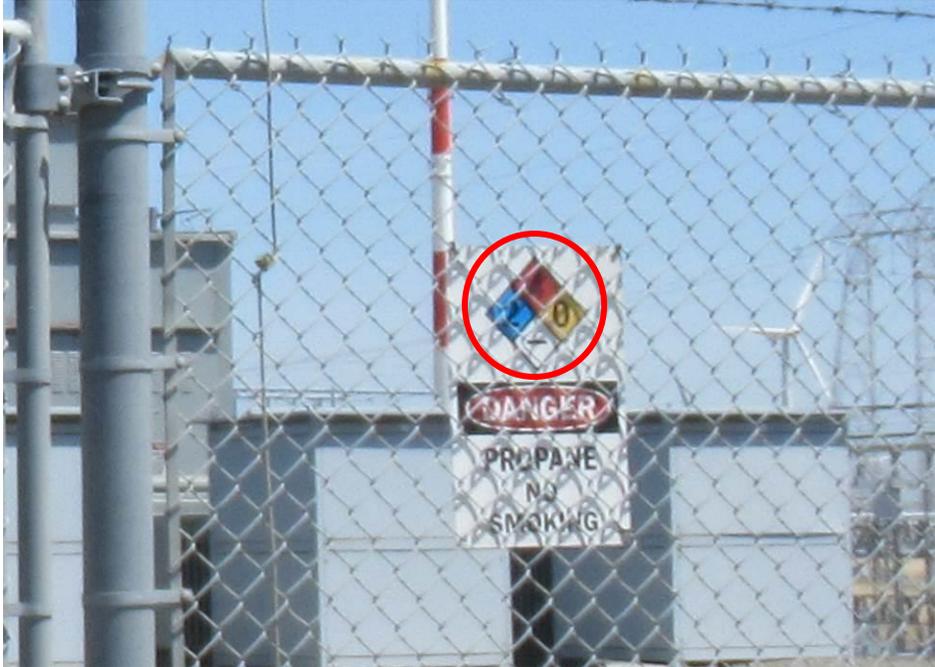
Figure 5: Mismatched placards at the substation.

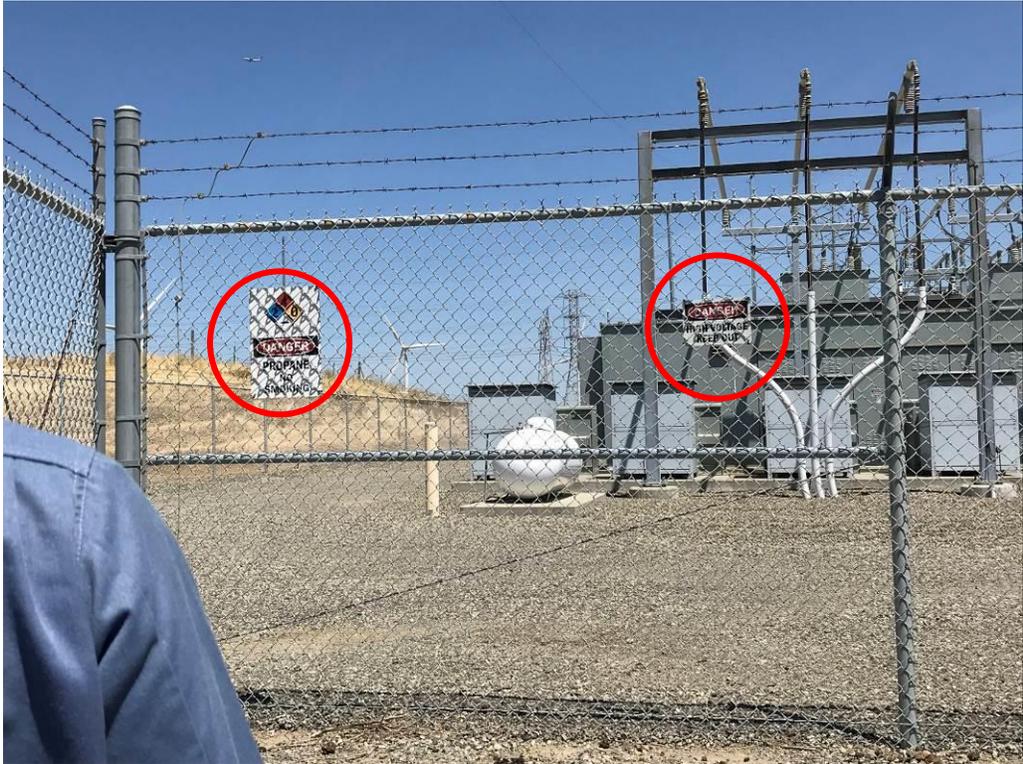
Further, warning placards at the substation were incorrectly installed on the interior side of the chain link fence, rendering them unreadable and ineffective. The Plant must reinstall placards on the fence's exterior such that they are visible and unobstructed.

Figure 6: Warning placards visibly obstructed by chain link fence.

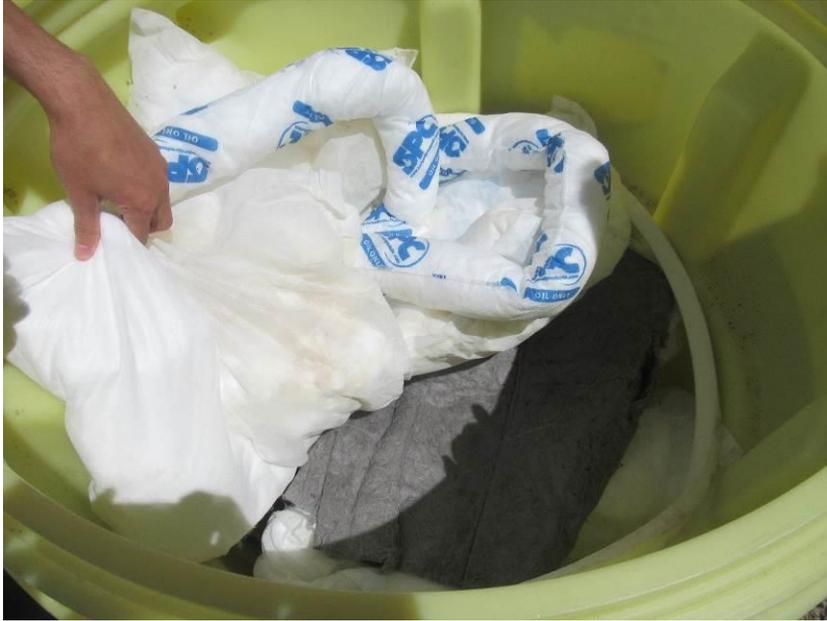
**Finding 8: Spill kits are not properly inspected.** Shiloh maintains multiple spill kits onsite in order to respond quickly in case of a spill. According to plant procedures, Shiloh inspects these spill kits on a monthly basis to ensure all materials within the kits are in working order. However, ESRB noticed that the kit in the shop had wet absorbent socks, and that a bag of absorbent that had holes causing loose absorbent materials to leak. ESRB had learned that the kits were only visually inspected, which as evident in this case, was not sufficient to ensure its contents are in good working order. According to the Plant, the kit was in-use before Avangrid purchased the Plant. The Plant must retrain its workers on how to effectively inspect spill kits.

*Figure 7: Wet and defective absorbent socks in the spill kit.*

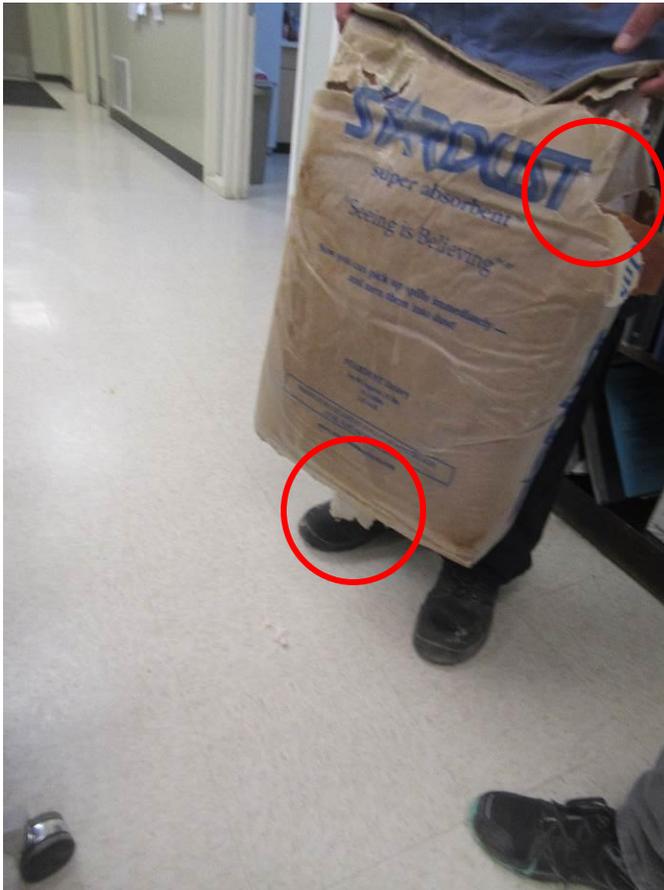
*Figure 8: A bag of absorbent had holes causing loose absorbent materials to leak.*

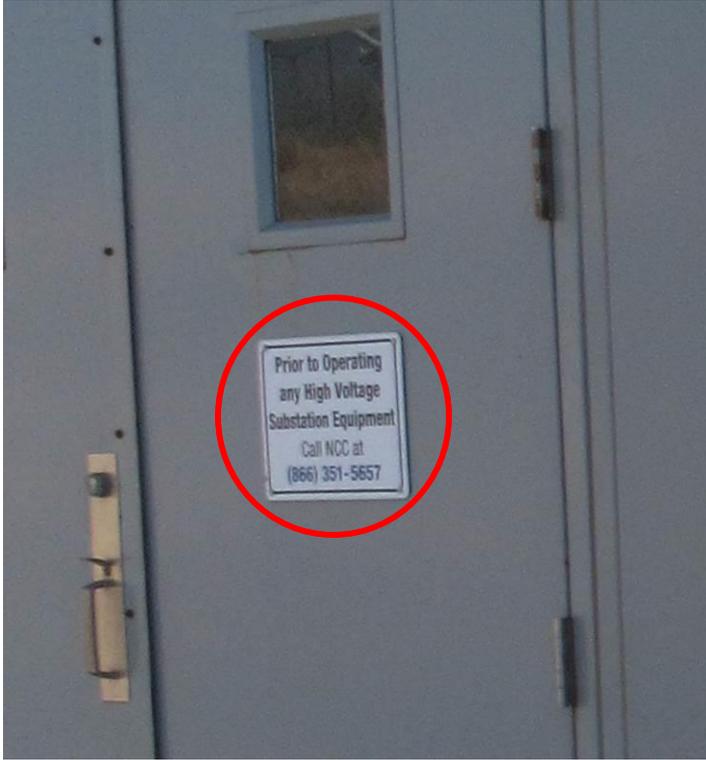
Further, ESRB observed that a similar warning sign is also missing on one of two entrances to the substation control room. One entrance has a sign that alerts and directs worker to call the National Control Center prior to operating any high voltage substation equipment. The Plant must install an identical sign on the second entrance to avoid workers confusion.

Figure 10: Warning sign on one entrance to the substation control room.

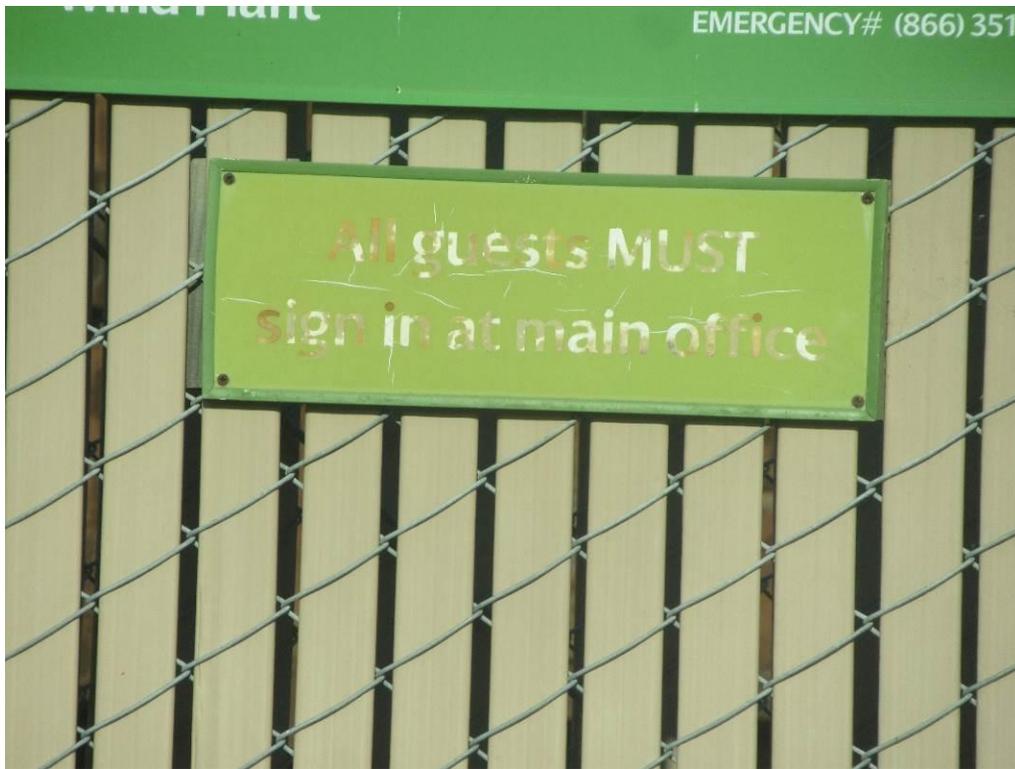
**Finding 10: Damaged and illegible sign.** ESRB observed a damaged and illegible sign on the perimeter gate of the O&M yard. The sign informs and directs all visitors to sign-in at the main office. Shiloh must replace the defective sign to help reinforce its security protocol.

*Figure 11: Damaged and illegible sign on the perimeter gate of the O&M yard.*
