PUBLIC UTILITIES COMMISSION

GA2022-03AHB

SUBJECT: Audit report of AES Huntington Beach Energy Project

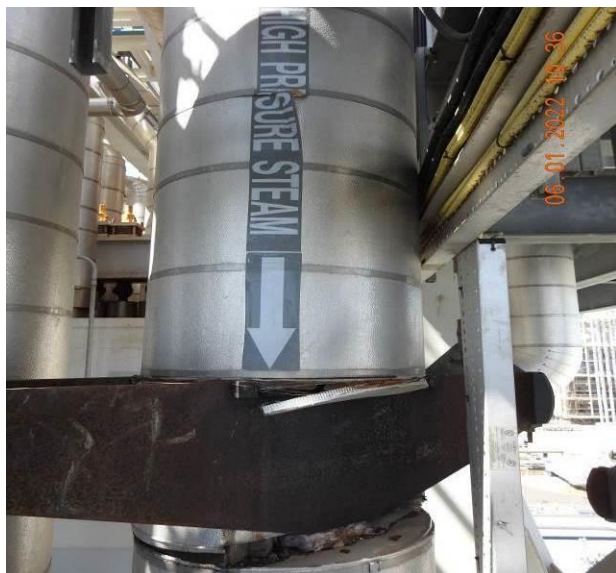
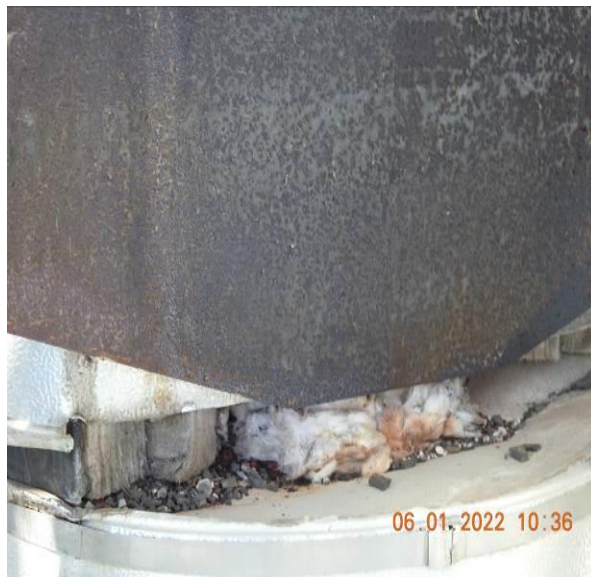
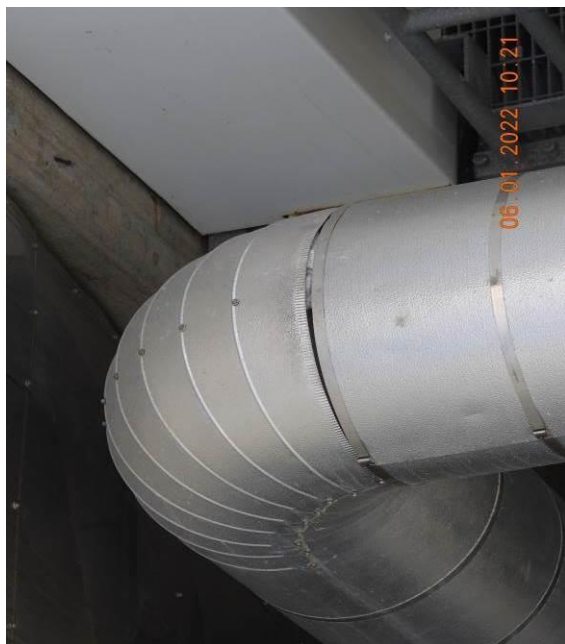
ESRB staff witnessed damaged insulation on some pipes. Damaged insulation can result in accelerated heat gain or loss and can result in corrosion under insulation.

Damaged Insulation

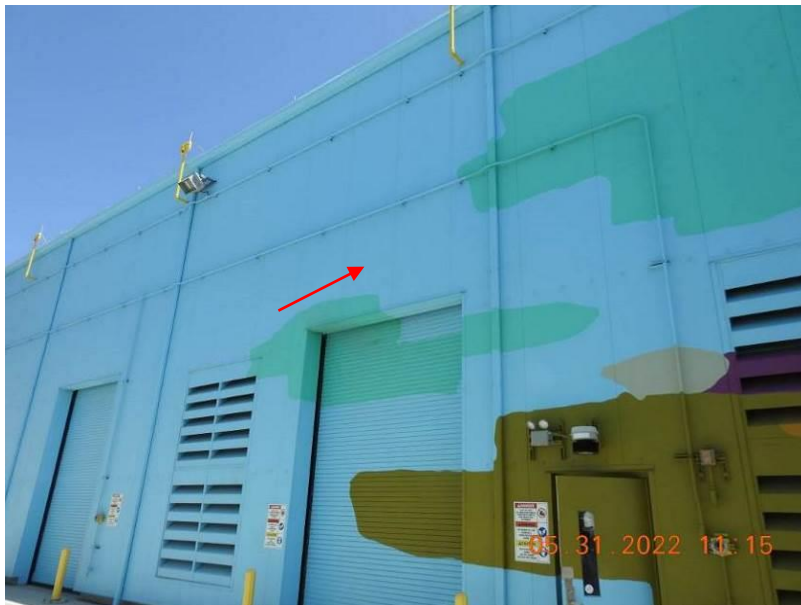
ESRB staff found missing NFPA sign (the fire diamond) in the natural gas compressor room as indicated below. The numbers in the diamond are important to provide information related to hazards.

Missing NFPA sign (fire diamond)

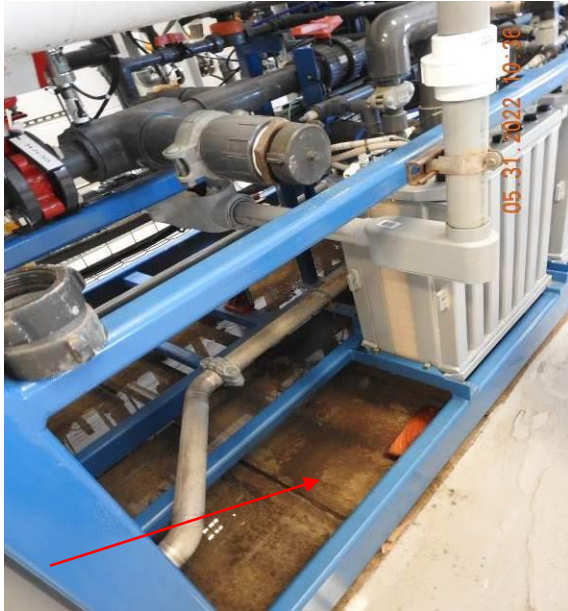
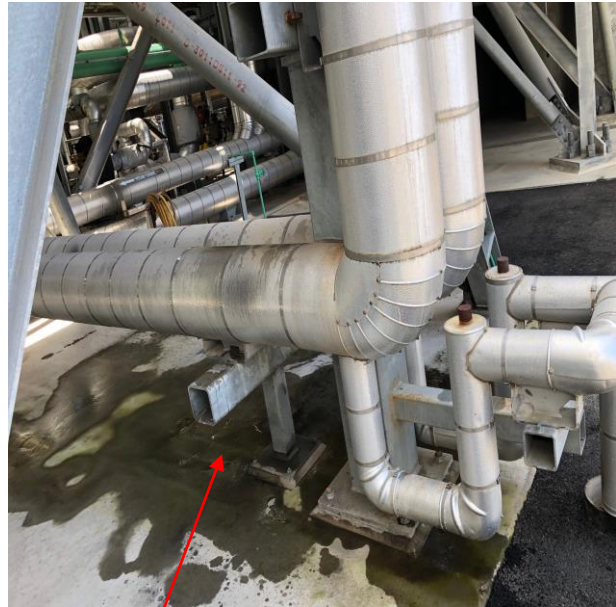
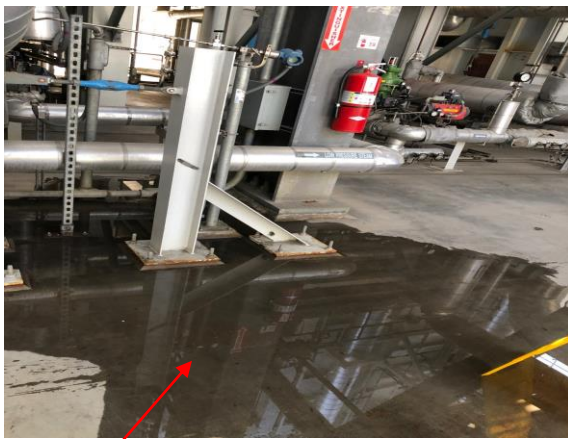
ESRB staff witnessed standing waters and few leaking pipes. Leaking pipes are indication of lack of maintenance and standing water can result in tripping hazards. Also, staff observed standing lube oil from an old leak.

Standing water in different areas of the plant

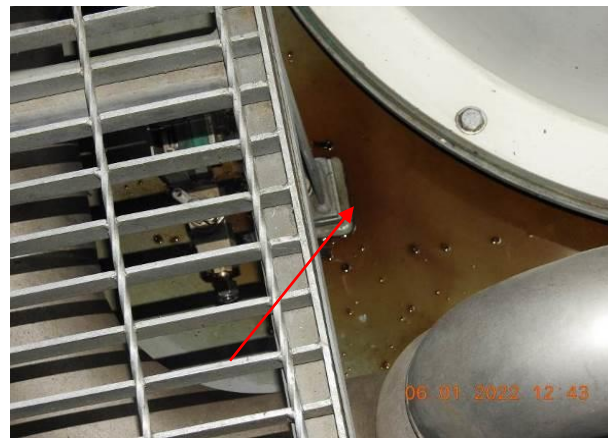
Standing Lube oil

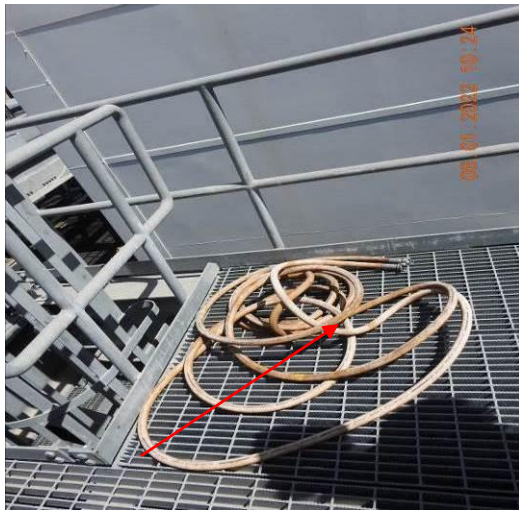
Hoses on the ground

ESRB staff observed gloves, some unsued pipe joints and buckets on the floor. The staff also observed hoses kept on the ground. All these pose tripping hazards for plant personnel. The plant should ensure that its staff store tools and equipment back in their proper place after each use. ESRB Staff also observed loose insulation covers in several areas of the plant.

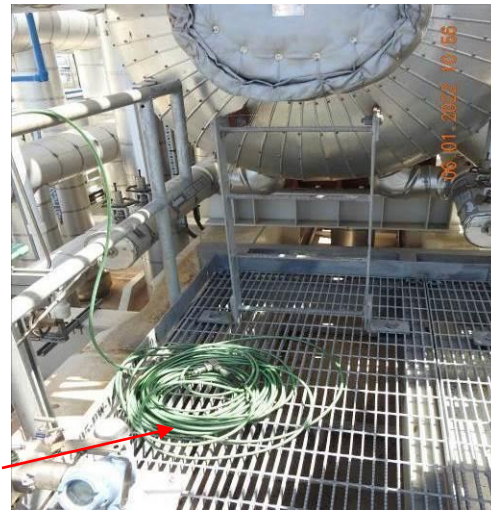
Hoses on the ground

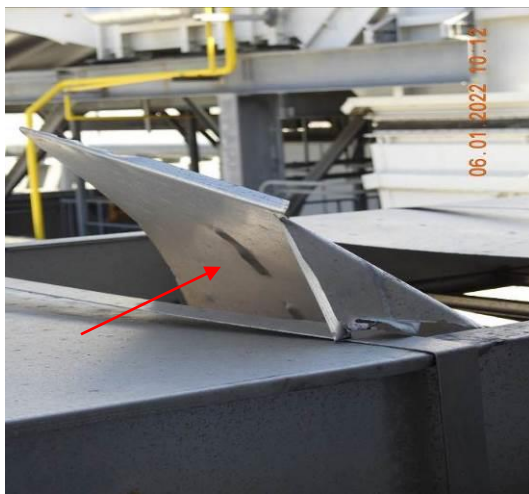
Broken cover of Cable Tray

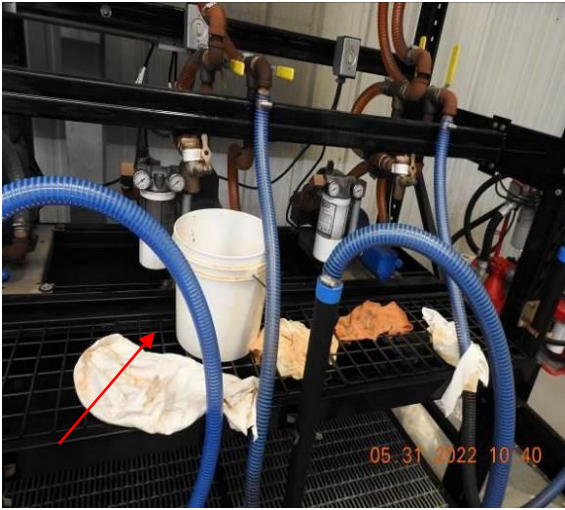
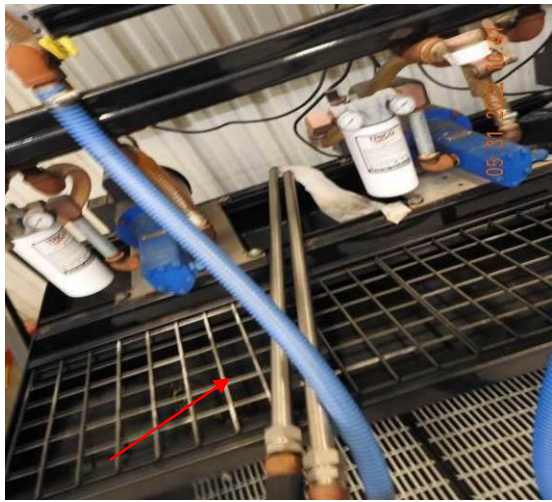
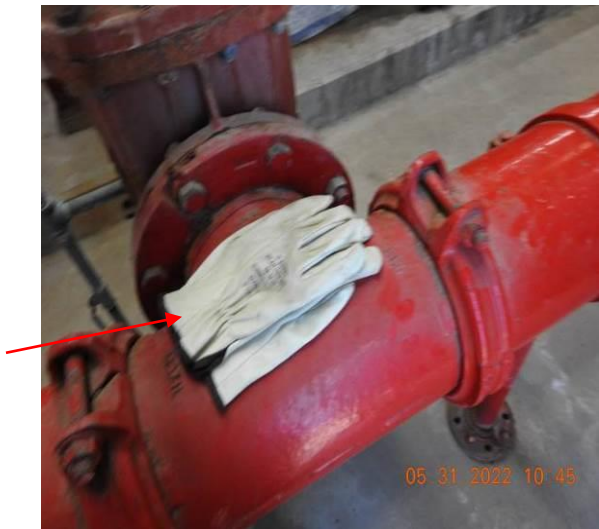
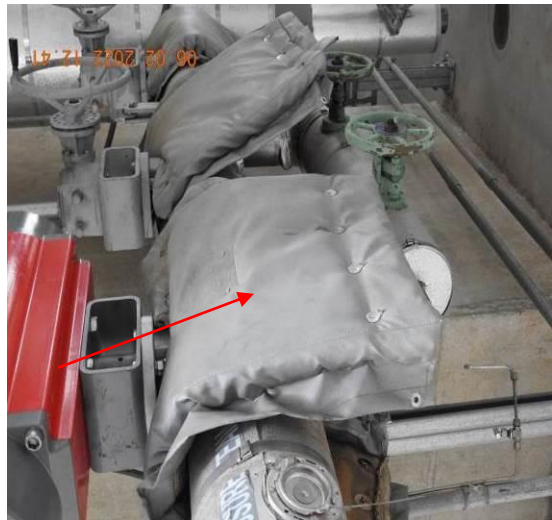
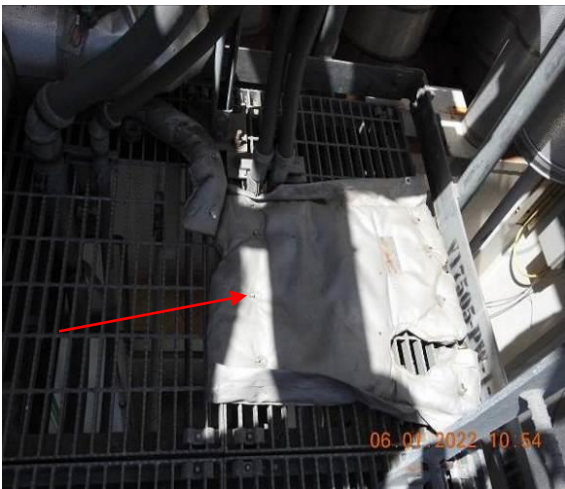
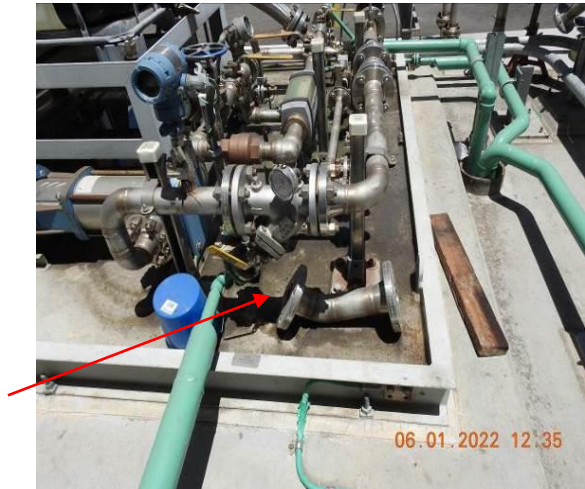
Gloves, pipe joint, insulation cover on the ground

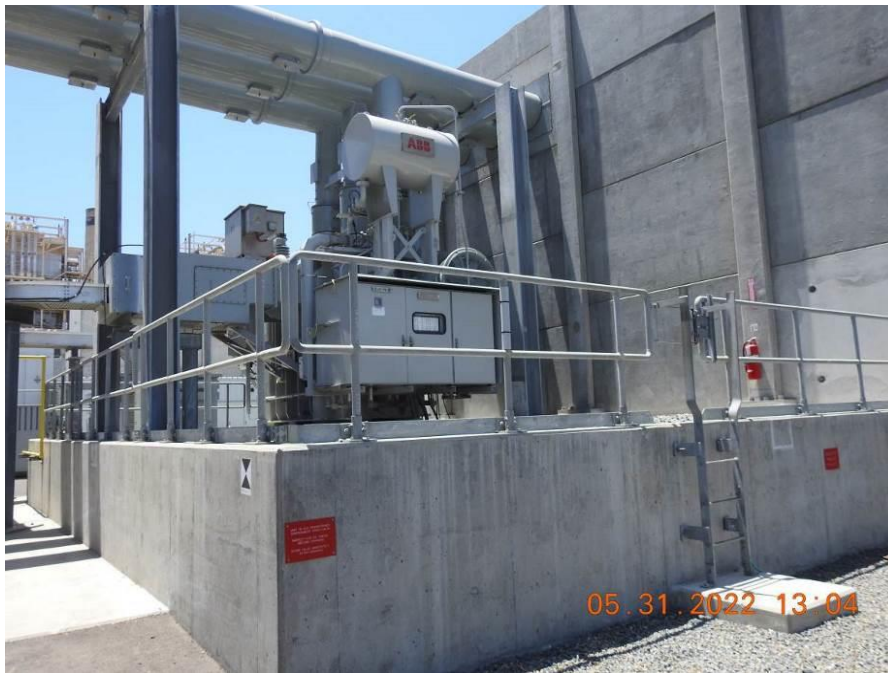
ERSB staff witnessed missing High Voltage sign around the transformer.

Missing High Voltage sign

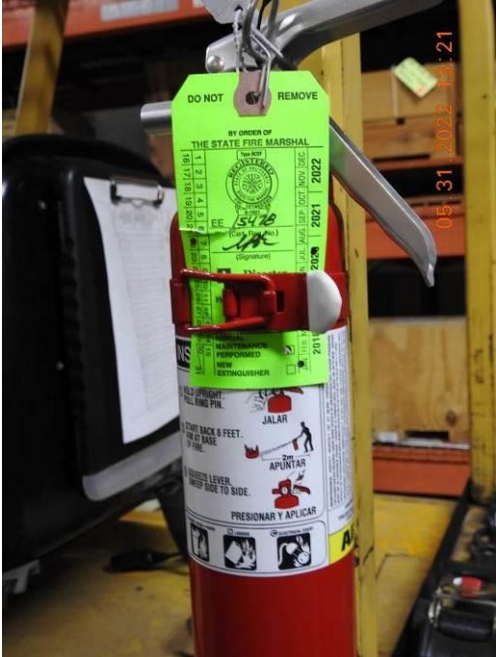
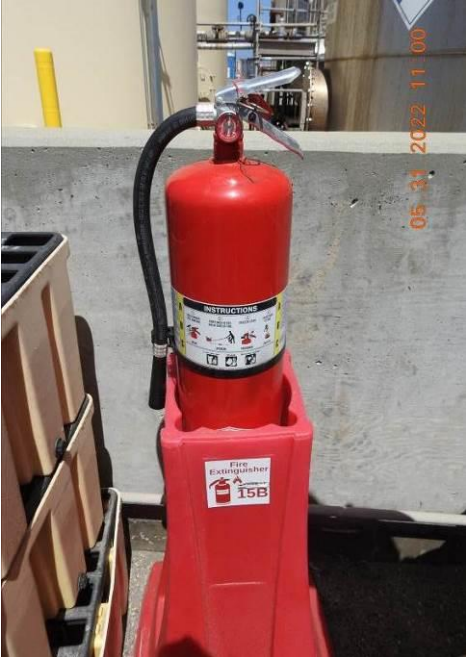
ERSB staff found an outdated fire marshal inspection tag and also another fire extinguisher had no tag. Fire extinguishers are required to be inspected by Fire Marshal annually to make sure they are in good condition and ready to use in case of an emergency.

Outdated inspection tag and missing inspection tag

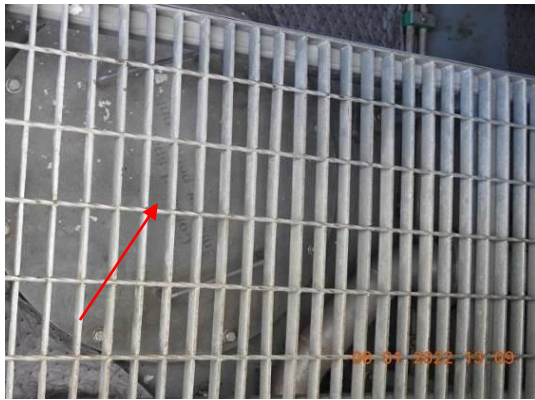
ERSB staff found a Confined Space Sign missing in a lube oil room. Also, a danger sign for Hydrogen Gas was not properly attached near Hydrogen gas cylinder storage. Missing safety signs can result in injury for the plant personnel.

Missing Confined Space Sign

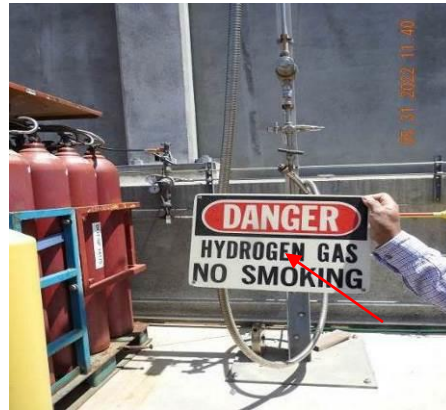
Danger sign not properly attached
