Shiloh I Wind Project LLC

April 8, 2024

RE: Response to General Order (GO) 167 Compliance Audit of Shiloh Wind Project
Audit Number GA2023-16SW

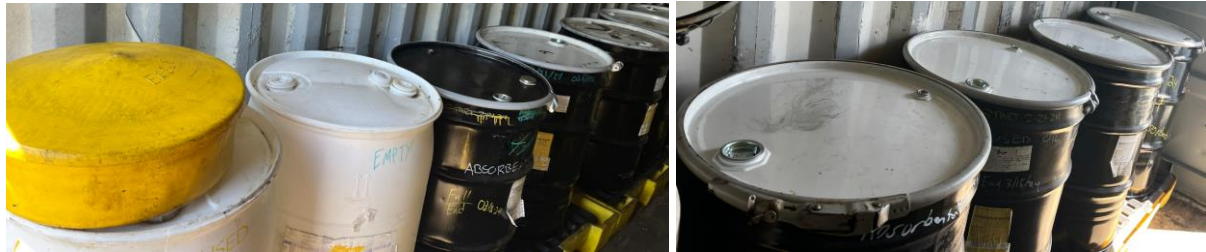
Finding 2: Hazardous waste containers are corroded.

The Company is subcontracting the waste management to a third party who provides the site with containers and replaces the containers when they are full. The Company has notified the supplier to immediately remove the corroded containers and make sure that future containers must align with regulation and must not be compromised in any other way. The Company will also be inspecting containers on delivery to ensure compliance. The Company is working on a fleet-wide change to our controlled waste inspections to include looking at container condition, emergency response resources, clutter and labeling.

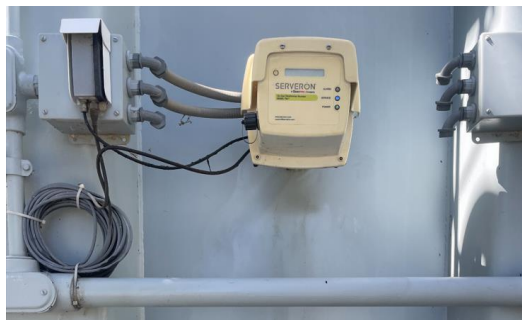
Finding 3: Oil seepage and bird nest found at main transformer.

Regarding the oil seepage finding, Spill Prevention Containment Countermeasure (SPCC) audits indicated that there was a previous leak from the manifold and another leak from Serveron valve, both of which resulted in stains. During the 2021 NERC Outage, the Serveron valve and the manifold were both tightened, but the stains were not sufficiently cleaned up. What was seen as seepage during the 2024 audit was actually a stain from this previous leak. The stained Serveron valve was cleaned on March 18, 2024 and the stained manifold will be cleaned in the next NERC outage scheduled Dec 10-13, 2024.

Evidence of the cleaned Serveron valve can be seen in the picture below.

Serveron valve was cleaned March 18, 2024

Manifold will be cleaned during the NERC Outage scheduled December 10-13, 2024

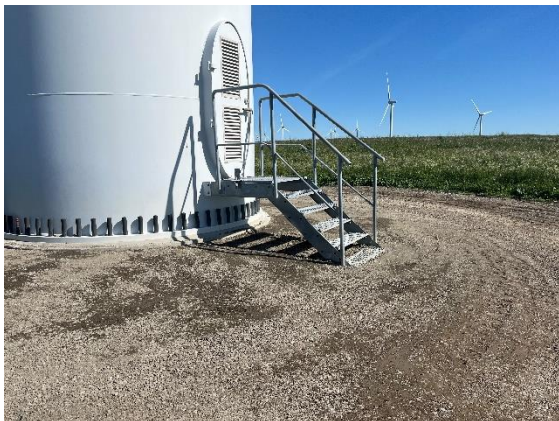
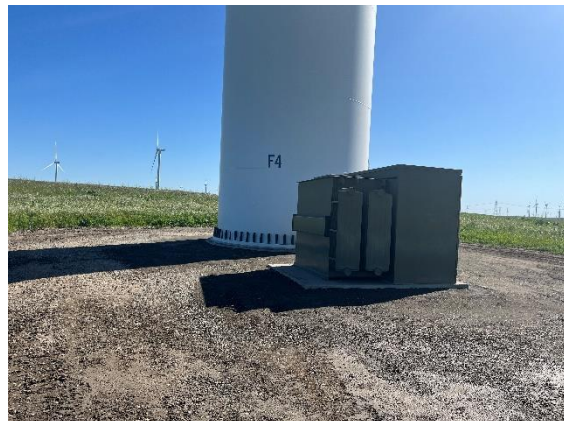
Finding 4: Insufficient grading and water drainage at WTG F4.

Evidence of the remediated grading at the foundation area can be seen in the picture below.

Regrading will be performed at WTG F4 to remove the accumulation of water. As the Company feels we can constantly improve our process, we will be carrying out a site-wide campaign at Shiloh this year to record the condition of the foundations. Inspections will be performed by an experienced foundation vendor. Part of the scope is to prepare a report for each foundation, so if there are concerns with items such as pooling water, they will be noted, and corrective measures will be defined.

WTG F4 foundation remediated April 8, 2024.
