Henrietta Solar Facility CPUC Audit GA2024-02HS: SPC Response

**RE: Generation Audit of Henrietta Solar Facility (Henrietta) – Audit Number GA2024-02HS**

CPUC Audit GA2024-02HS:  
Henrietta Solar Facility  
February 5-7, 2024

## **CORRECTIVE ACTION PLAN**

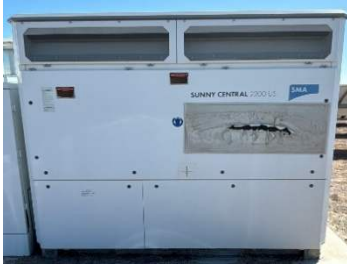
### Finding 1. Henrietta Solar needs to install and/or replace deteriorated high voltage signage.

Action	Issue	Description of Action	Assigned Person	Maximo WO	Date
1	Stickers on west side of inverters: Location Nomenclature stickers	The signage should denote location of inverter, ex: "A01-INV04". Site team is currently working on removing the old sign and using stencils and high temperature paint to permanently re-create the sign. Some inverters are complete, site is in progress.	G. Parker	HRS1931	7/31/24
<p>Finding</p>

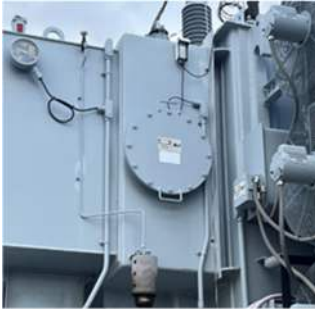
**Finding 2. The Plant needs to install and/or replace deteriorated confined space signs.**

Action	Issue	Description of Action	Assigned Person	Maximo WO	Date
1	Deteriorated confined space sign on manhole of main power transformer in substation	New Confined Space signs were ordered and were placed during 4/24/24 outage to fix leak (see Finding 3). Grainger item is #465K40.	L. Stephens	HRS1932	4/24/24

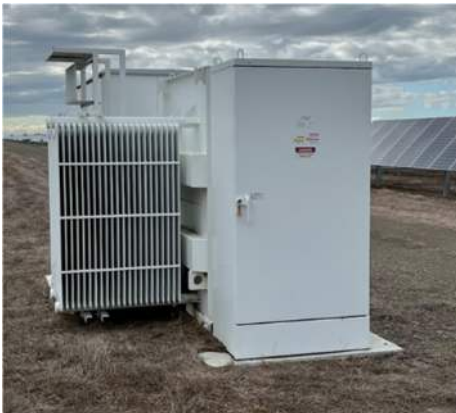
Finding

**Finding 5. Vegetation control around inverters – grass growing into the inverter and very close to the surrounding concrete base.**

Action	Issue	Description	Assigned Person	Maximo WO	Date
1	Overgrown vegetation extending under inverter, including cut or dead vegetation. Proximity of vegetation poses a potential fire hazard and safety risk.	Henrietta Solar has moved to pre-emergent spraying to remove all vegetation from the site to remove any potential energy source for fire. Spraying was completed in March 2024, and will be utilized on an ongoing basis to appropriately control vegetation growth in accordance with our weed abatement plan.	G. Parker	HRS1833-110	3/31/24
