SUBJECT: Generation Audit of Shiloh Wind Project - Audit Number GA2023-16SW

**CPUC AUDIT FINDINGS OF
SHILOH WIND PROJECT
January 22 – January 24, 2024**

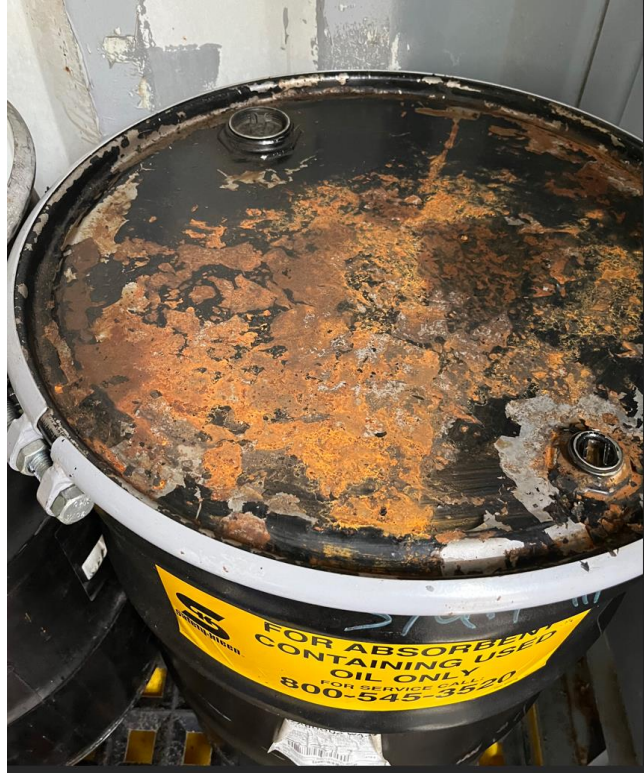
ESRB observed hazardous waste containers with corrosion at the Plant’s O&M facility. In order to prevent leaks that could harm personnel or the environment, hazardous waste containers should be free of rust or other structural defects. The Plant staff stated that that was the condition of the containers upon receipt by a contracted provider. The Plant management reached out to the contracted provider and one of the defective containers was removed with assurances that future barrels provided to the Plant would be free of rust. One additional container remained that had mild corrosion on it.

Figure 3. Waste barrel with corrosion.

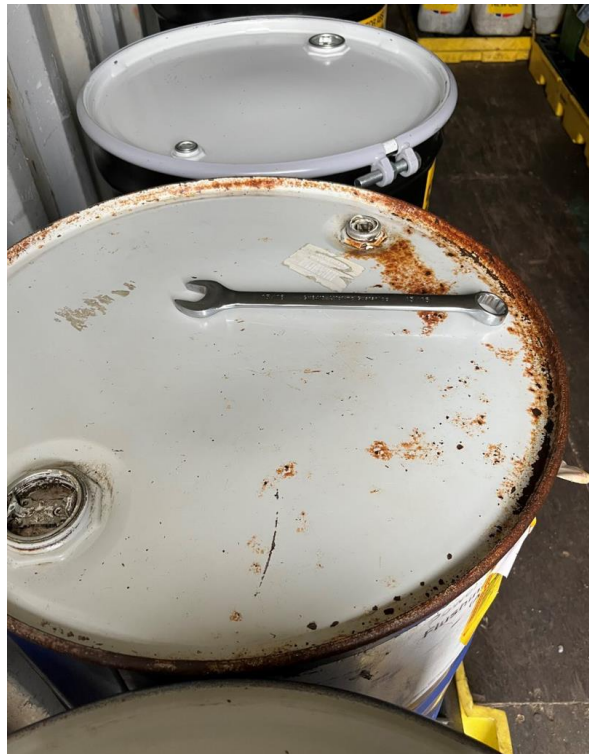
Figure 4. Second waste barrel with corrosion.

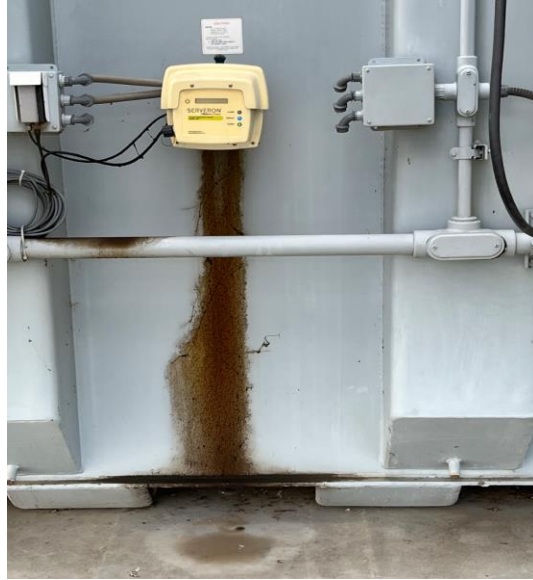
ESRB observed oil leaking from the power transformer at the Plant’s substation. In order to maintain reliable operation, transformer oil leaks should be addressed promptly. This is especially important for the power transformer, as all the power of the plant is delivered via this transformer and the lead time for the Plant to procure a temporary replacement transformer is approximately six to eight weeks. However, these oil leaks were observed by the Plant staff in January of 2021, were not addressed during the NERC outage later that year and were still present in the field at the time of ESRB’s audit in January 2024.

Figure 5. Oil leak from Serveron valve.

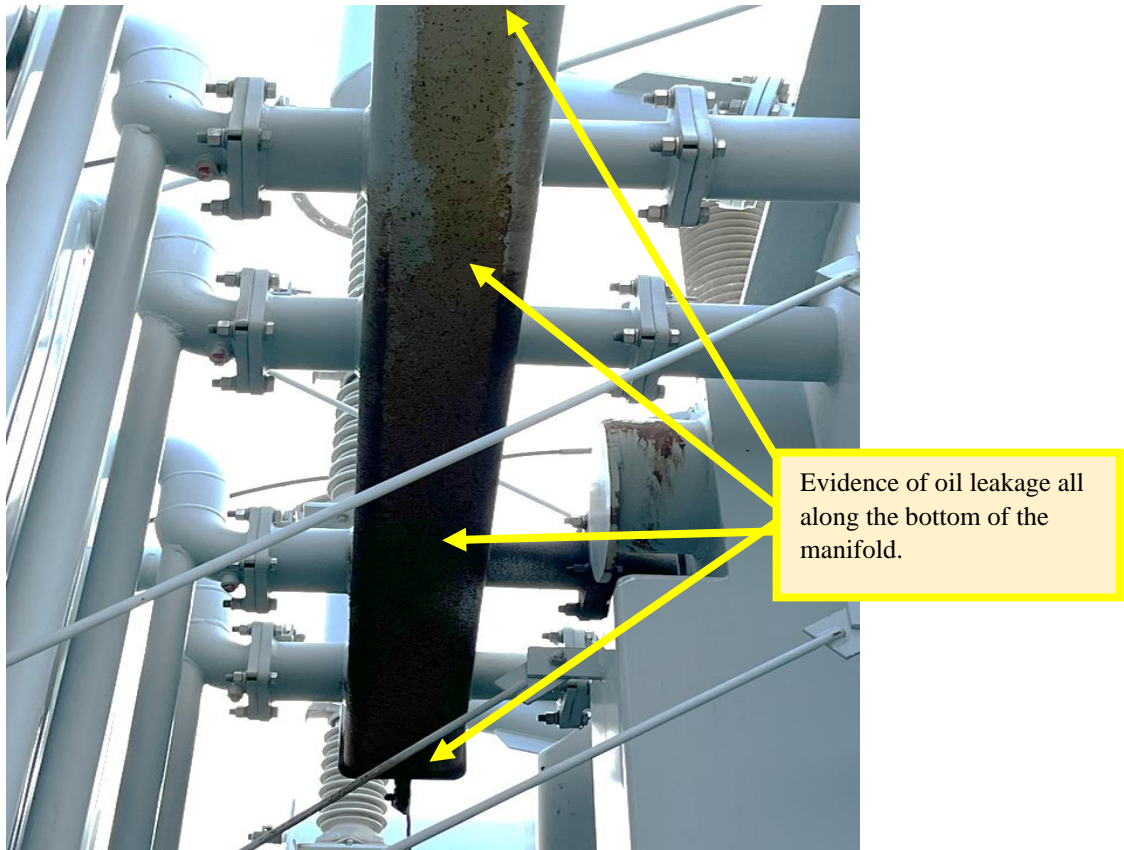
Figure 6. Additional Oil seepage in manifold between transformer body and radiator fins.

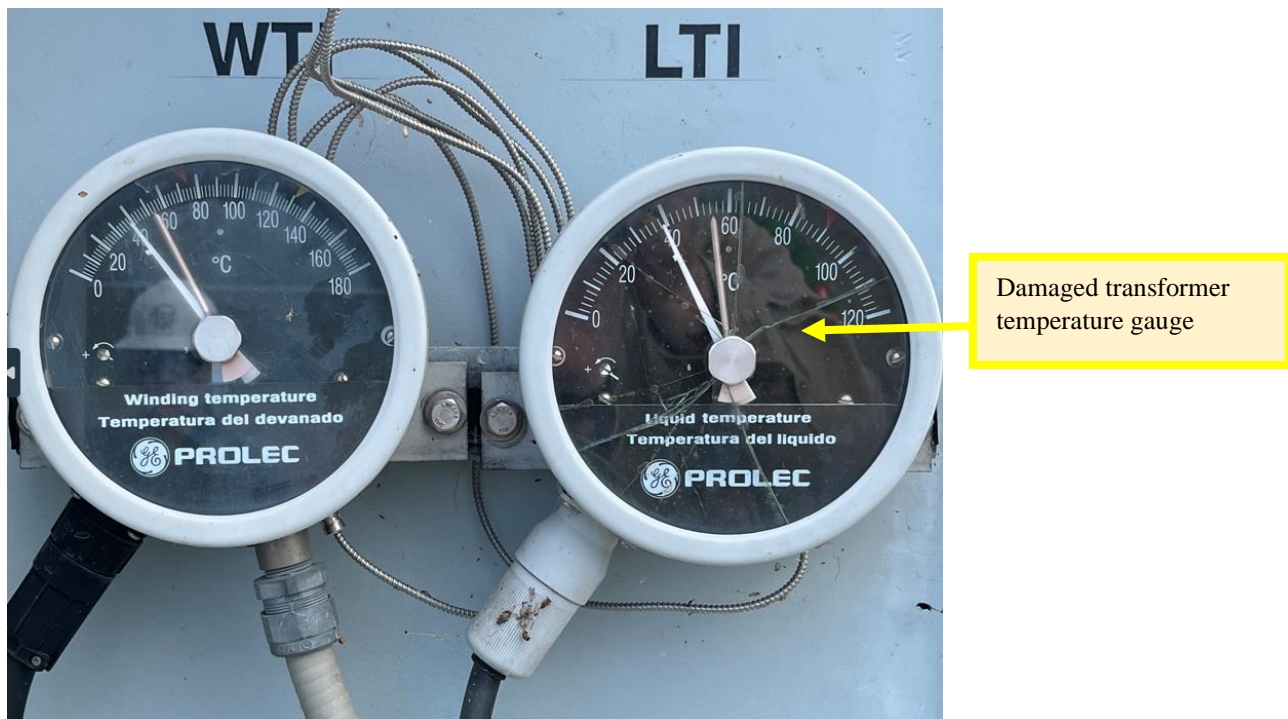
Similarly, there are monthly reports over a three-year period that reported an issue with a broken transformer gauge that was present from January 2021 to December 2023. Figure 8 is a photograph of the damaged transformer gauge. The Plant technicians and BOP team need to establish a standardized tracking system for the maintenance of High Voltage assets and ensure issues reported

Similarly, ESRB observed a broken oil temperature gauge on the power transformer. Similar to the power transformer’s oil leaks, the oil temperature gauge has been broken since January 2021 and was not corrected during the NERC outage. In order to prevent further damage and ensure reliable transformer operation, the power transformer’s oil temperature gauge issue should be appropriately corrected.

Figure 8. Cracked oil temperature gauge.

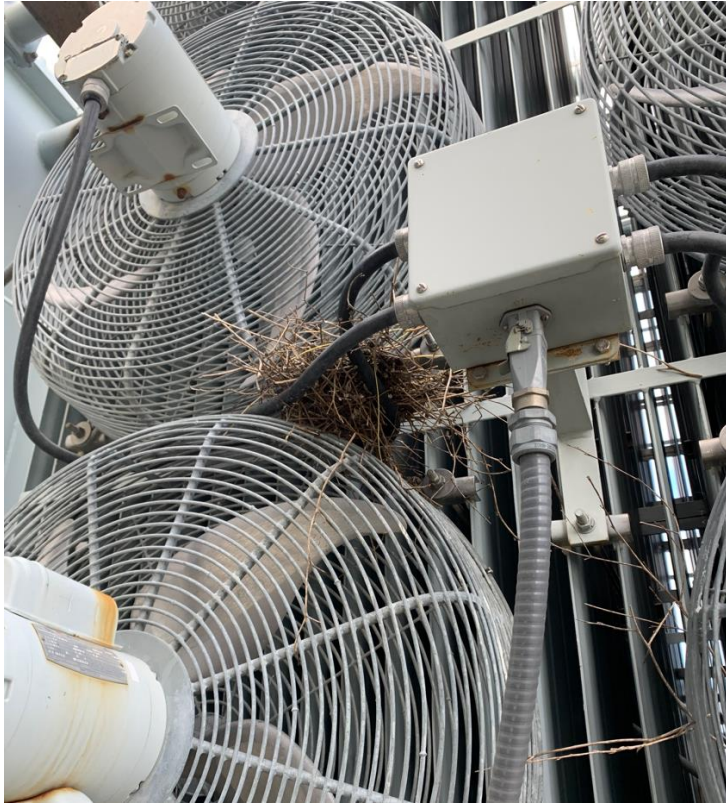
ESRB also observed a bird nest near one of the fans of the power transformer. Bird nests can block air flow around transformer radiator fins and inhibit the transformer’s ability to regulate its oil temperature. Plant staff expressed concern that removing any bird nest is against California law. However, the California Fish and Game Code, Section 3503 states that:

Figure 9. Bird nest near radiator fans.

ESRB’s understanding is that removal of the bird nest in order to maintain equipment operation is acceptable, provided that the nest is not an active nest.

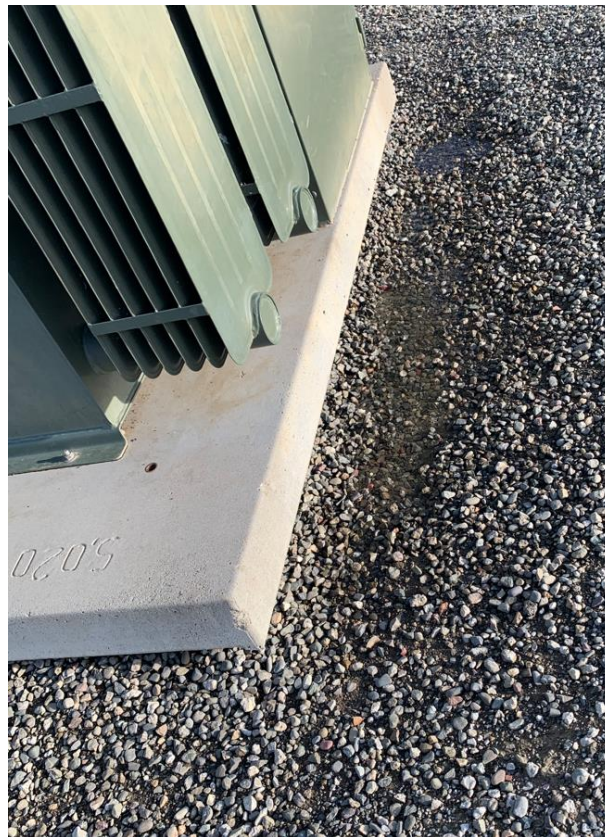
ESRB observed issues related to the grading and water drainage around WTG F4. First, the concrete pad that supports the padmount transformer for WTG F4 is not fully supported by the ground. One edge of the pad is elevated over the ground. Further erosion around the pad could cause the transformer to lean and possibly impact Plant operation.

Figure 10. Base of padmount transformer at WTG F4.

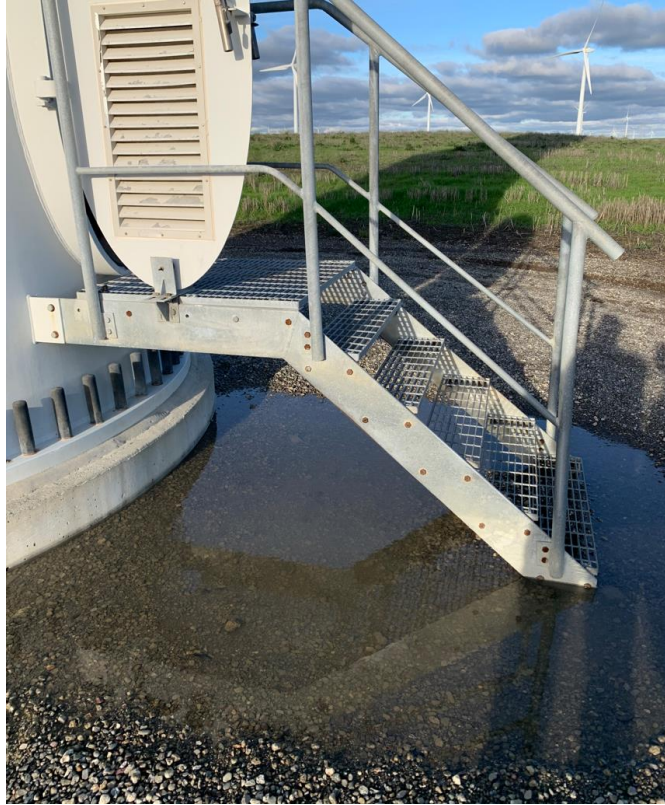
ESRB also observed a large amount of standing water at the base of the WTG F4 tower. That body of water extended to, and fully surrounded, the stairs leading into the tower. The presence of standing water pooling at the site could indicate erosion issues around the tower. General Electric’s maintenance manual requires that visual inspections should include identifying water erosion/intrusion around the foundation. The presence of standing water surrounding the entrance to the tower could also be a slipping hazard.

Figure 11. Tower base and stairs of WTG F4.

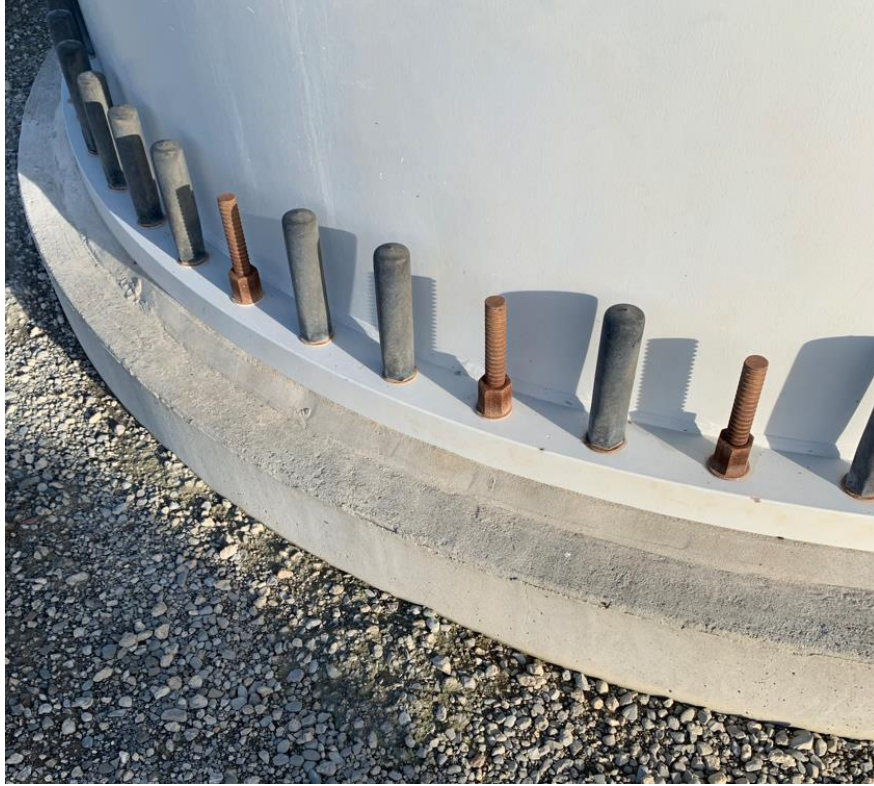
ESRB observed multiple instances in which bolt covers at the base of wind towers had been removed, presumably by livestock. Three bolt covers were missing from WTG B16R and four were missing from WTG F4. The bolt covers protect the exterior bolts from damage from the environment. The covers for all bolts at the base of wind towers throughout the Plant should be maintained and replaced to maintain the towers’ structural integrity.

Figure 10. Missing bolt covers at tower base of WTG F4.
