**CALIFORNIA PUBLIC UTILITIES COMMISSION
Safety and Enforcement Division
Electric Safety and Reliability Branch**

Incident Investigation Report

Incident Number: E20200614-01

Utility Facilities Involved: Buellton 1101, 12 kV Circuit.

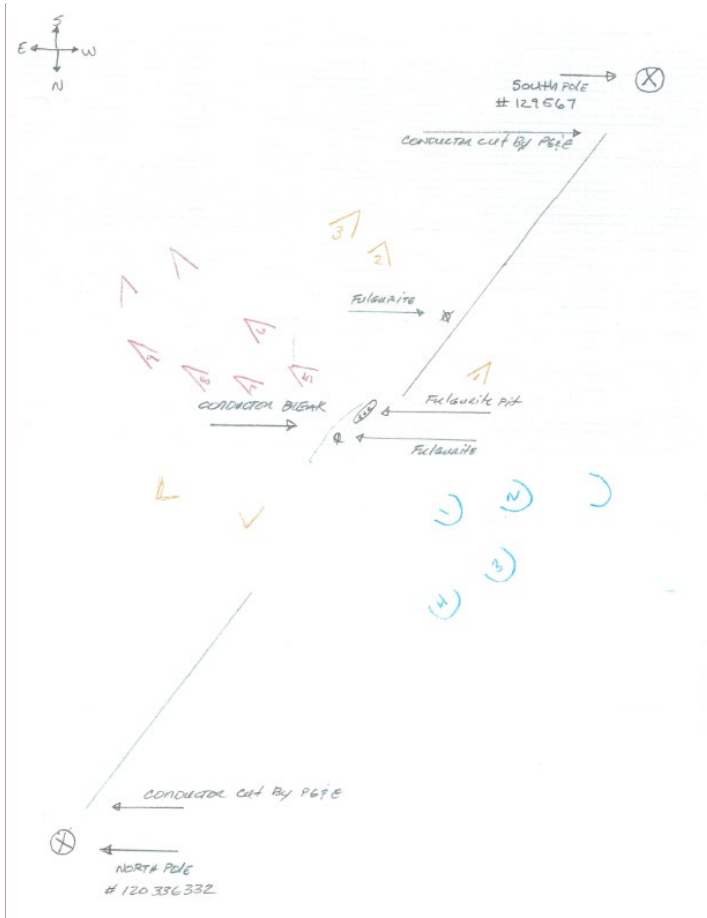
Figure 3: Drawing of incident location provided by SBCFD (not to scale)⁴.

The incident location near Highway 246 and Drum Canyon Road did not involve any vegetation or other foreign object contact. SBCFD provided a drawing of PG&E's facilities and evidence of electrical ignition in Figure 3.

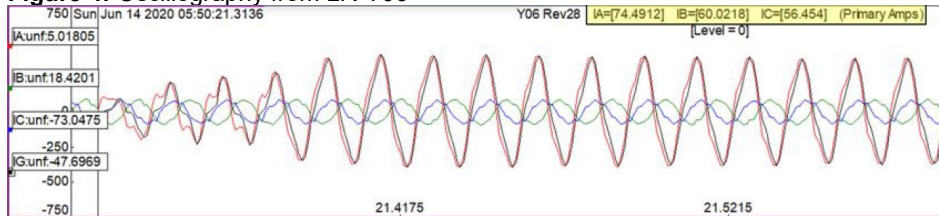
Figure 4: Oscillography from LR-Y06¹³

PG&E was able to provide oscillography from the nearest upstream line recloser, LR-Y06, when the South PG&E Distribution and Control Center (DCC) tried to remotely close the recloser at 1250 hours on June 14, 2020. The recloser detected a fault and automatically reopened. The A, B, and C phase conductors recorded loads of 74, 60, 56 amps, respectively. The oscillography in Figure 4, below, shows the spike in current on the A phase and ground, indicating a line-to-ground fault on the A phase. Measurements of the current are shown at the black vertical line on the left of the image, between Sun and Jun in the date heading.

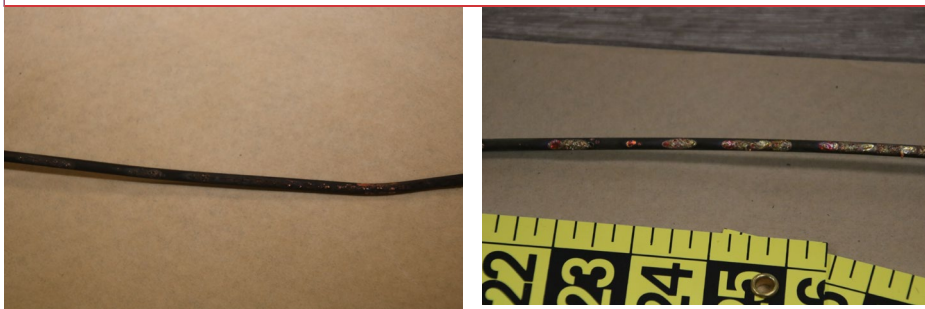
The east and center conductors both had damage indicating electrical arcing. The damage can be seen in Figures 6 and 7.

Figure 6: Damaged east conductor.

Figure 7: Damaged center conductor.

SBCFD's investigation report concluded that the origin and cause of the Drum Fire was a conductor owned and operated by PG&E. It was determined that the fire was ignited when an electrical conductor failed and arced to ground. The SBCFD eliminated all other potential causes of the fire.¹⁸ The faulted east conductor, and the center conductor that later failed while SBCFD was on scene, were determined to have sustained damage consistent with electrical arcing during a conductor-to-conductor contact.¹⁹
