CALIFORNIA PUBLIC UTILITIES COMMISSION
Safety and Enforcement Division
Electric Safety and Reliability Branch

Incident Investigation Report

Incident Number: E20191024-01

Regulated Entity Facilities Involved: Geysers #9 Lakeville 230 kV Line

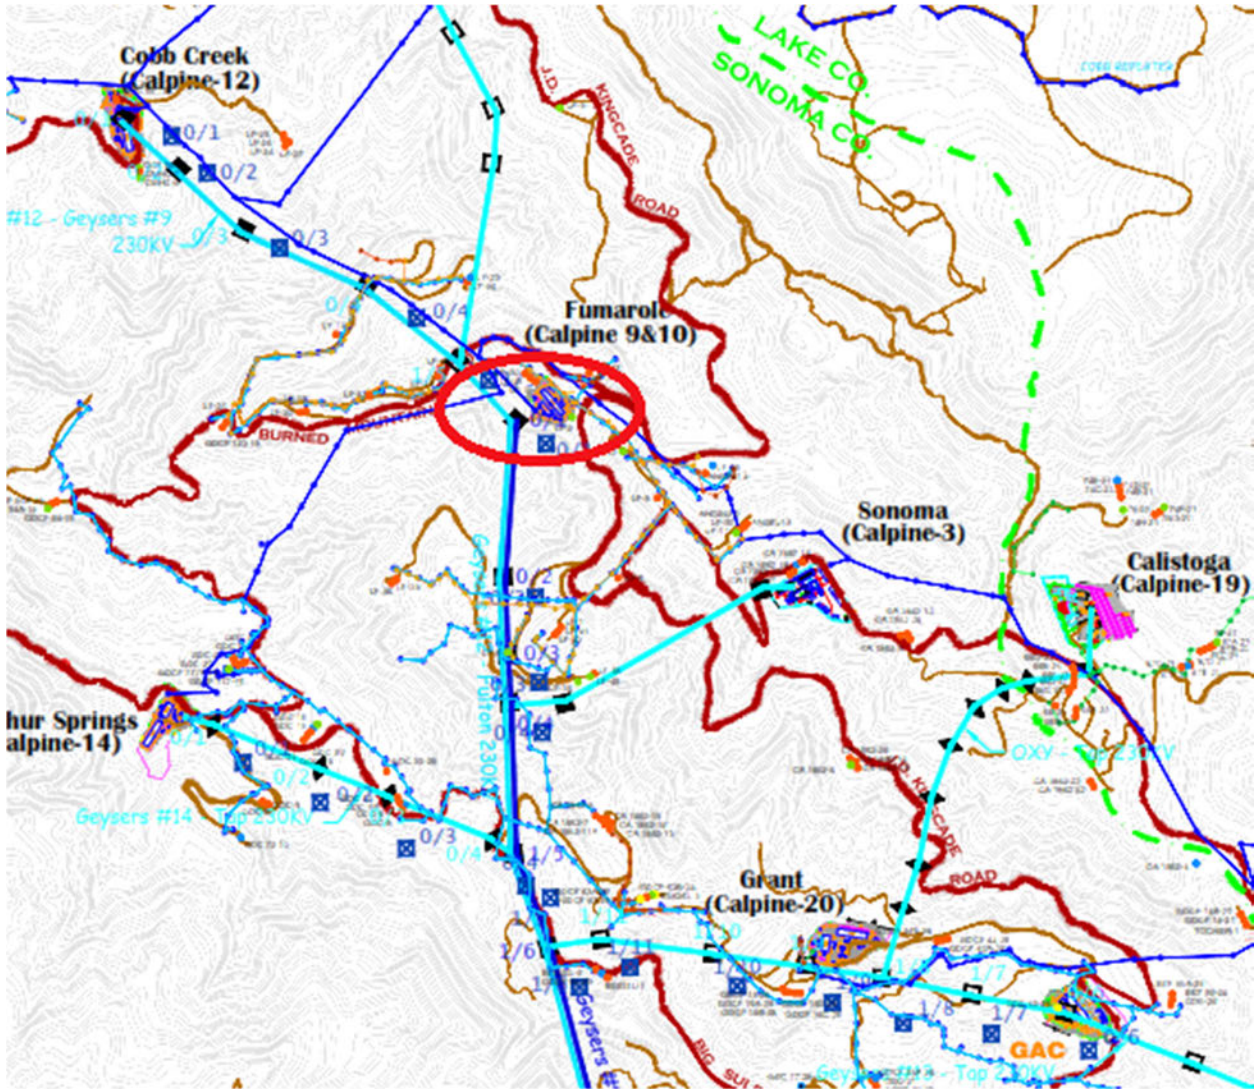
Figure 2: Map indicating incident location (circled) and Incident Line. The dark blue line approaching from the south and terminating at “Calpine 9&10” is the Incident Line. The blue line that is parallel to the Incident Line and continues running northwest past Unit 9/10 is the Geysers #12 Fulton Line.

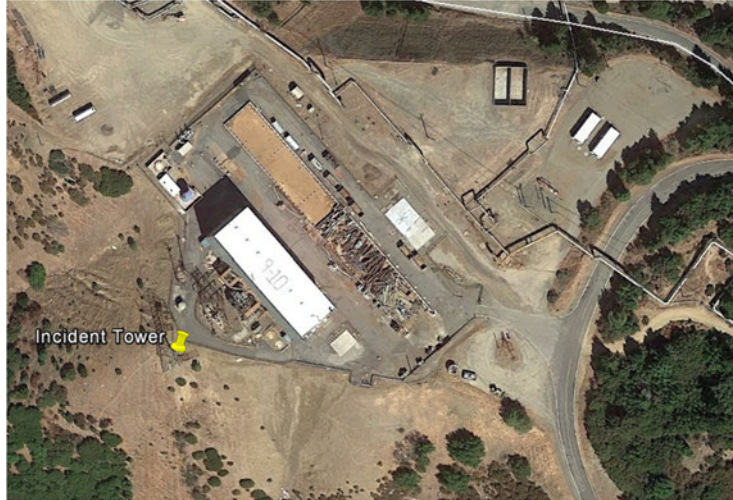
For purposes of this Report, the Incident Tower and the nearby GPC Unit 9/10 are referred to as the “Incident Site” and are shown in Figure 3. The Incident Site is accessible by automobile via Kincade Road in Sonoma County.

Figure 3: Google Earth view of the Incident Site. Incident Tower (shown with pin) located immediately southwest of GPC Unit 9/10. Road to the east is Kincade Road.

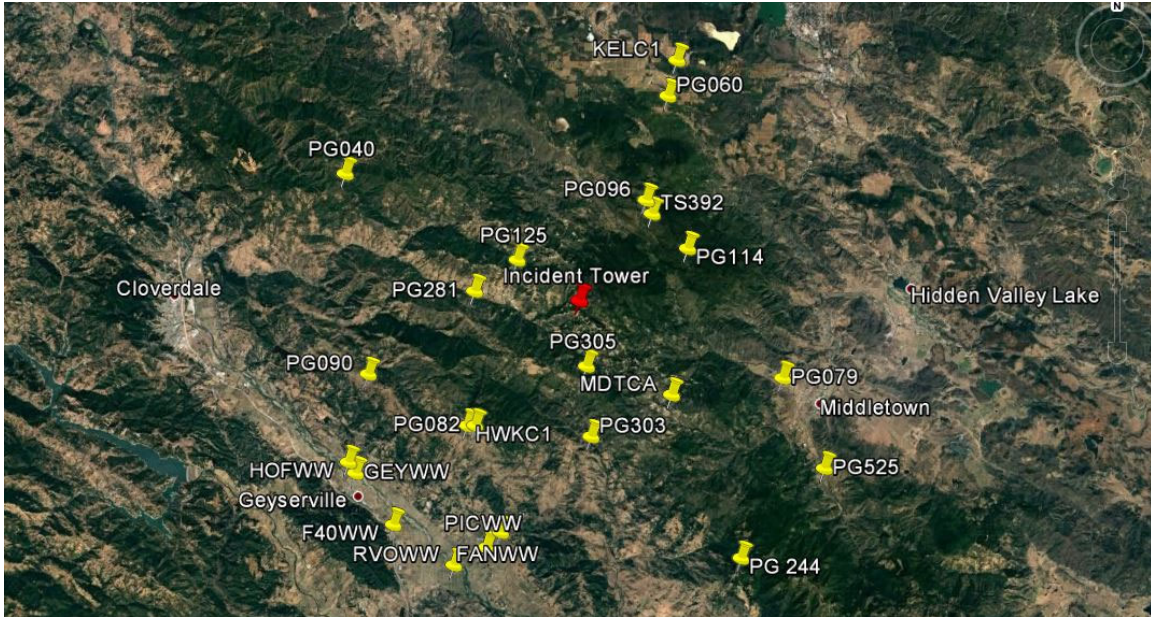
At the time of the incident, the highest measured wind gust speed within a 10-mile radius of the Incident Tower was 63 miles per hour (mph). This was recorded by weather station PG305, which is located about 2.2 miles south of the Incident Tower.¹⁴ Other weather stations in the incident area recorded wind gust speeds of approximately 30 mph or lower. At 00:20 on the night of the incident, CAL FIRE measured wind speeds of 35 mph from the North, North/east direction at the incident location.¹⁵ Figure 4 below is a map of nearby weather stations, including station PG305 and the Incident Tower location.¹⁶ Figure 5 shows ten weather stations which recorded the highest wind gust speeds around the Incident Site.¹⁷

Figure 4: Map of Incident Site and nearby weather stations. Distance from Incident Site to weather station PG303 is approximately 4.6 miles.

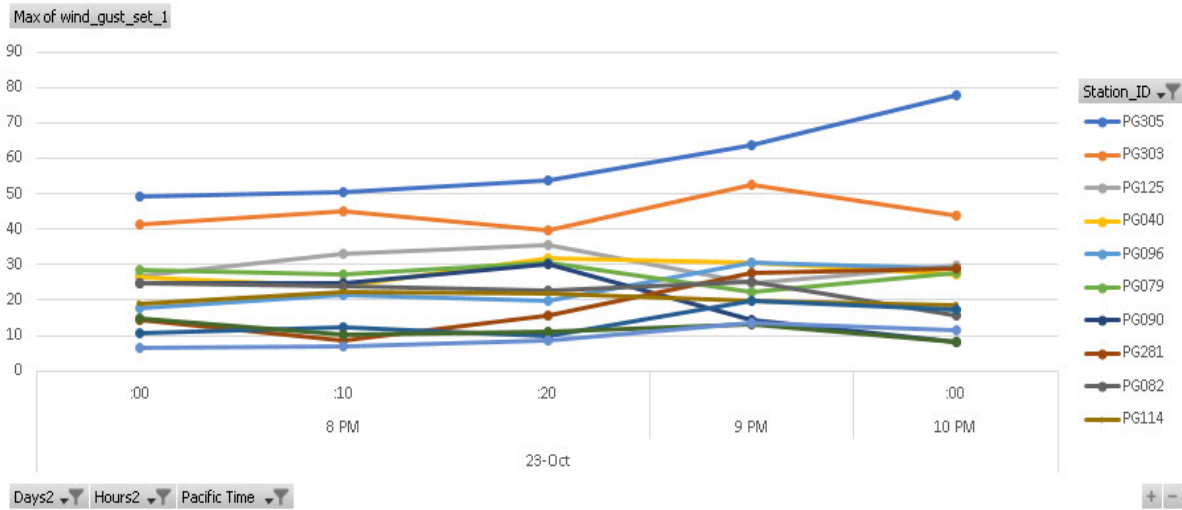
Figure 5: Wind gust speed of the 10 weather stations within 10 miles of the Incident Site that recorded the highest wind gust speeds at the time of the incident. (vertical axis indicates wind gust speeds in miles per hour)

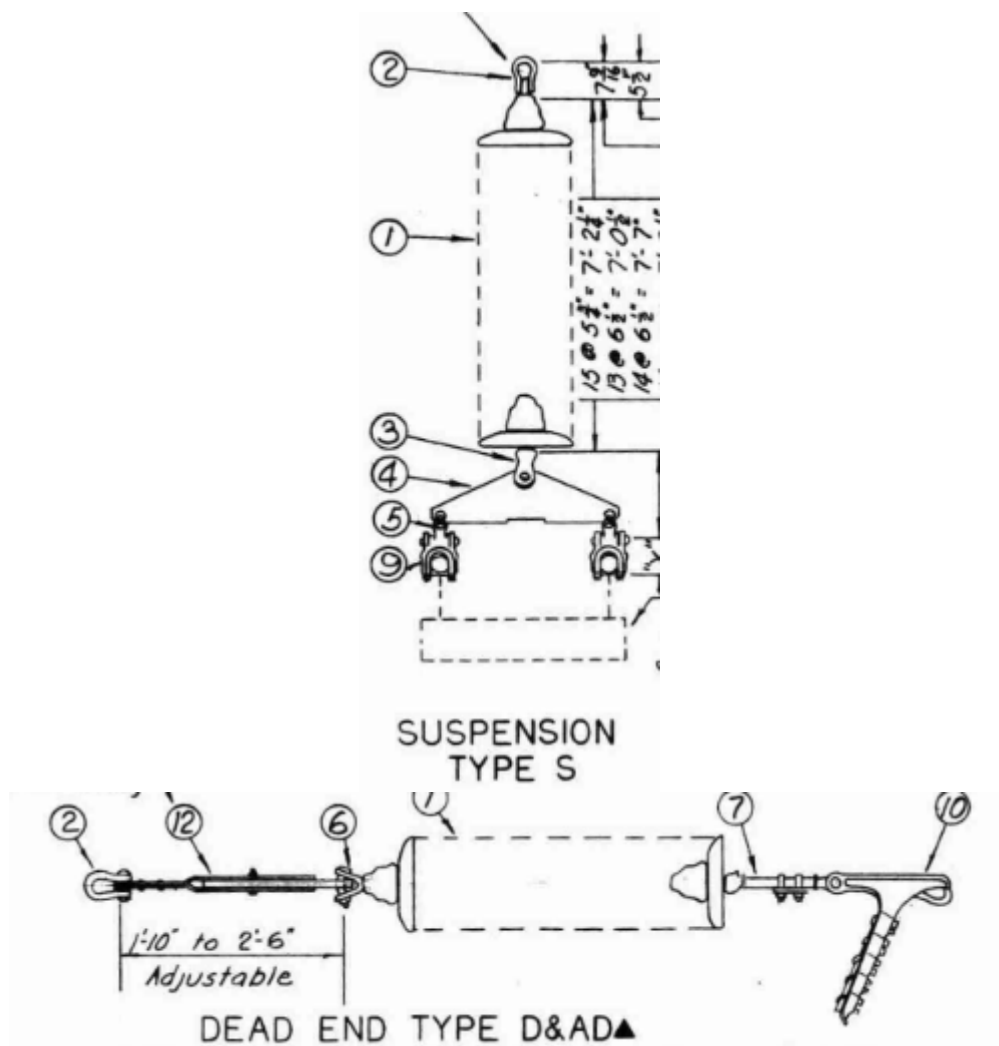
Figure 19: Design drawings of suspension and dead end type insulator configurations⁶¹

Design drawings provided by PG&E and shown in Figure 19 above, illustrate the use of a “jumper string” configuration at the Incident Tower that uses a weight to limit the movement of the insulator string.^{62,63} There are also items that were not on the tower at the time of the incident that are marked on a 1985 structure data sheet from PG&E. These include the aforementioned “hold down weights” and the “hold down shackles” that are used to attach the weights to the jumper cable assemblies.⁶⁴

With regards to the incident, there was nothing that limited the movement of the bottom end of the Lakeville-side suspended insulator strings. As noted in CAL FIRE’s report, the original configuration of the Incident Tower secured the jumper cables and insulator strings in place and prevented excessive movement of that equipment.⁸¹ By configuring the Incident Tower’s jumper cables and insulator strings in the manner shown in Figure 9 after disconnecting GPC Unit 9/10 from PG&E’s transmission system, PG&E allowed that equipment to have a greater range of
