**SUBJECT: General Order (GO) 167 Audit of Delta Energy Center
Audit Number GO167-1026**

STAFF REPORT

Audit Report of Delta Energy Center

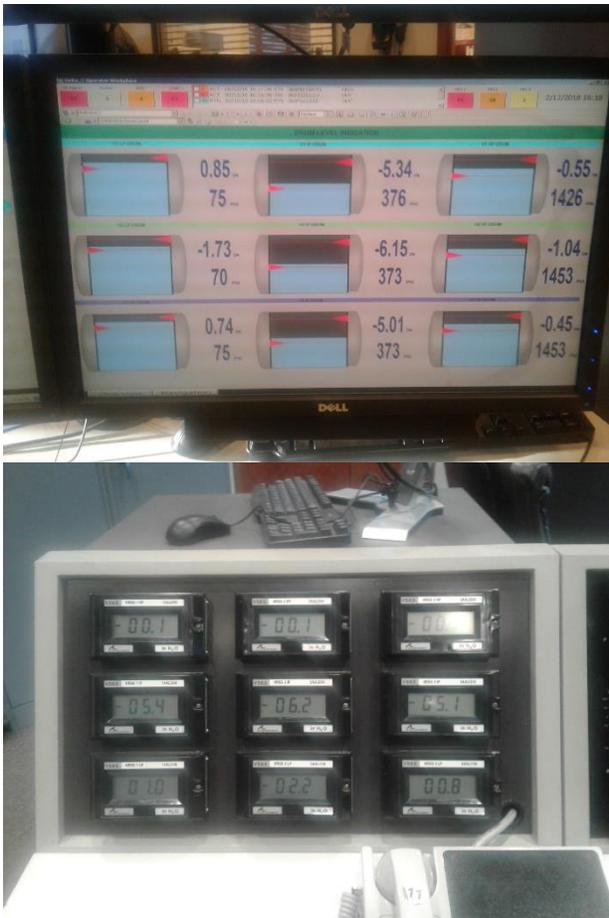
Figure 7: Delta's DCS provides drum level readings in computer displays and digital gauges.

Second, ESRB observed defective Eye-Hye® drum level gauges in the Control Room, see Figure 6. These gauges provide water level readings in the HRSG drums that are crucial for normal operation. Per ASME Code Section 1 (Part PG-60.1.1), “Boilers having a maximum allowable working pressure exceeding 400 psi shall have *two* gage glasses.” While the plant’s Digital Control System (DCS) also provides drum level readings on computer displays and digital gauges, both of these readings come from the same feed, see Figure 7. Per the Code, two independent and discrete systems (that continuously measure, transmit, and display water level) must be provided. Therefore, Delta must repair the Eye-Hye® gauges to comply with this ASME requirement.

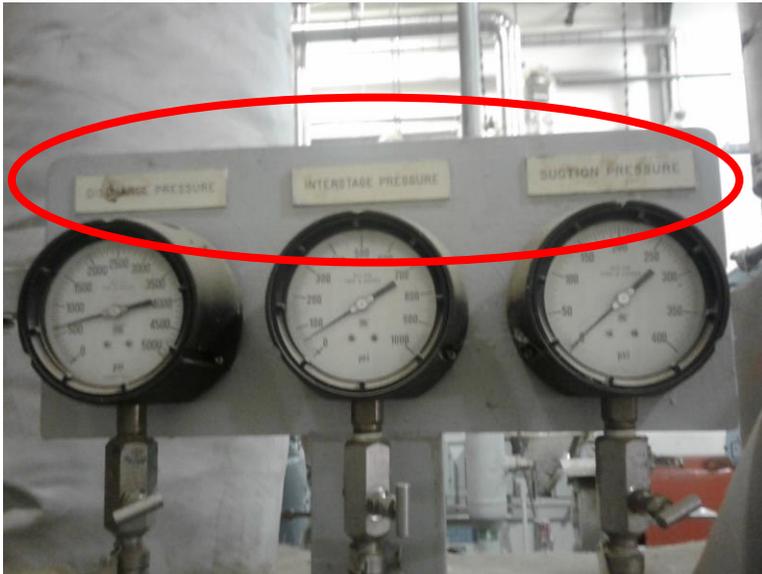
At Unit 1's Boiler Feed Pump (BFP), ESRB observed unlabeled pressure gauges, see Figure 20. These gauges provide the pump's suction and discharge pressure readings that are crucial for normal operation. While these gauges are also equipped with digital transducers that provide the same readings to the plant's DCS, outside operators often look at these gauges to reconcile and

identify disparities between the digital and analog readings. The same set of gauges were properly labeled at Unit 2's BFP, see figure 21.

Figure 21: Labeled pressure gauges at Unit 2's BFP.

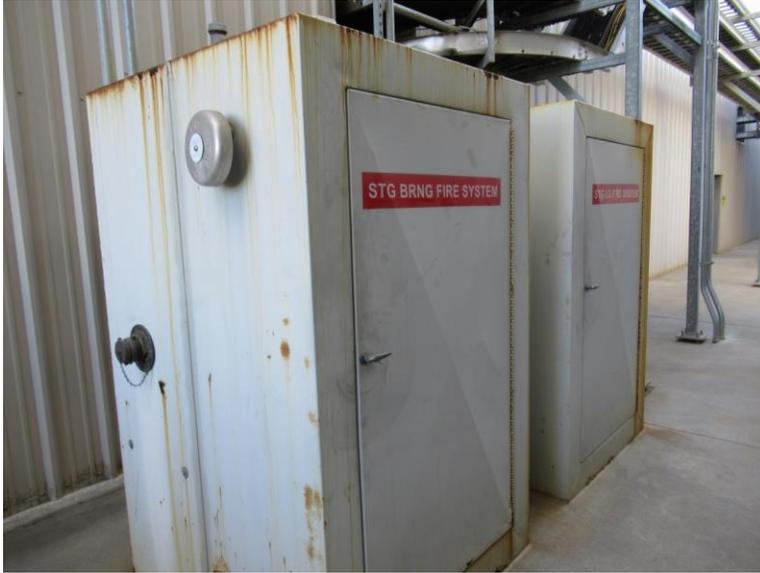
The Plant uses tags to record inspection dates for its STG (Steam Turbine Generator) fire system. ESRB inspected control valves inside a fire system cabinet and found most inspection tags out-of-date, see Figures 25 and 26. For example, the STG fire system cabinet had inspection tags dating back to May 5, 2016. Delta explained that it regularly inspects its fire protection system, but its contractor has not kept its inspection tags up-to-date. Inspection tags provide crucial data for operator and maintenance workers at the equipment's physical location. Delta must keep its inspection tags up-to-date.

Figure 25: STG bearing fires system cabinet.
