Re: 2023 Annual Electric Distribution Reliability Report, D. 16-01-008

Pursuant to the California Public Utilities Commission (Commission) Decision (D.) 16-01-008, "Updating the Annual Electric Reliability Reporting Requirements for California Electric Utilities," Bear Valley Electric Service, Inc. (BVES) submits herewith its 2023 Annual Electric Distribution Reliability Report (Report).

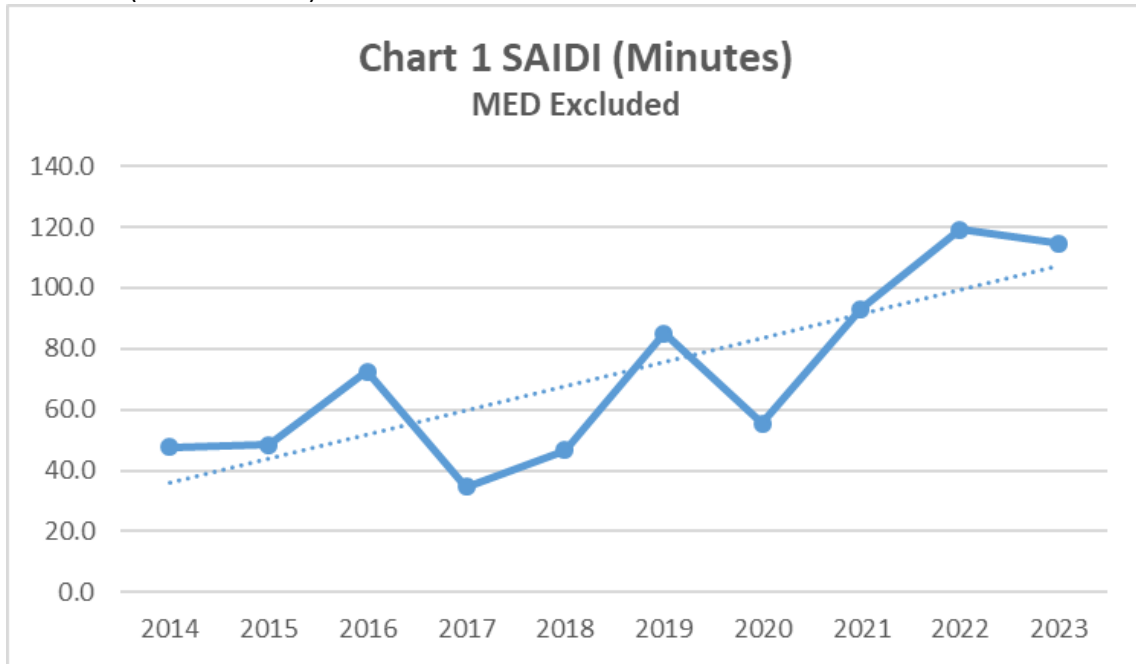
Charts 1 through 4 provide line graphs of SAIDI, SAIFI, MAIFI and CAIDI for the past 10 years with linear trend line (MED Excluded).

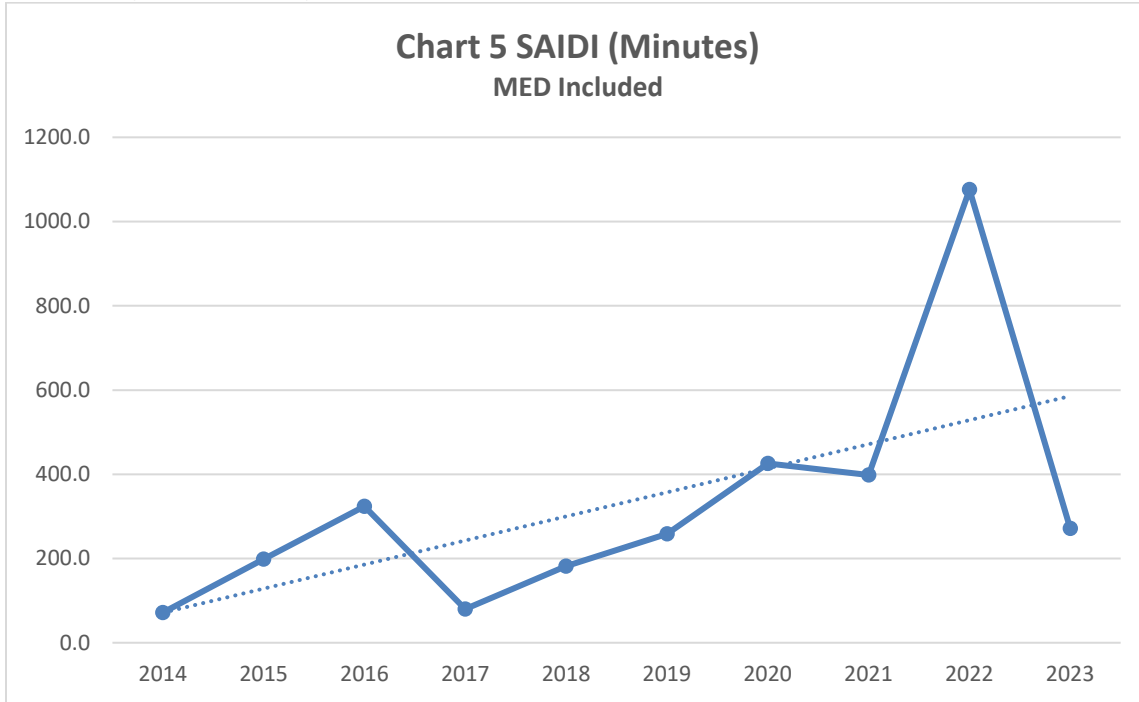
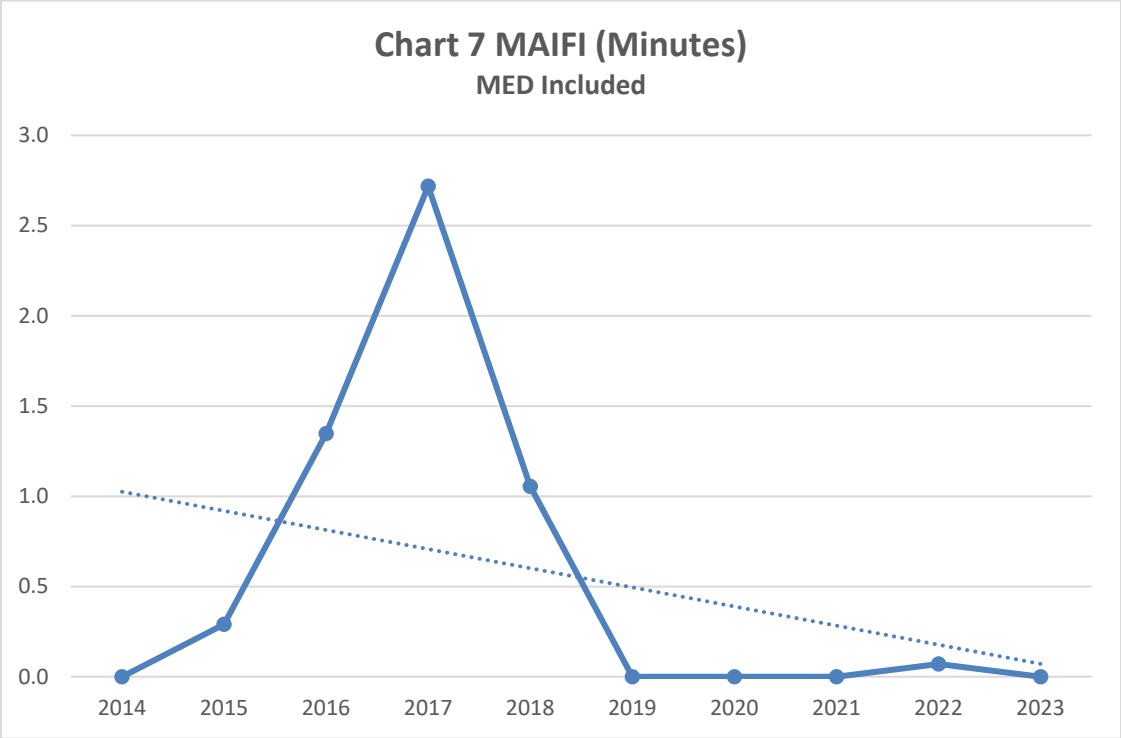
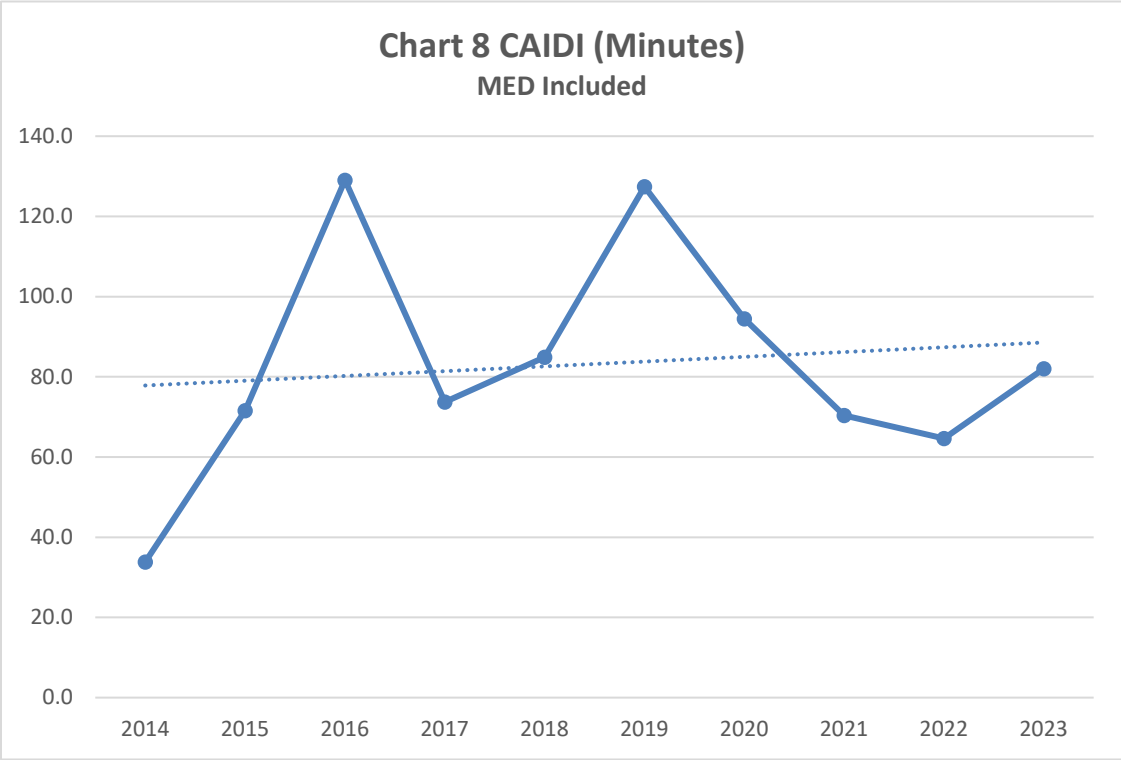
Charts 5 through 8 provide line graphs of SAIDI, SAIFI, MAIFI and CAIDI for the past 10 years with linear trend line (MED Included).

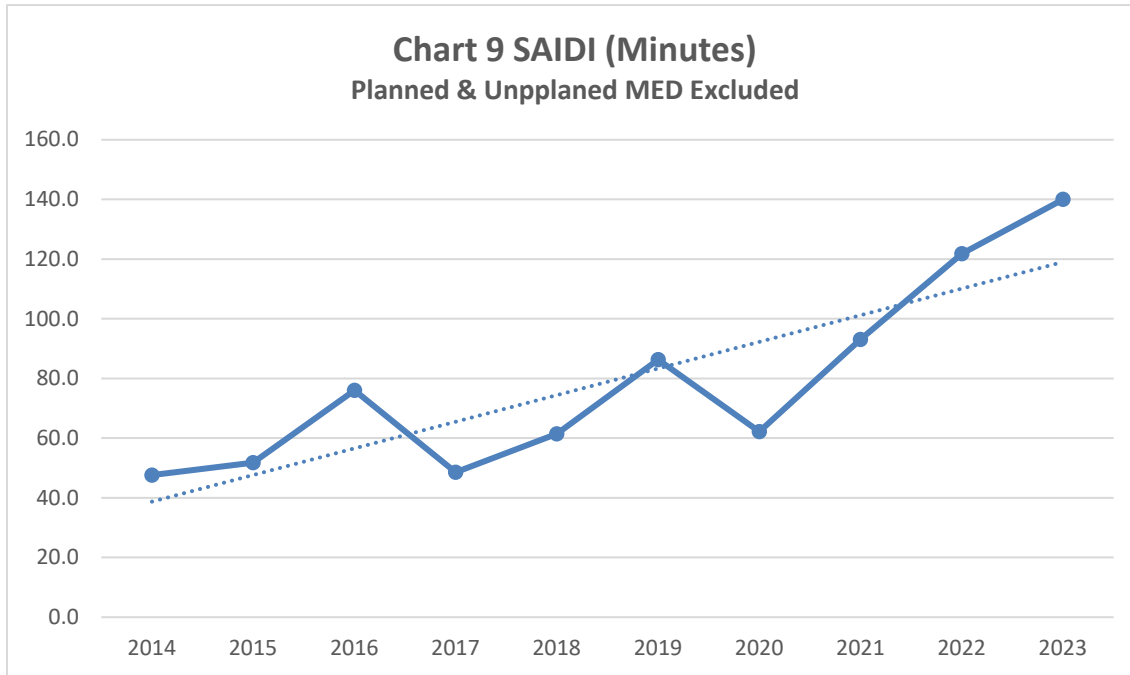
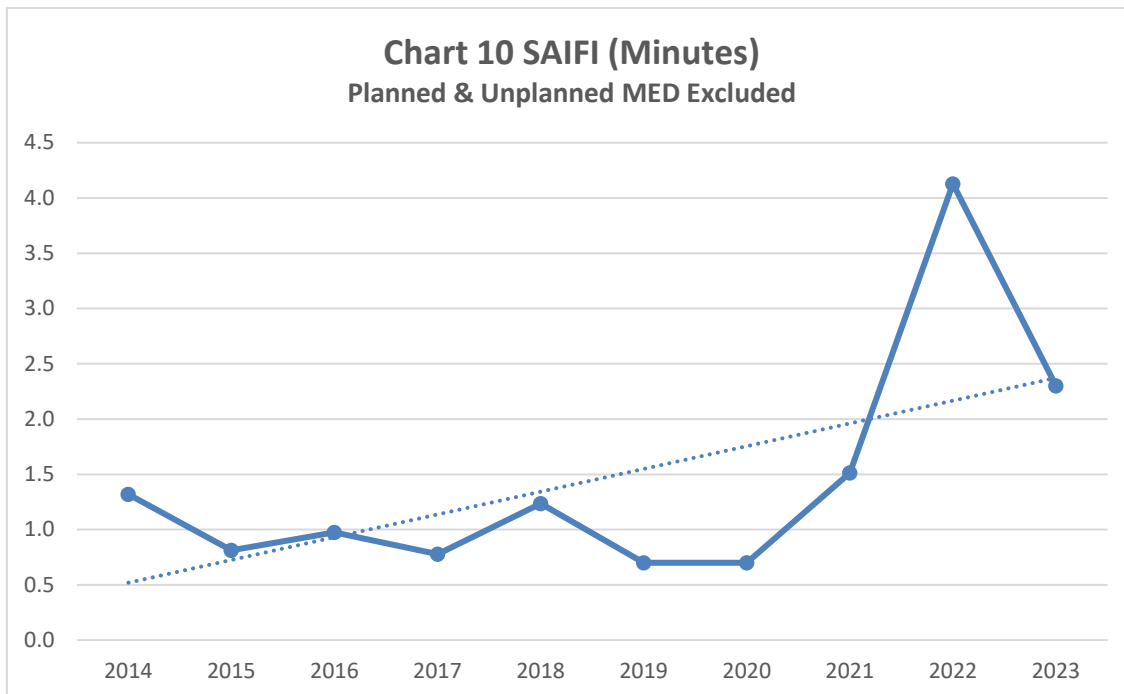
Charts 9 through 12 provide line graphs of SAIDI, SAIFI, MAIFI and CAIDI for the past 10 years with linear trend line for planned and unplanned outages (MED Excluded).

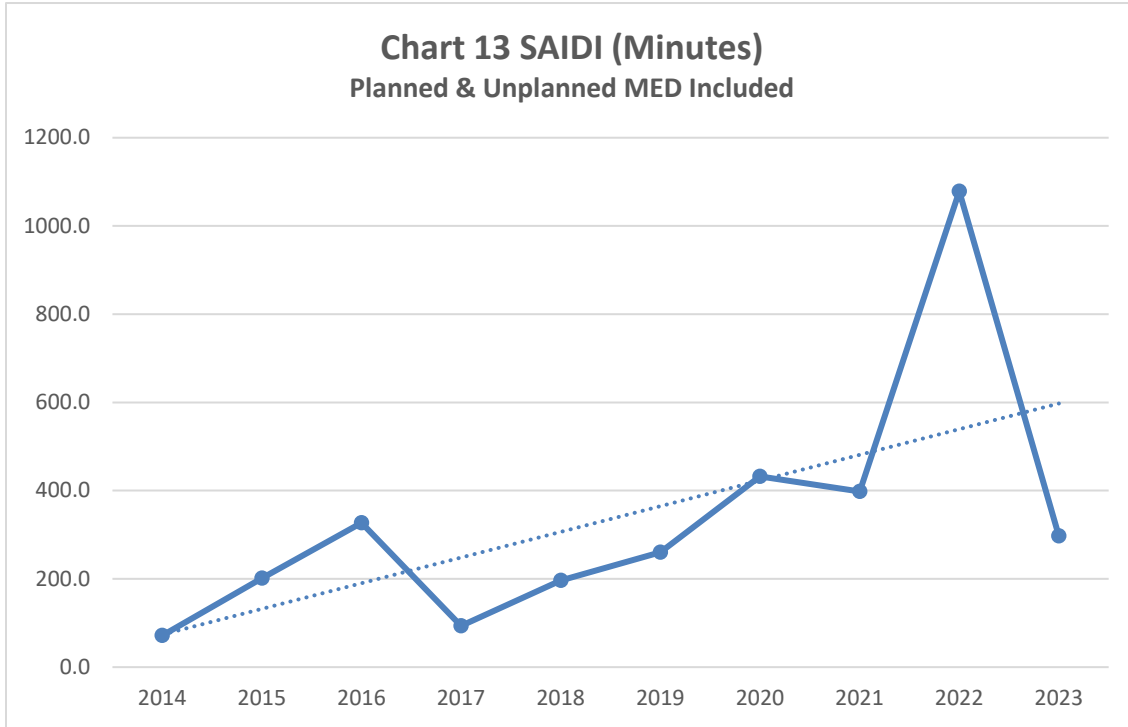
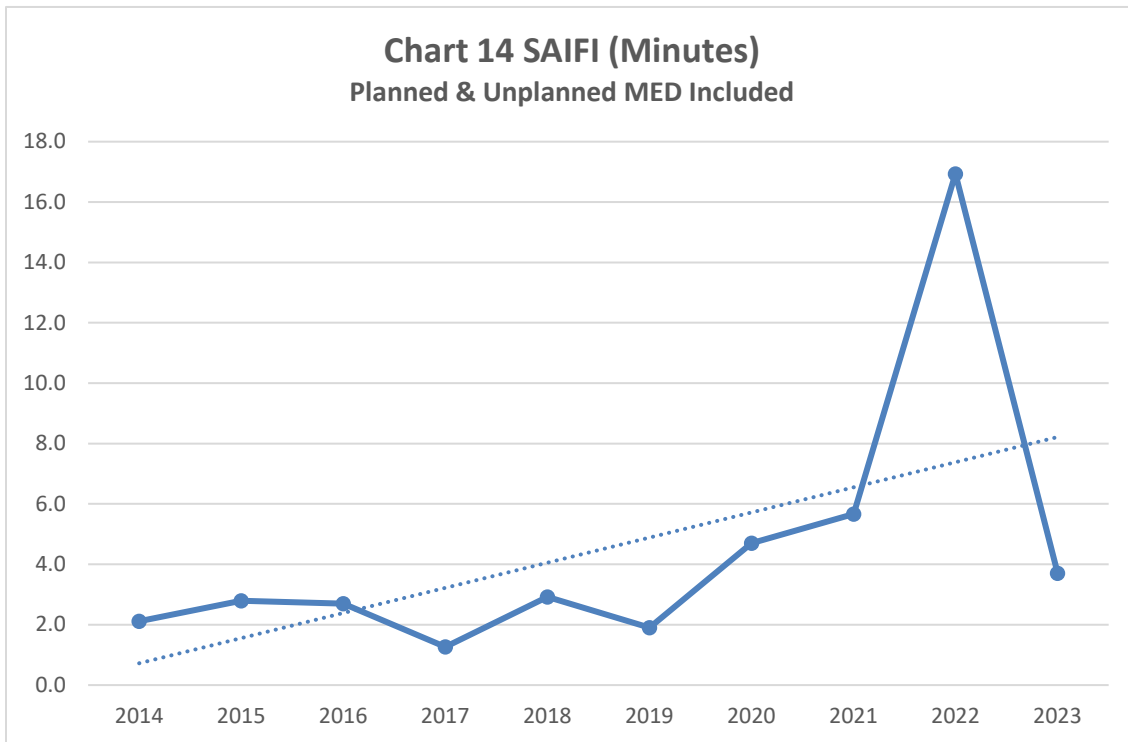
Charts 13 through 16 provide line graphs of SAIDI, SAIFI, MAIFI and CAIDI for the past 10 years with linear trend line for planned and unplanned outages (MED Included).
